**Internal Review of MSHA's Actions at the
Darby Mine No. 1
Kentucky Darby LLC
Holmes Mill, Harlan County, Kentucky**

U.S. Department of Labor
Mine Safety and Health Administration
Program Evaluation and Information Resources

Date June 28, 2007

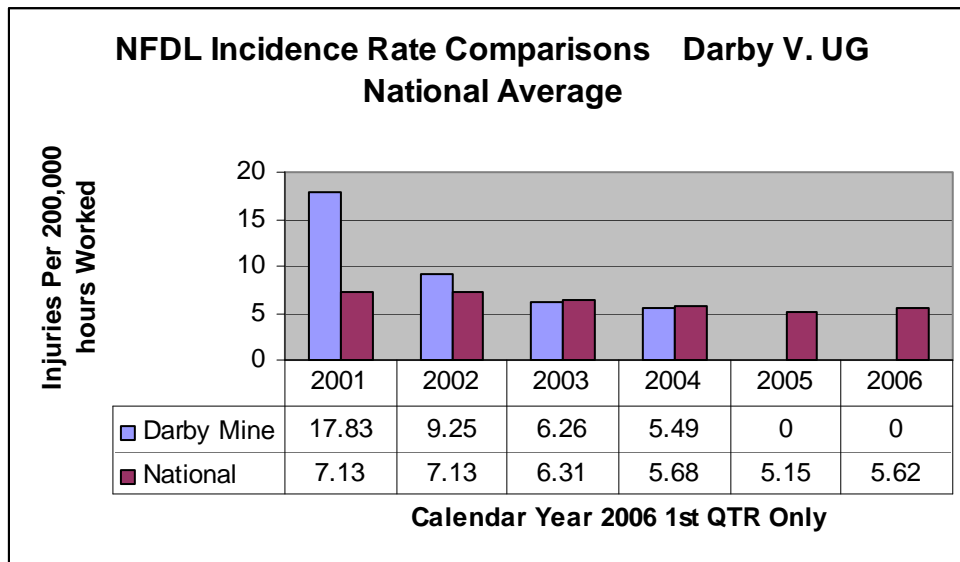
The review team examined the nonfatal, days-lost (NFDL) injury incidence rates for the Darby Mine from 2001 through the 1st quarter of 2006. In 2001, the NFDL injury incidence rate for Darby Mine was significantly above the national average for underground coal mines. The NFDL injury incidence rate for the first quarter of 2006 was 0.00 for the Darby Mine and 5.62 for the nation.

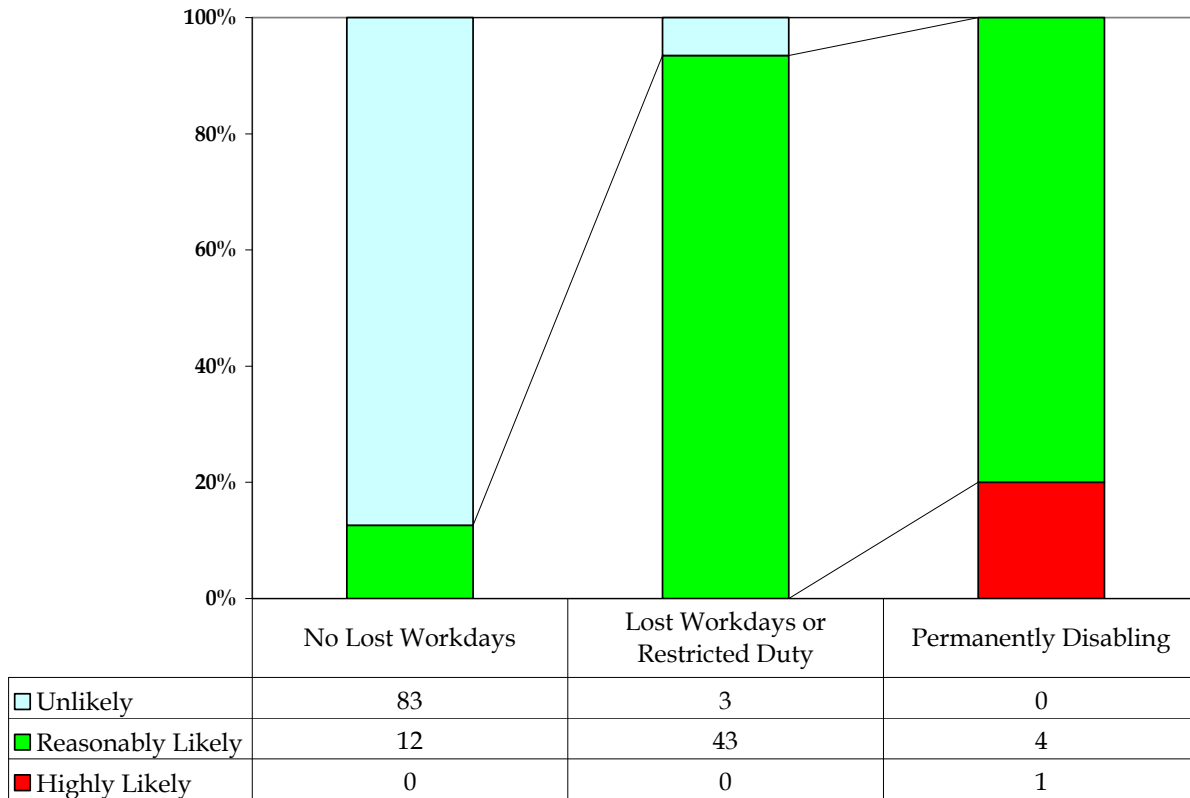
During the review period, only 5 citations out of 146 issued at the Darby Mine were designated with an anticipated injury exceeding “lost workdays or restricted duty.” In their interviews with the review team, several inspectors indicated that determinations of likelihood of injury or illness and the expected injury or illness are interrelated. For example, inspectors believed that if the injury was “unlikely” to occur, the expected injury could not be “fatal.” Similarly, inspectors believed that if an injury or illness would be “reasonably likely” to occur it most likely would result in “lost workdays or restricted duty.” The inspectors’ opinion was shared by District 7 conference and litigation representatives. The following chart illustrates the results of the perceived nexus between the likelihood of occurrence and the anticipated injury or illness. Eighty-seven percent of the citations issued at the Darby Mine during the review period followed this pattern.

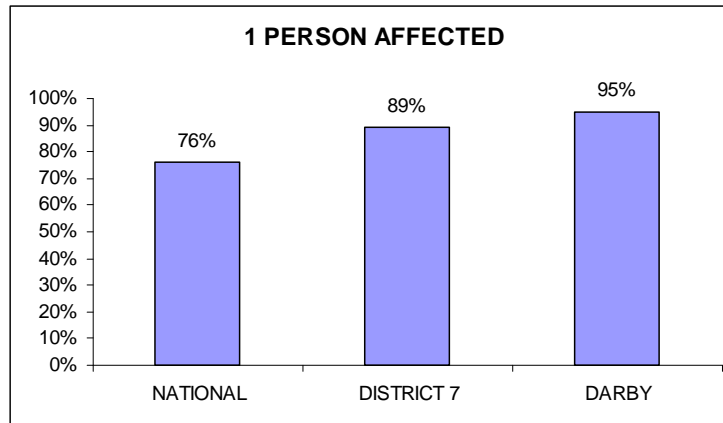
Of the 146 section 104(a) citations issued at the Darby Mine during the review period, 139 (95 percent) indicated only one person affected. In District 7, 89 percent of all citations and orders issued at underground mines during the review period indicated one person affected. The following chart compares determinations of the number persons affected at the Darby Mine with all underground mines in District 7 and the nation.

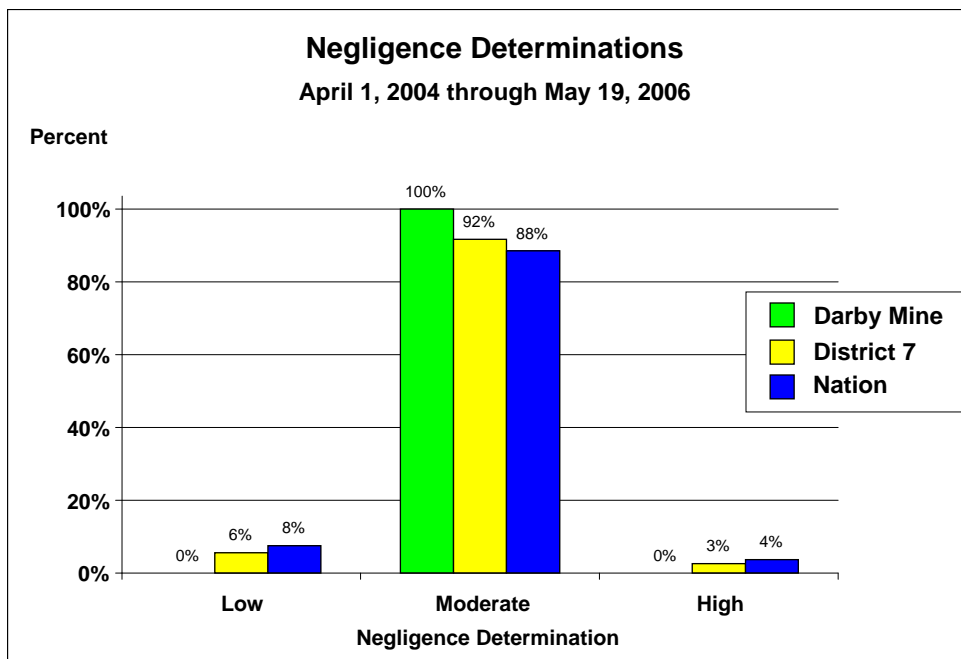
The following chart shows a comparison of negligence determinations at the Darby Mine, District 7 underground mines, and underground coal mines nationwide during the review period.

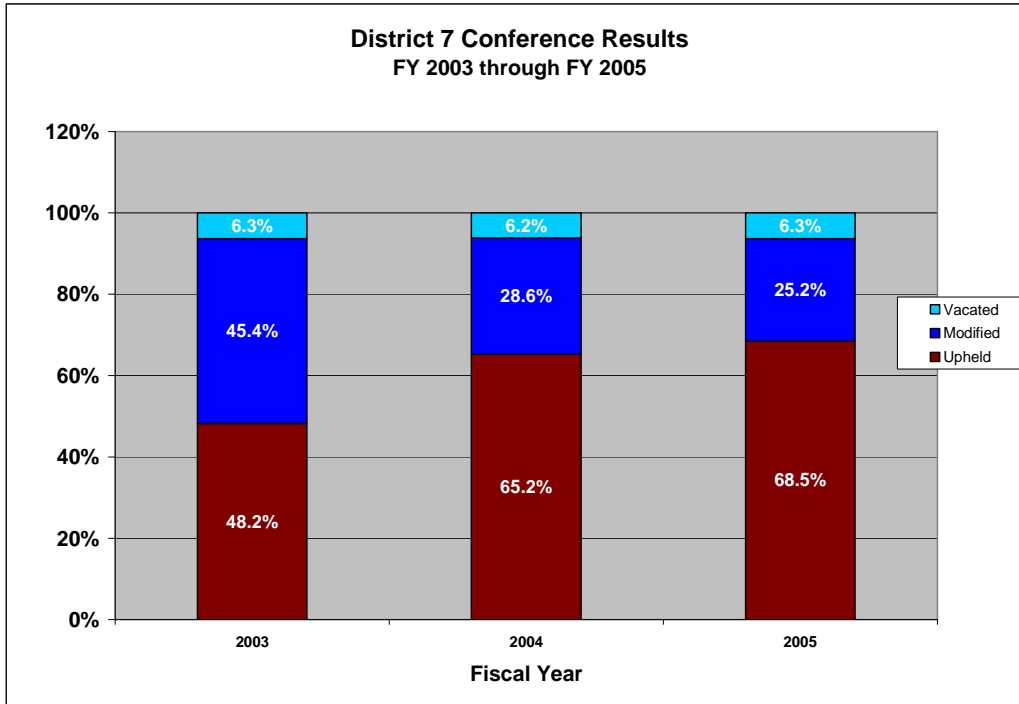
Fiscal Year	Violations Issued	Conferenced		Modified		Upheld		Vacated	
		Number	Percent	Number	Percent	Number	Percent	Number	Percent
2003	7,973	427	5.4%	194	45.4%	206	48.2%	27	6.3%
2004	8,652	552	6.4%	158	28.6%	360	65.2%	34	6.2%
2005	9,992	682	6.8%	172	25.2%	467	68.5%	43	6.3%
Total	26,617	1,661	6.2%	524	31.5%	1,033	62.2%	104	6.3%

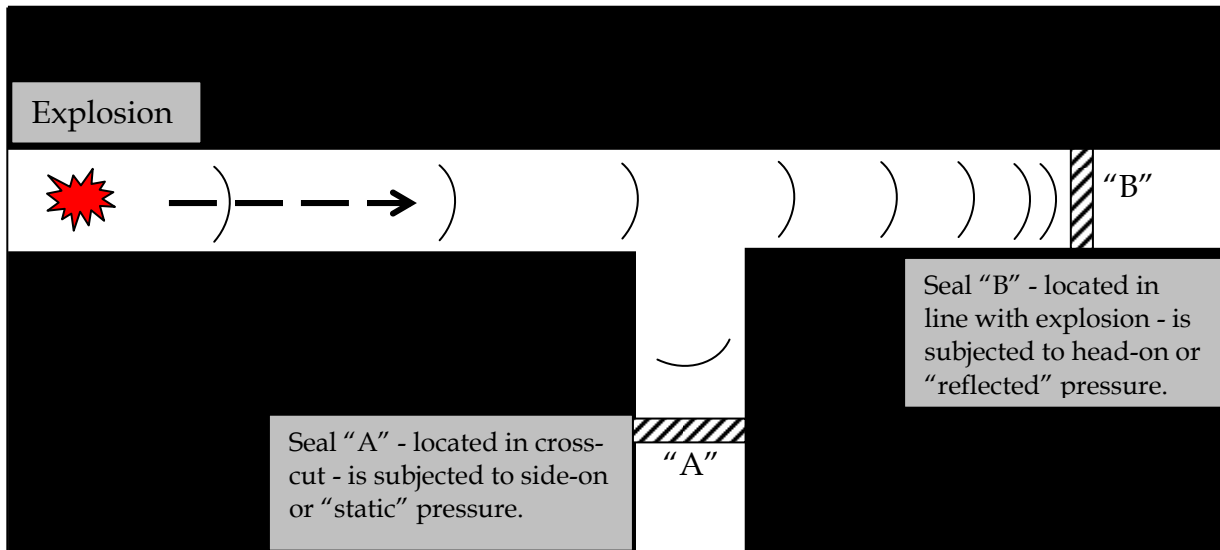
Figure 1 - Simplified illustration of "side-on" or "static" pressure versus "head-on" or reflected pressure.

While the Lake Lynn Experimental Mine is a limestone mine, the seal tests were conducted in mine openings configured similar in size to coal mine openings. The tests involved constructing seals and subjecting them to a pressure pulse of 20 psi generated from a methane explosion. The test seals were constructed in cross-cuts off of the entry in which the methane explosion was initiated (see Seal "A" in Figure 1). As a result, the seals were subjected to a "side on" or "static" pressure. This test set up was used based on RI 7581's recommendation that a seal be considered explosion proof if it could withstand a "static" pressure of 20 psi (versus a head-on or "reflected" pressure). The seal would be subjected to a head-on or "reflected" pressure if it was constructed across the entry in which the explosion was initiated (see Seal "B" in Figure 1).
