Technical Manual: Conduits through Embankment Dams

Best Practices for Design, Construction, Problem
Identification and Evaluation, Inspection,
Maintenance, Renovation, and Repair

September 2005

Federal Emergency Management Agency

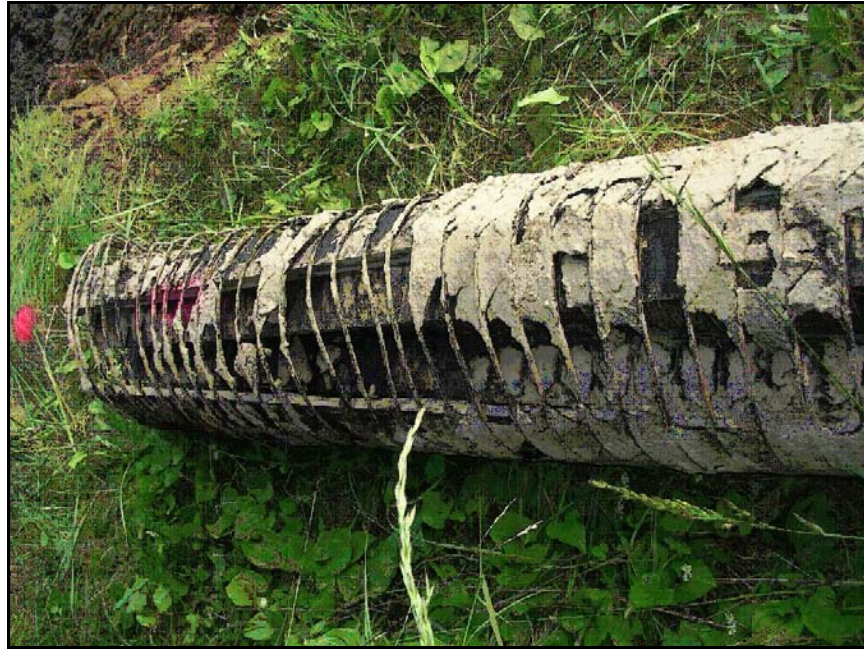
Figure 3.—A 15-inch diameter, wire-wrapped wood stave pipe used as an outlet works conduit within a 75-year old embankment dam. The outlet works conduit was removed and replaced due to deterioration and backward erosion piping concerns.

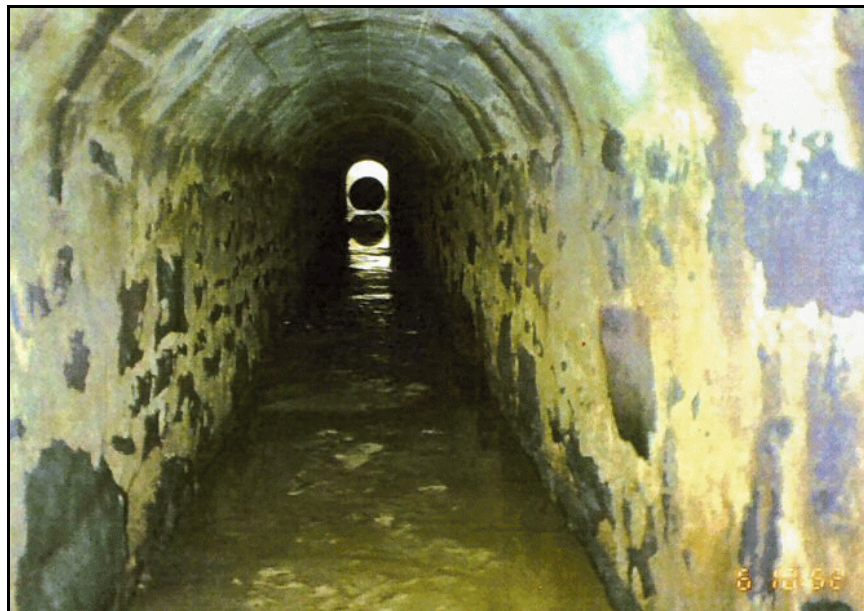
Figure 4.—A 100-year-old, mortar-lined, rubble masonry outlet works conduit.

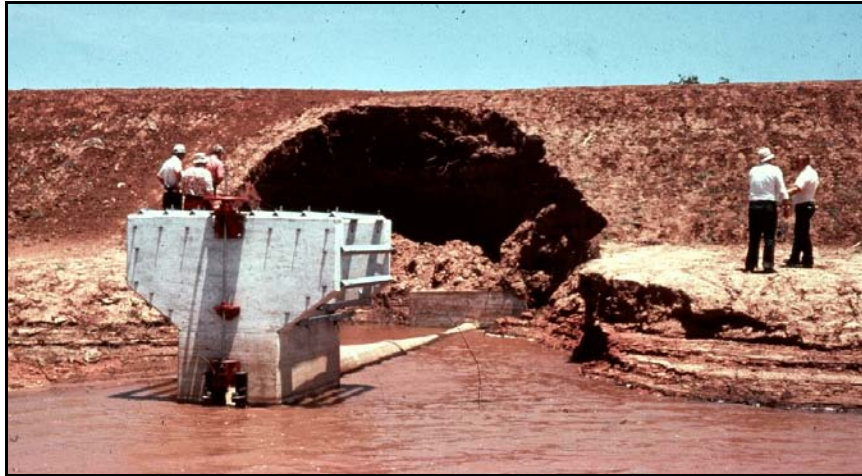
Figure 5.—Embankment dam failure caused by internal erosion of earthfill near the conduit. Flow was not directly along the contact between earthfill and conduit, but in the earthfill away from conduit. Hydraulic fracture in highly dispersive clay embankment soils caused the failure. The embankment design included antiseep collars, but not a filter diaphragm.

Historically, a single term, “piping,” has been commonly used in literature to describe all erosional processes involved in embankment dam failures. The reason for this is that frequently after a failure, a tunnel-shaped feature resembling a pipe is observed. See figure 5 for an example. In this document, two terms will be used to describe failures of embankment dams associated with uncontrolled flow of water, rather than using a single generic term. The two terms that will be used in this document are:

Often, the end result of internal erosion along the hydraulic fracture is a tunnel-shaped void (see figure 5). Loss of the reservoir contents can occur by water flowing through the tunnel-shaped void. Where the tunnel-shaped void enlarges sufficiently (see figure 5), the roof of the tunnel collapses, leaving a v-shaped notch in the embankment dam like that shown in figure 6. If the reservoir had contained a little more storage and the flow had continued a little longer through the tunnel-shaped void, the embankment dam shown in figure 5 would have collapsed and looked similar to the embankment dam in figure 6.

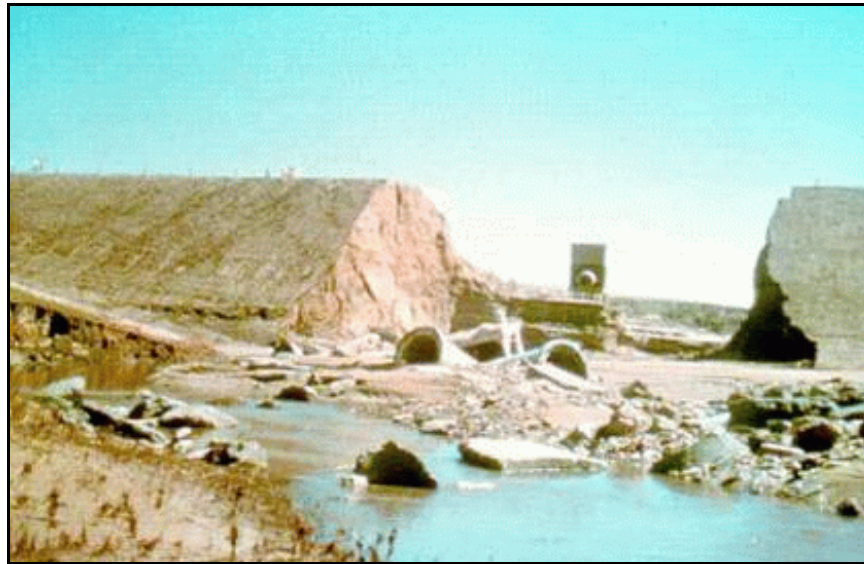
Figure 6.—Embankment dam failure caused by internal erosion of earthfill near the conduit. The initial failure was tunnel shaped, but the collapse of the roof of the tunnel resulted in the observed shape of breach. Hydraulic fracture in highly dispersive clay embankment soils caused the failure. The embankment dam design included antiseep collars, but no filter diaphragm.

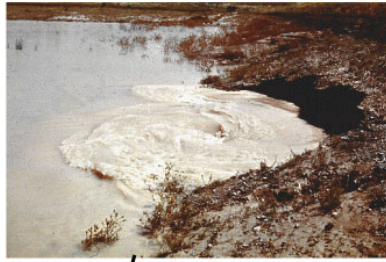
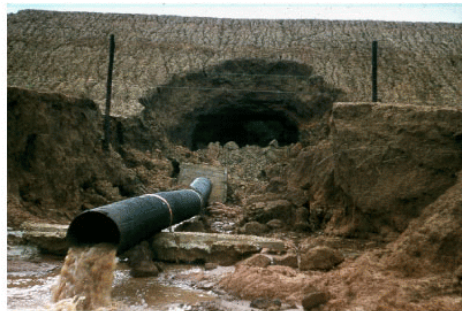
Figure 7 (cont'd).—The internal erosion process as a result of a hydraulic fracture.

A vortex may form at the location where water in the reservoir enters the upstream end of the hydraulic fracture.

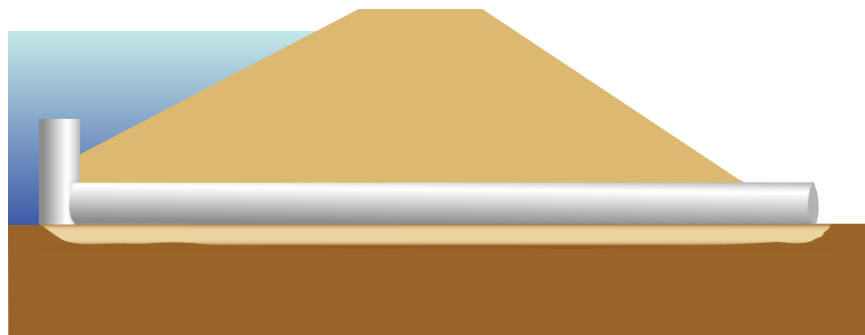
Figure 9.—The internal erosion process associated with the creation of a void caused by excessive compactive energy used to compact embankment materials against the conduit.

If too much compactive energy is applied while attempting to compact the embankment materials under the haunches of the conduit, a void can occur beneath the conduit.

The void can extend beneath the entire length of the conduit.

Water from the reservoir can penetrate the void, initiating internal erosion of the side walls.

- Figure 7 illustrates the internal erosion process as a result of a hydraulic fracture through the embankment dam.
- Figure 8 illustrates the internal erosion process as a result of low density embankment materials under the haunches of a pipe due to poor compaction.
- Figure 9 illustrates the internal erosion process associated with the creation of a void caused by excessive compactive energy used to compact embankment materials against the conduit.
- Figure 10 shows the backward erosion piping process associated with intergranular seepage and the subsequent backward erosion of soil particles.

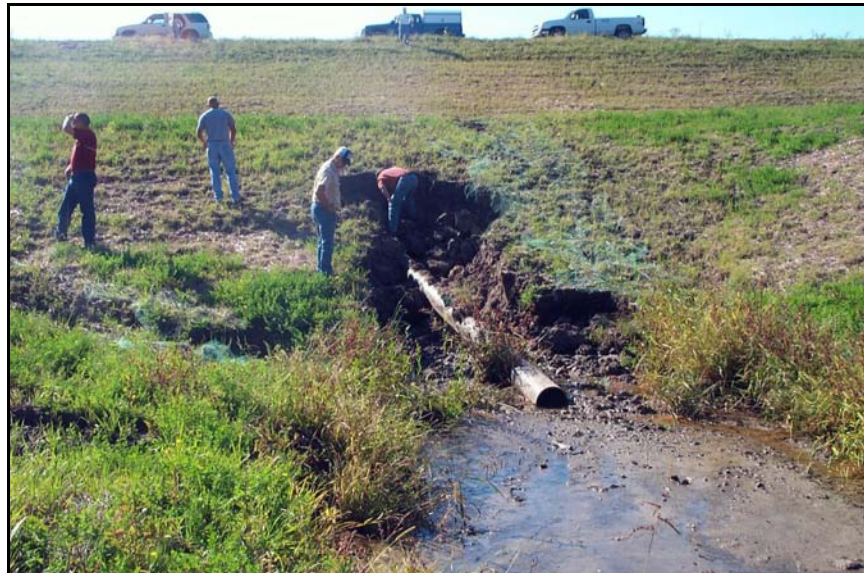
Figure 9 (cont'd).—The internal erosion process associated with the creation of a void caused by excessive compactive energy used to compact embankment materials against the conduit.

Flowing water from the reservoir continues the internal erosion process within the void. Intergranular seepage is not necessarily involved in this process, and the soils surrounding the void may be unsaturated.

The resulting failure often leaves a tunnel-shaped void along the conduit.

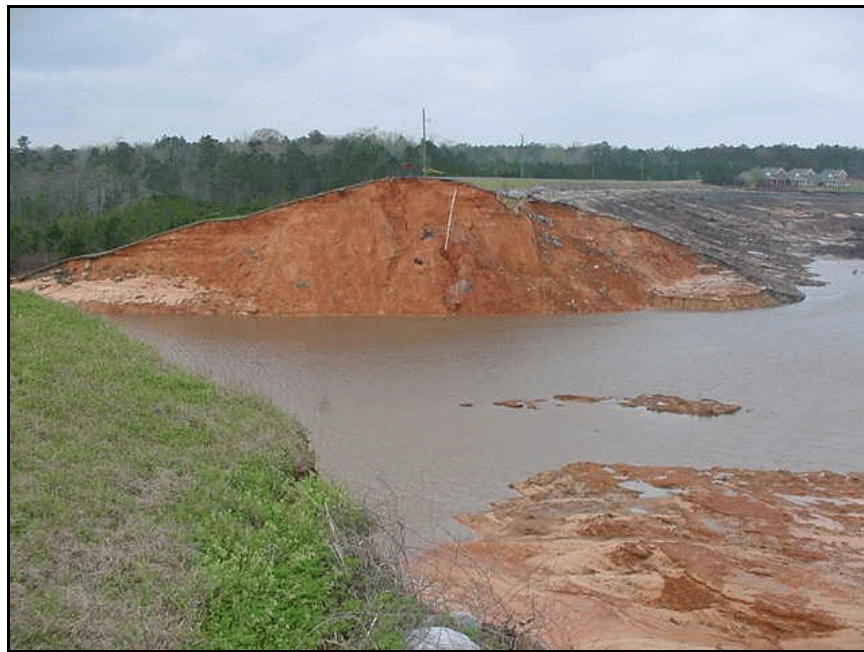
Figure 10 (cont'd).—The backward erosion piping process associated with intergranular seepage and the subsequent backward erosion of soil particles.

Eventually, the tunnel erosion feature reaches the reservoir. Outflow will then increase substantially, leading to direct erosion of the embankment dam and complete breach or draining of the reservoir through the tunnel that develops.

The resulting failure often completely destroys the embankment dam, leaving few traces of the original piping tunnel. The failure of this embankment dam was attributed to piping of foundation sands. Photo courtesy of National Oceanic and Atmospheric Administration.

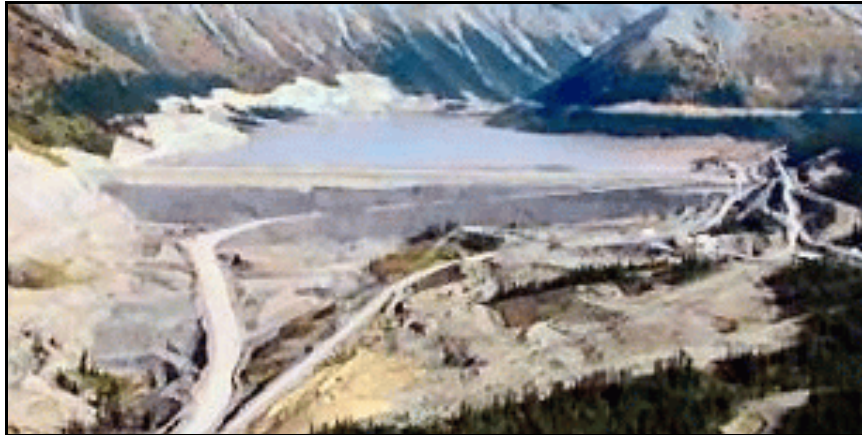
Figure 12.—An example of a tailings dam.

Tailings and slurry dams are an integral and vital component of mining operations. Tailings dams permanently retain mining, chemical, and industrial waste products (e.g., ground-up rock that remains after the mineral value has been removed from the ore). Figure 12 shows an example of a tailings dam. A slurry dam permanently retains waste created by the processing and washing of coal. These structures retain the waste products and allow them to settle out, enabling reclamation (recycling) of the slurry water, and permanent retention and eventual restoration of the site.

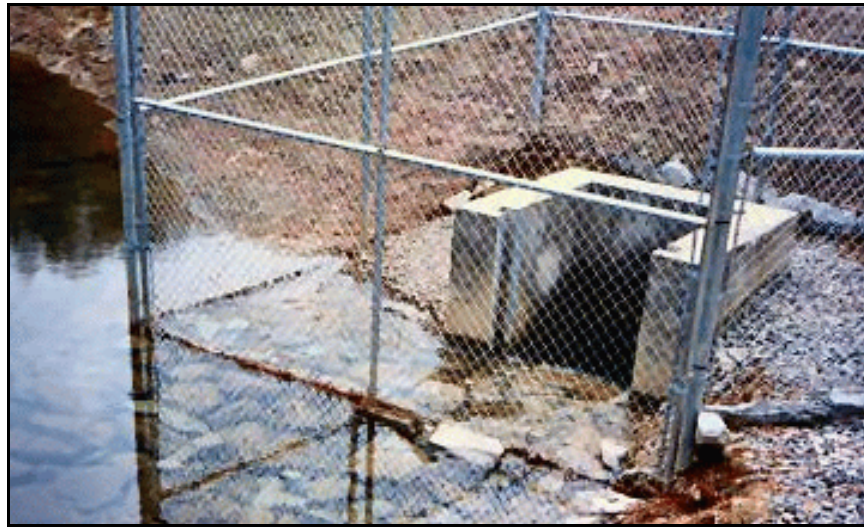
Figure 13.—An example of a decant intake structure.

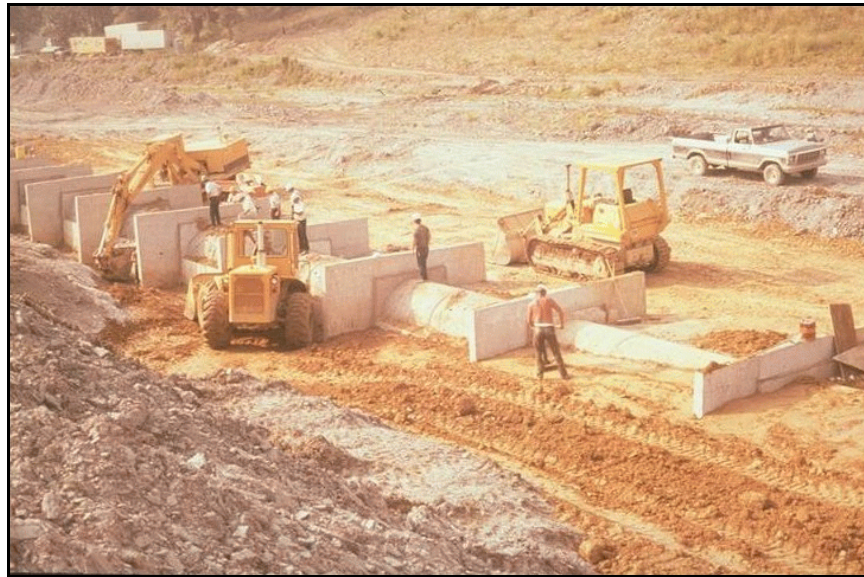
Figure 14.—Antiseep collars impeded the compaction of soils around the conduit. Hand tampers were used next to the antiseep collars.

Figures 14 through 16 show examples of the construction difficulties involved with compaction around antiseep collars. Appendix A gives a detailed history of the design rationale used for antiseep collars and reasons for their being discontinued. Figures 17 and 18 show examples of the ineffectiveness of antiseep collars in preventing embankment dam failure resulting from internal erosion near conduits.

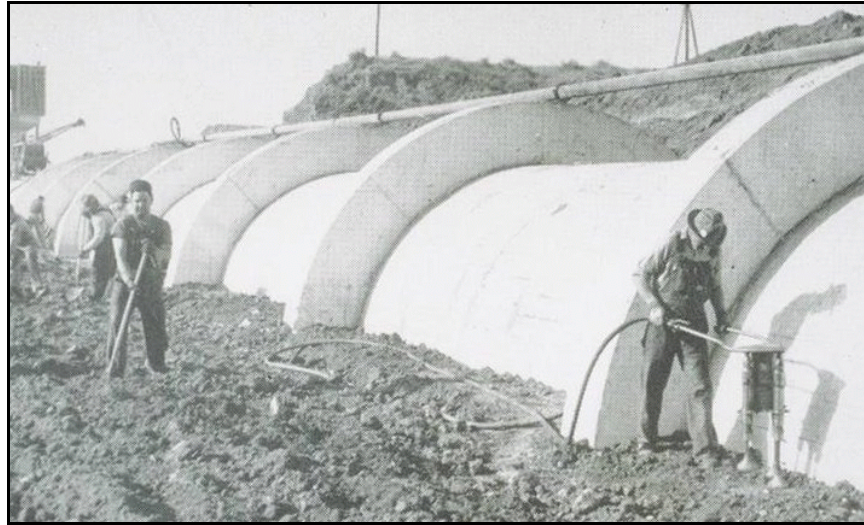
Figure 16.—Good compaction around antiseep collars was difficult to achieve.

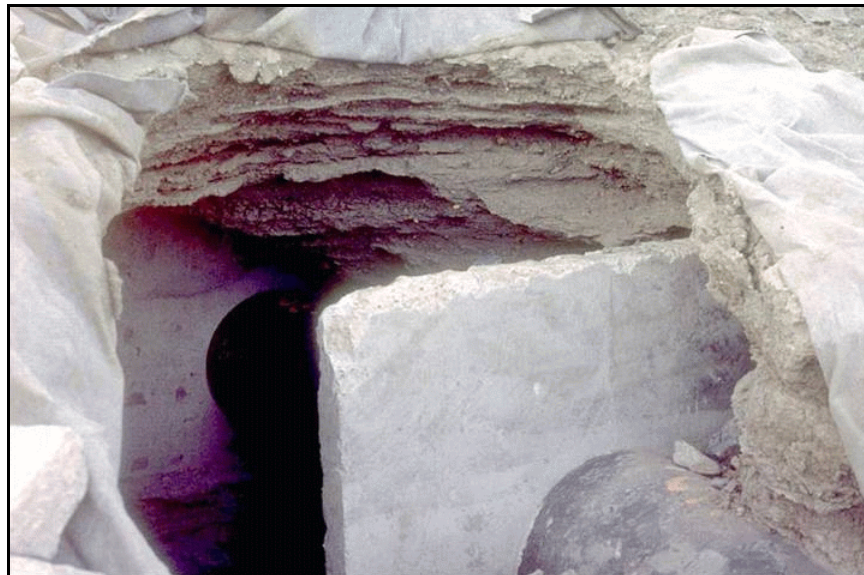
Figure 18.—Antiseep collars were not adequate to prevent the internal erosion failure of this embankment dam. The internal erosion that occurred on first filling of the reservoir occurred in dispersive clay soils that are not susceptible to backward erosion piping.

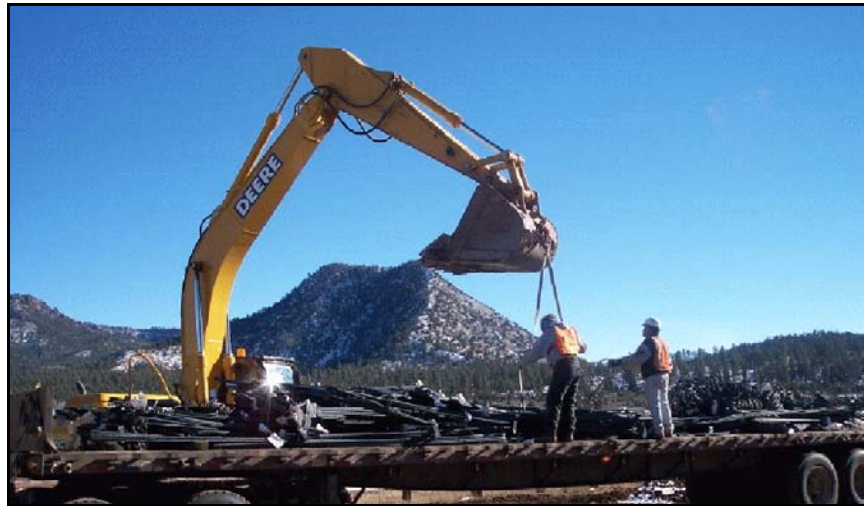
Figure 21.—Reinforcement being unloaded for use in cast-in-place concrete.

Reinforced cast-in-place concrete is placed and allowed to cure in the location where it is required to be in the completed conduit. Reinforced cast-in-place concrete is made by mixing cement, fine and coarse aggregates, sand, and water. Admixtures are frequently added to the concrete immediately before or during its mixing to increase the workability, strength, or density, or to lower its freezing point. A framework of reinforcing steel is constructed, and forms to contain the wet concrete mix are built around the reinforcement. The wet concrete mix is placed inside the forms and around the reinforcing steel. Typically, consolidation of the concrete mix is obtained by vibration. The final solidified mass becomes reinforced cast-in-place concrete. Reinforced cast-in-place concrete conduits are built at the construction site. Figure 21 shows typical reinforcement used with cast-in-place concrete.

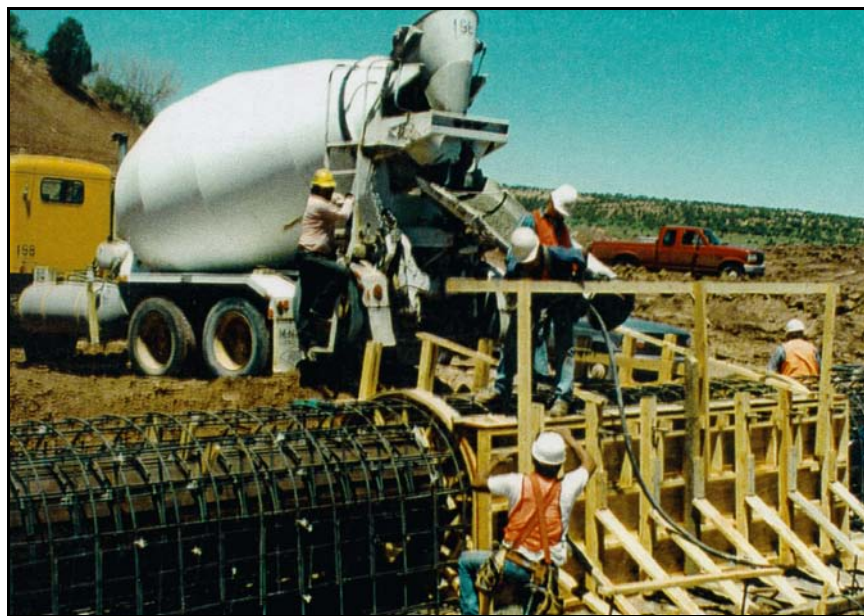
Figure 22.—Concrete placement for a reinforced cast-in-place conduit.

Reinforced cast-in-place concrete conduits (figure 22) have a long history of use by the major dam design agencies. Reinforced cast-in-place concrete conduits are very adaptable in their application and can be designed to fit specific project requirements and site conditions. A variety of design shapes are possible. For guidance on selecting the proper shape see section 4.1. Properly designed and constructed reinforced cast-in-place concrete should have a service life of 100 years or longer.

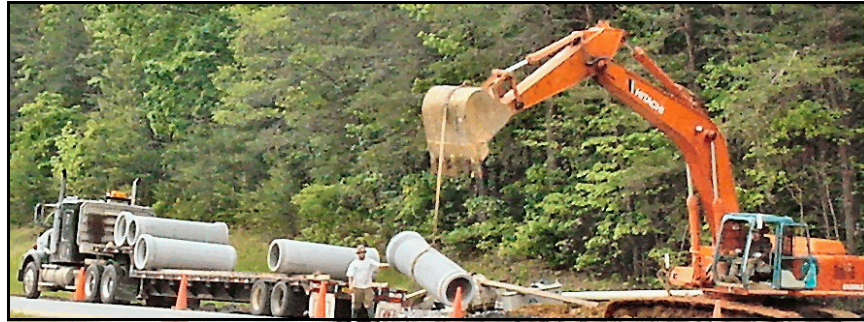
Figure 23.—Precast concrete pipe being unloaded from delivery truck.

Precast concrete refers to concrete pipe that is cast somewhere other than its final location. Precast concrete pipe sections are transported to the location where the conduit is constructed (figure 23). Three types of precast concrete pipe have typically been used in the construction of conduits through embankment dams: reinforced concrete pipe (RCP), reinforced concrete cylinder pipe (RCCP), and prestressed concrete cylinder pipe (PCCP).

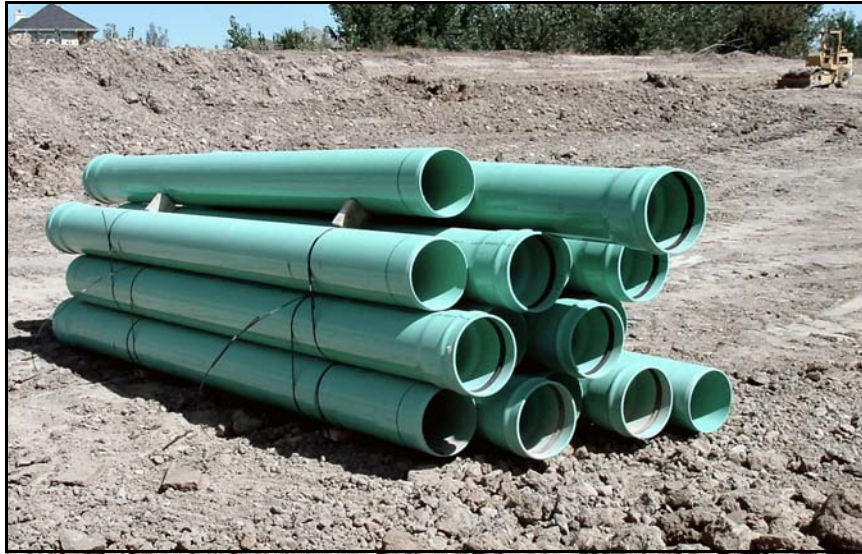
Figure 25.—PVC pipe has infrequently been used in conduit applications within low hazard embankment dams. The bell and spigot joint connection used for this type of pipe limits its use for most conduits.

PVC pipe (figure 25) is not as commonly used as HDPE pipe as a conduit or slipliner due to concerns with lack of watertightness and other inherent disadvantages. The major disadvantage with PVC pipe is the bell and spigot joint connections. This type of joint connection has the potential for leakage or can separate as the embankment dam settles. The bell and spigot joint integrity must be tested for leaks to ensure that the gasket has not rolled off during installation. Use of PVC bell and spigot joints should only be considered for nonpressurized, low hazard dam applications. PVC is typically available in sizes up to 48 inches in diameter.
