Building Number: 607
Area: West Barracks
Date of Construction: 1887
Period of Significance: 1880-1899
(per HSR Part One)
Historic Use: Infantry Barracks
Current/Recent Use: Office use 1939

Task One: Conditions Assessment

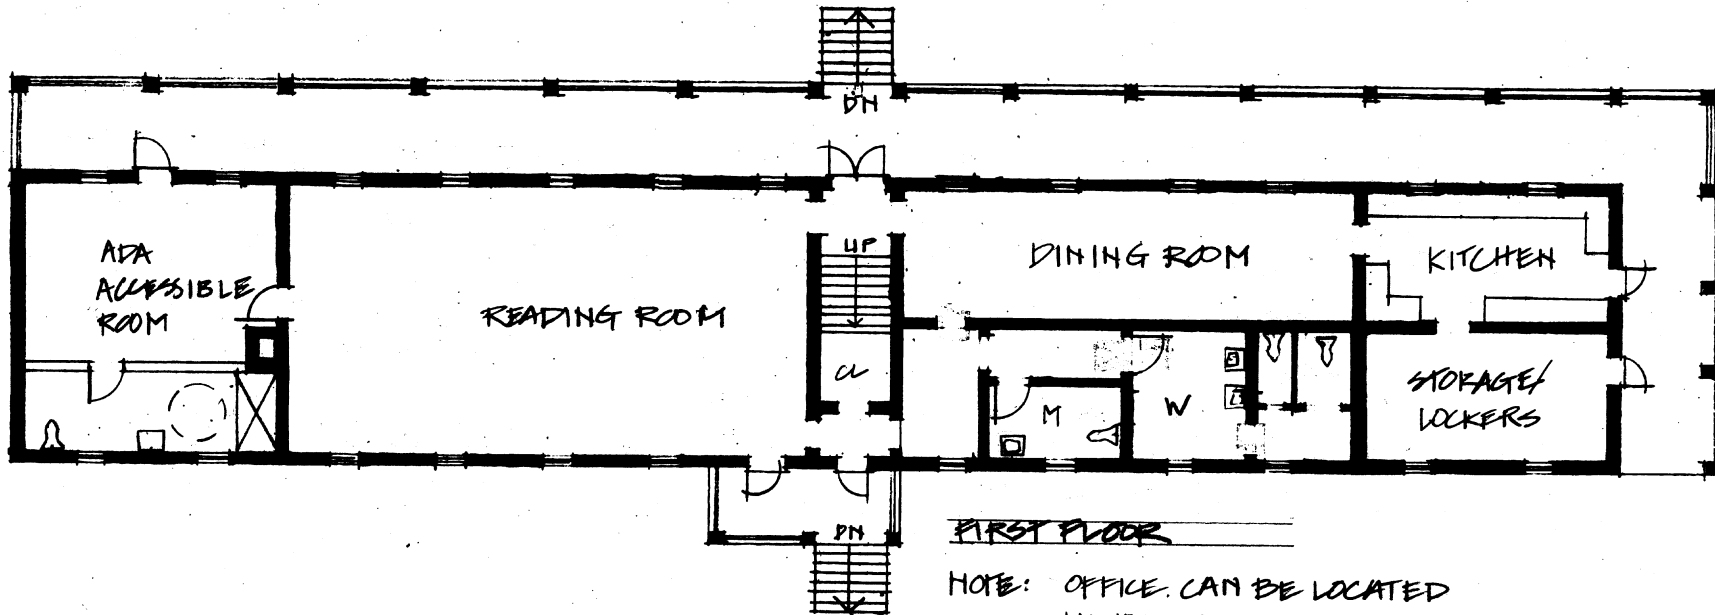
PLAN A

FIRST FLOOR

NOTE: OFFICE CAN BE LOCATED
IN THE BASEMENT.

BUILDING 607 HOSTEL
SCALE: 1/16" = 1'-0"

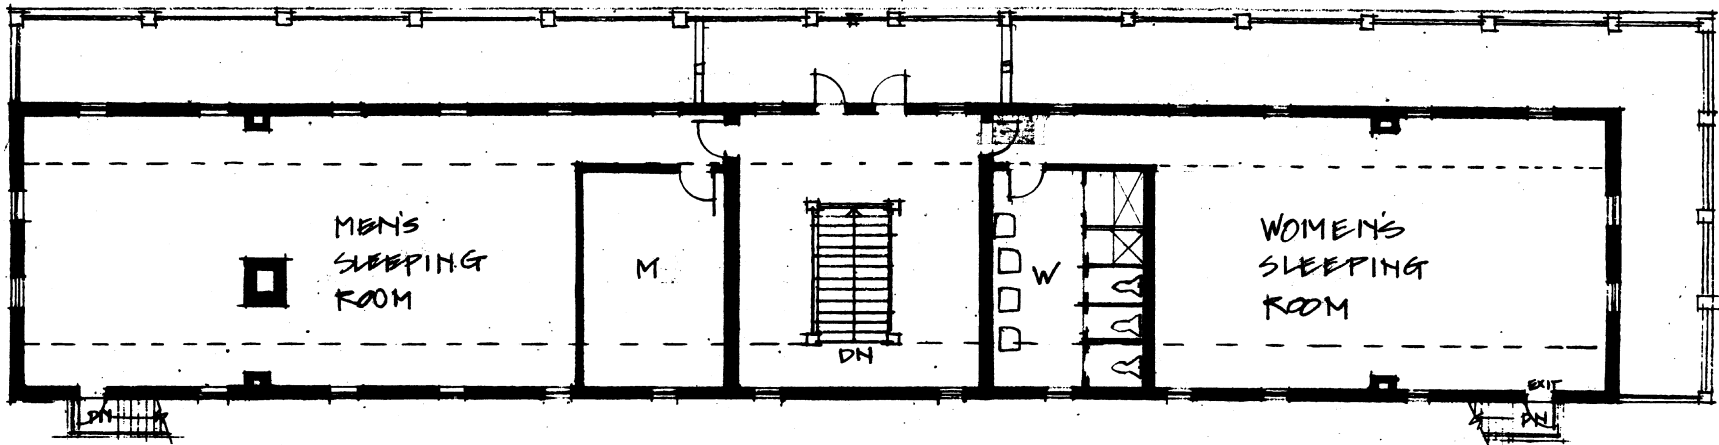
SECOND FLOOR

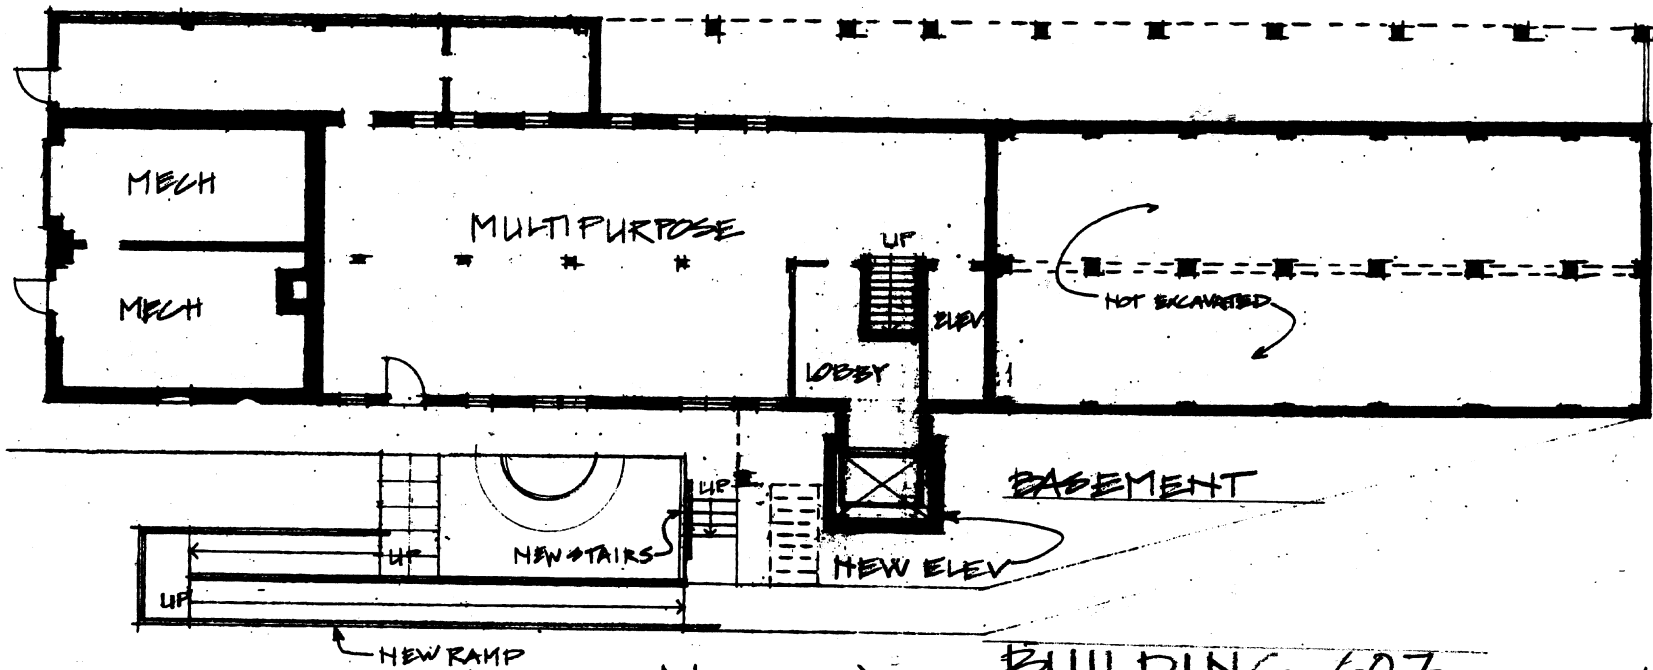
PLAN B

BUILDING 607 EDUCATION/ARTS
 SCALE: 1/16" = 1'-0"

The Class 'C' cost estimate for an arts/education use for the year 2003 is \$133.01 per square foot. This includes minimal interior changes for a range of arts uses and media, including pottery and painting studios to a foundry.
