Circuit Analysis - Failure Mode And Likelihood Analysis

A Letter Report to the USNRC

Final Report

Sandia National Laboratories
Albuquerque New Mexico 87185-0747

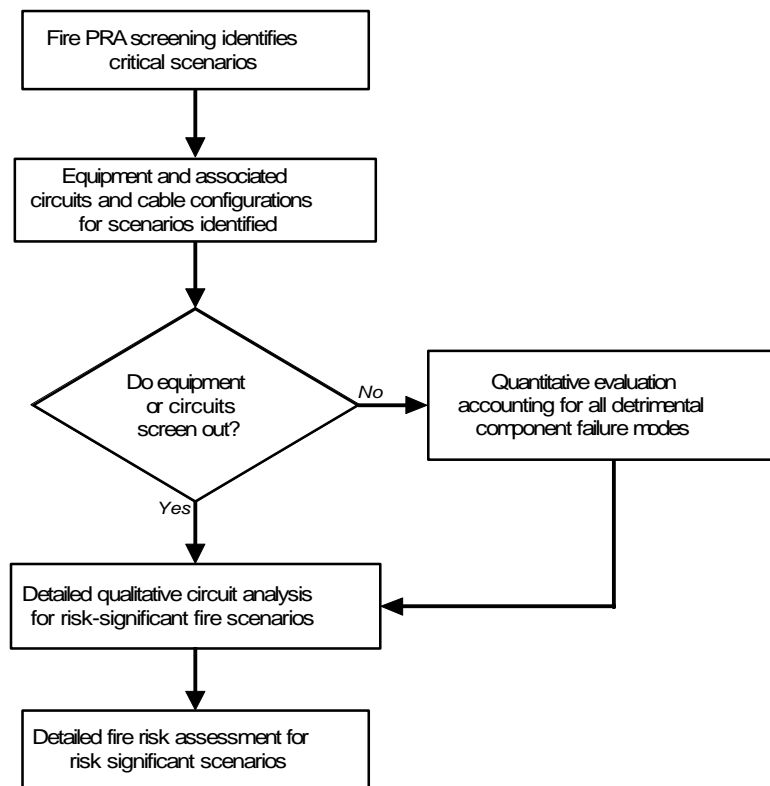
Figure 4-1. Circuit analysis process for fire risk assessment.

A proposed process for including circuit analysis into a fire PRA is shown in Figure 4-1. The process strives to minimize the amount of circuit analysis that is performed through a series of screening steps. The output of the process is a quantitative assessment of fire-induced cable failures for risk-significant scenarios.

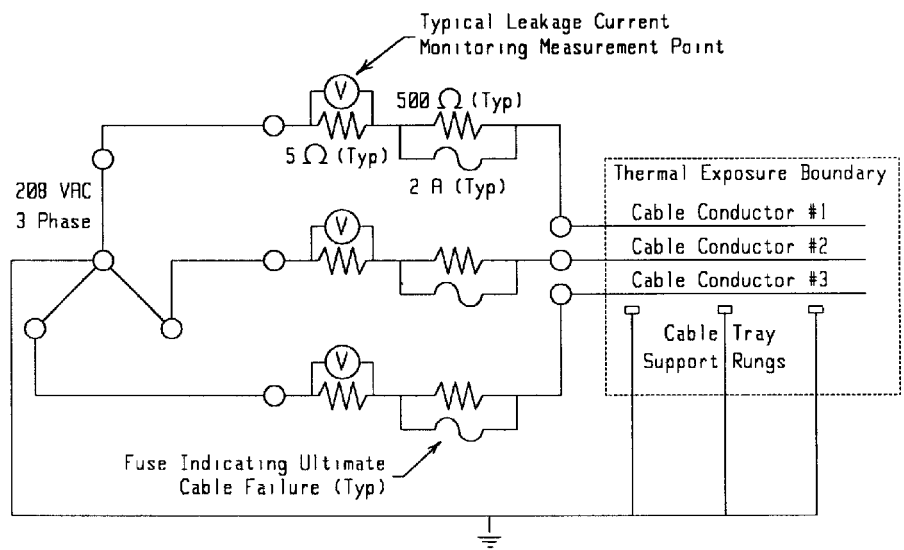
Figure A-6: Circuit used in NUREG/CR-5546 tests.

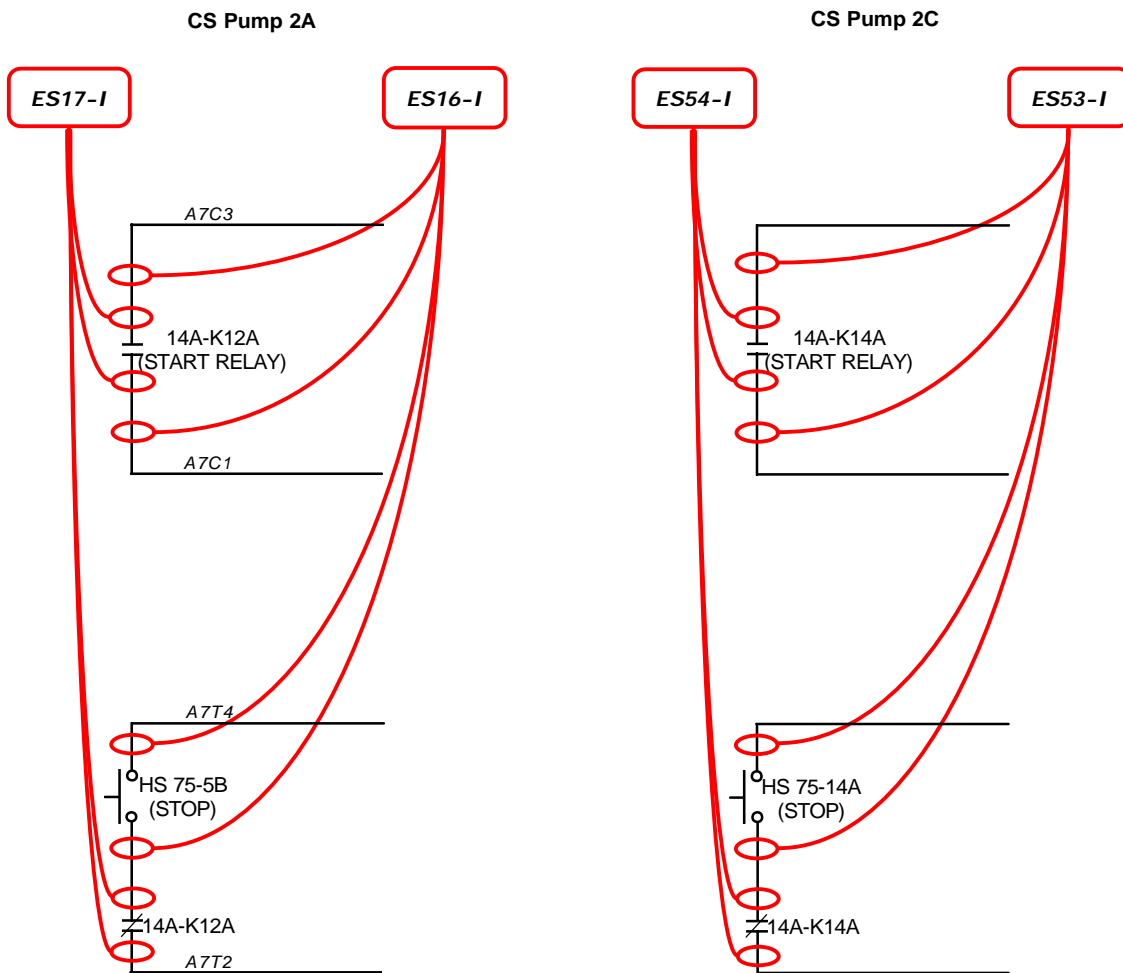
(Ref.: TVA 45N765-7, CS Pump Control Circuit)

Figure C-6. Partial schematic of the relay and hand switch branches for the core spray pump control circuits.

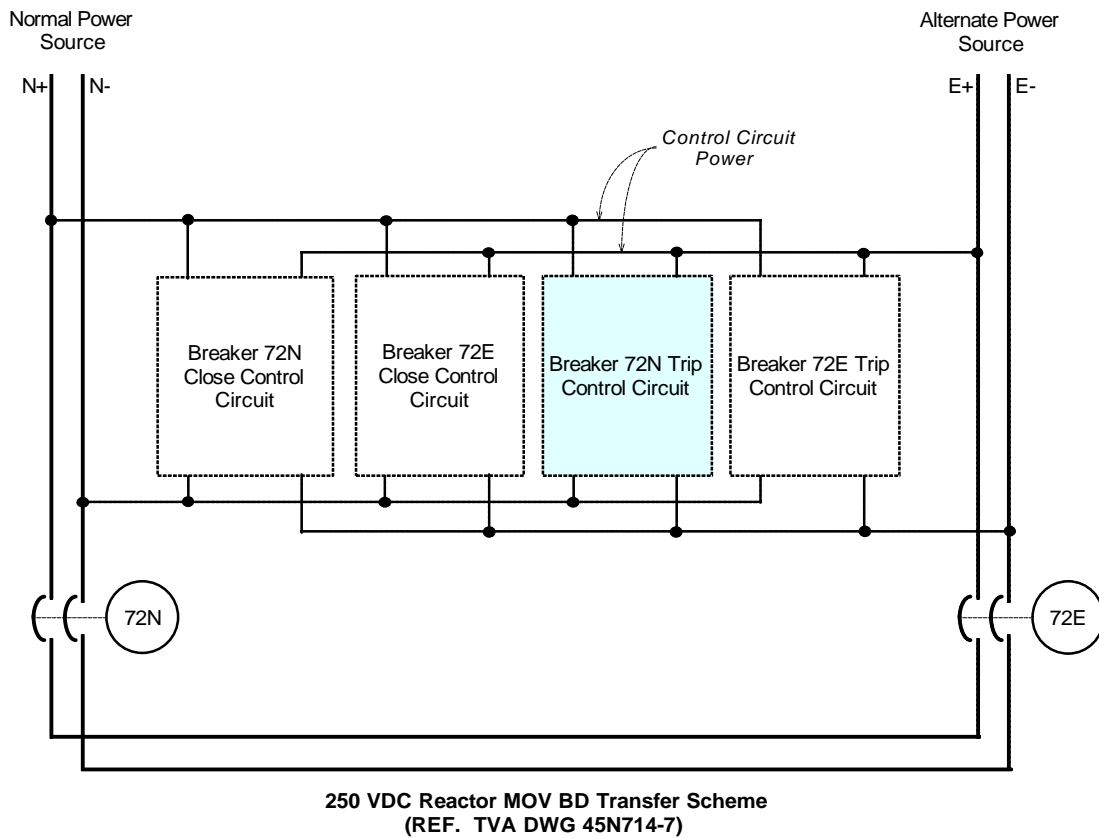
Figure C-7. Breaker control circuit block diagram. Note control power is tapped off both sources. (Detail of the 72N Trip Control Circuit is provided in Fig. 8.)

Power to the trip control circuit (Fig. 8) is selectable by setting device 43 to the normal (N) or alternate (E) power supply. This closes the 43N or 43E contacts to the control circuit power supply buses. The breaker is usually tripped manually by a control switch on the switchboard (72 CSN) which allows control power to energize the trip coil (TC) through the closed 72N contacts. These contacts are closed whenever the 72N circuit breaker is closed. In this case, however, both circuit breakers (72N and 72E) were open, thus it is not reasonable to postulate that the trip coil was continuously energized by a current backfed through the indicating light during the fire. On the other hand it is reasonable to suppose that a hot short on the indicating light circuit energized the upstream connection to the 72N contacts and only allowed the trip coil to be energized each time the breaker was closed. This, of course, caused the 72N breaker to immediately trip open again. The same scenario applies to the alternate feeder breaker 72E as well as to the normal and alternate feeder breakers on the 480-volt MOV boards.
