# Orbiter Inspection and Repair Summary

**JSC Mission Operations Directorate  
Flight Director Office**

**9 September 2003**

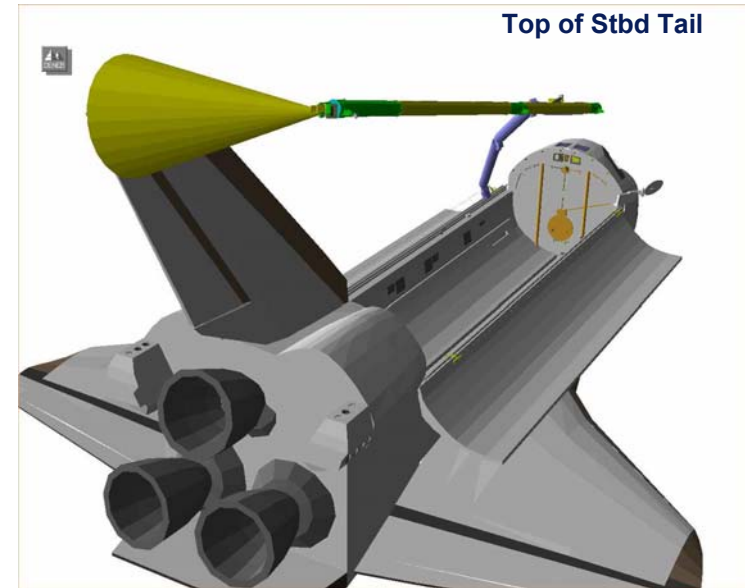
# Example Boom on the SRMS for TPS Viewing

Example of SVLCS Coverage (30 x 30 deg FOV at 5m)
