23<sup>rd</sup> Annual Airport Conference

# Survival Factors/Airport Accident Investigation

Mark H. George,  
Survival Factors Investigator

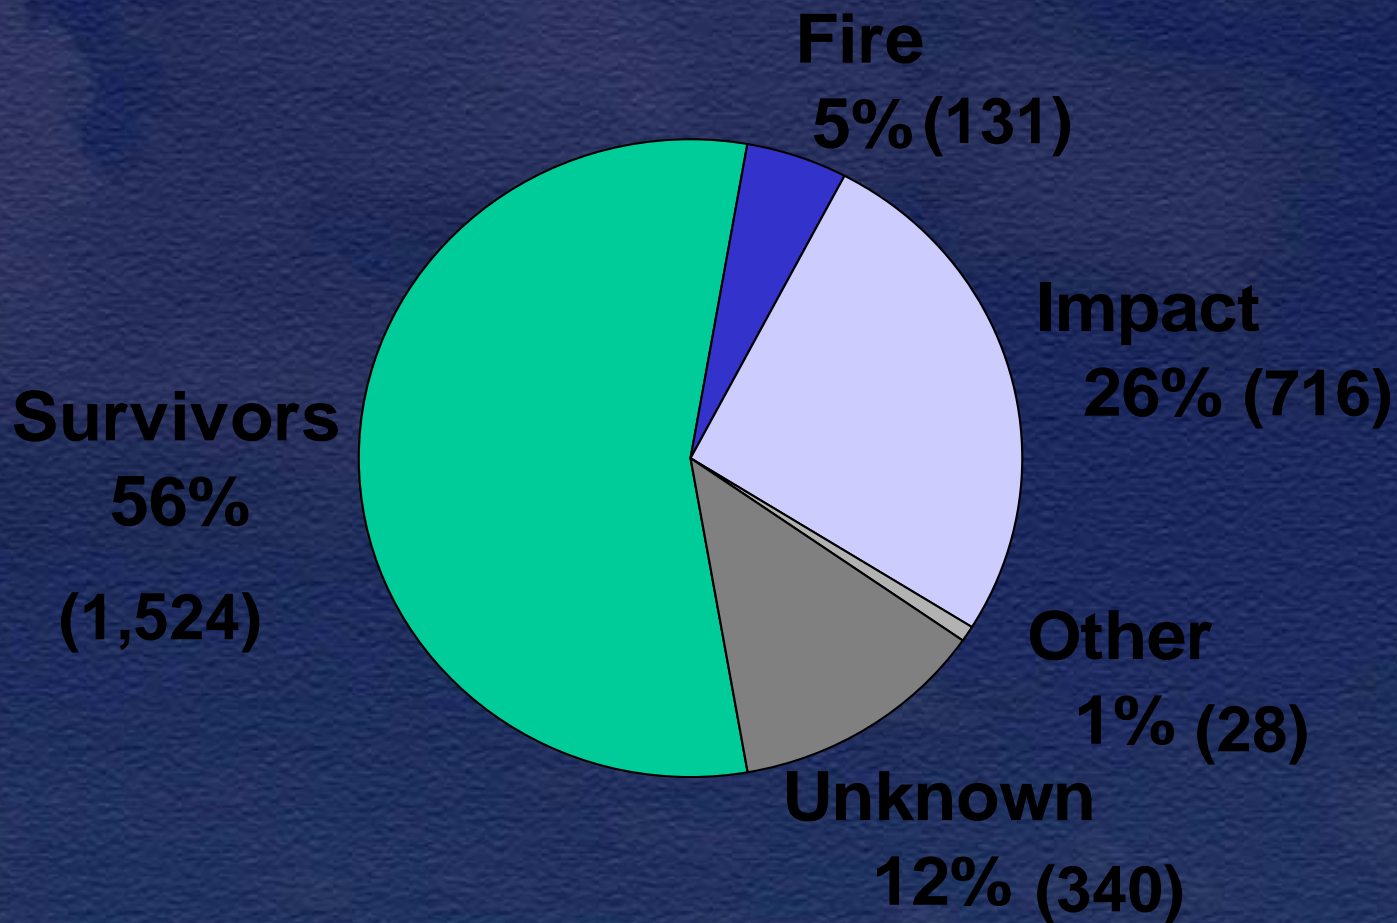
# Occupant Survival for Serious Part 121 Accidents

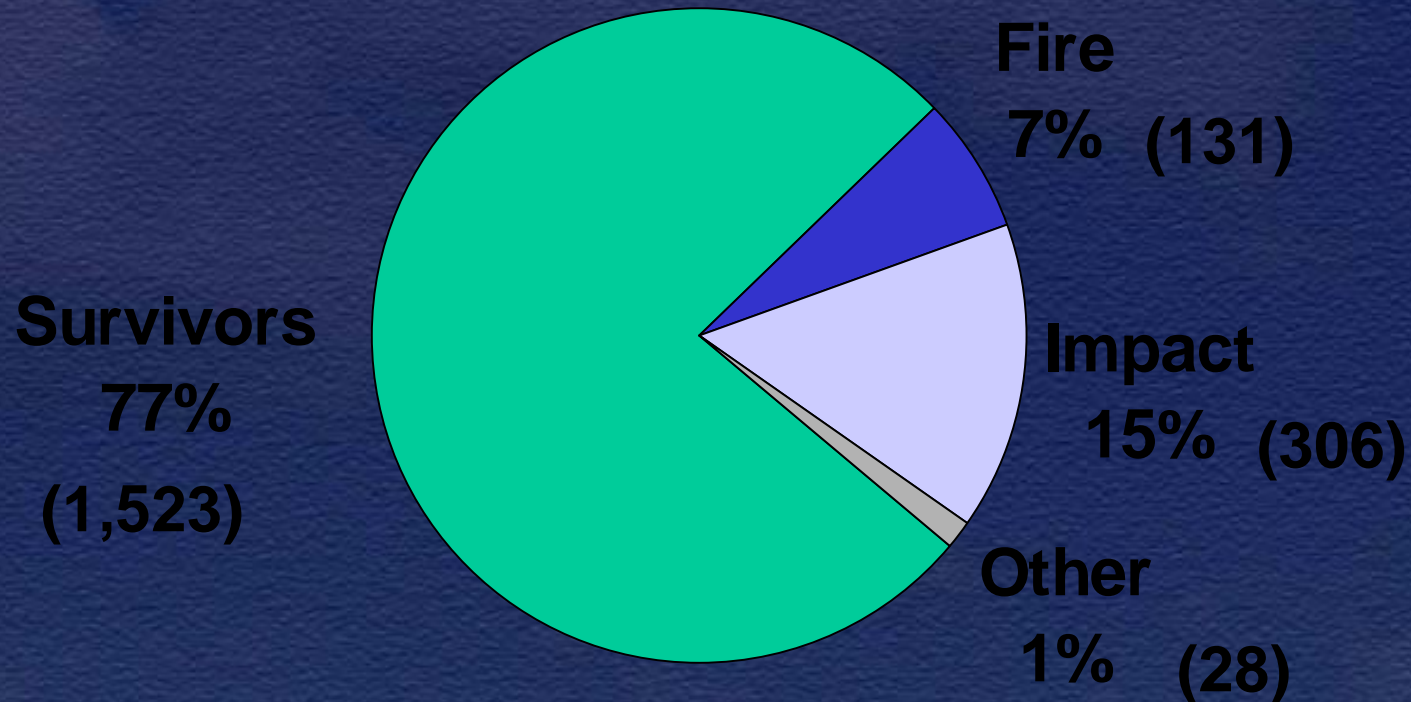
# Occupant Survival for *Survivable* Serious Part 121 Accidents

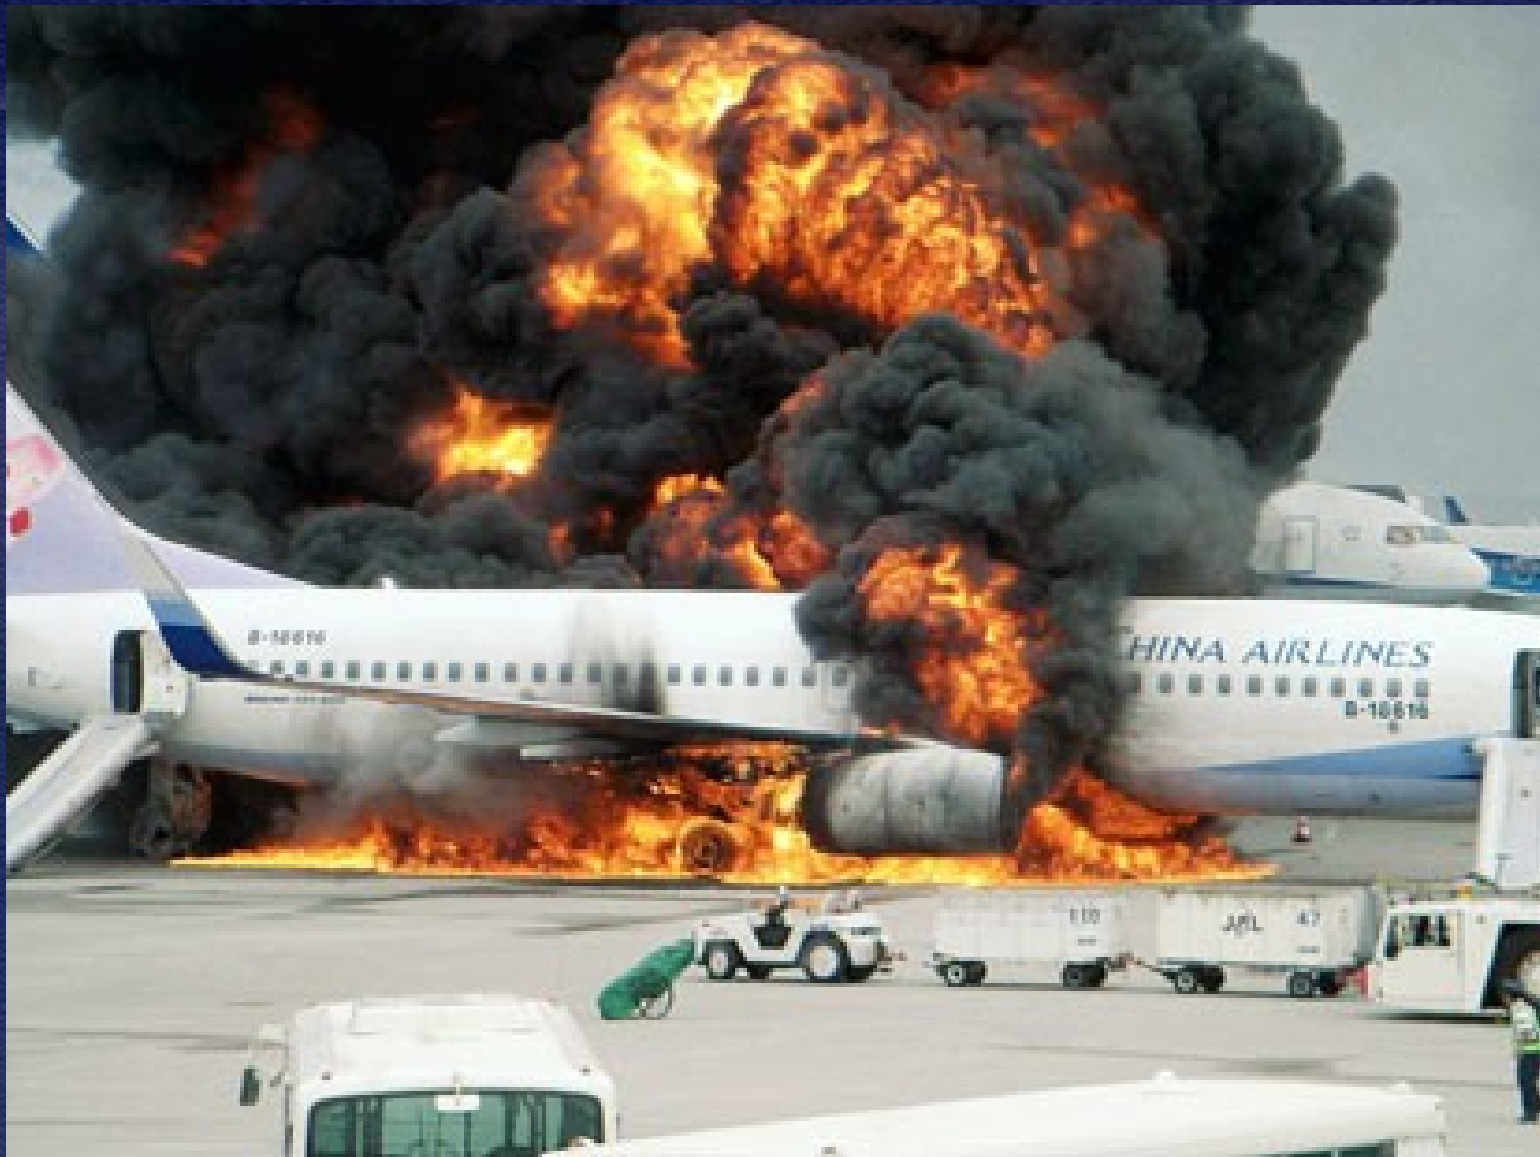
- August 2, 2007
- Okinawa, Japan
- China Air B-737
- Fuel leak at the gate
- Issues:
  - Evacuation procedures
  - Evacuation slides
  - Fire/smoke
  - ARFF response

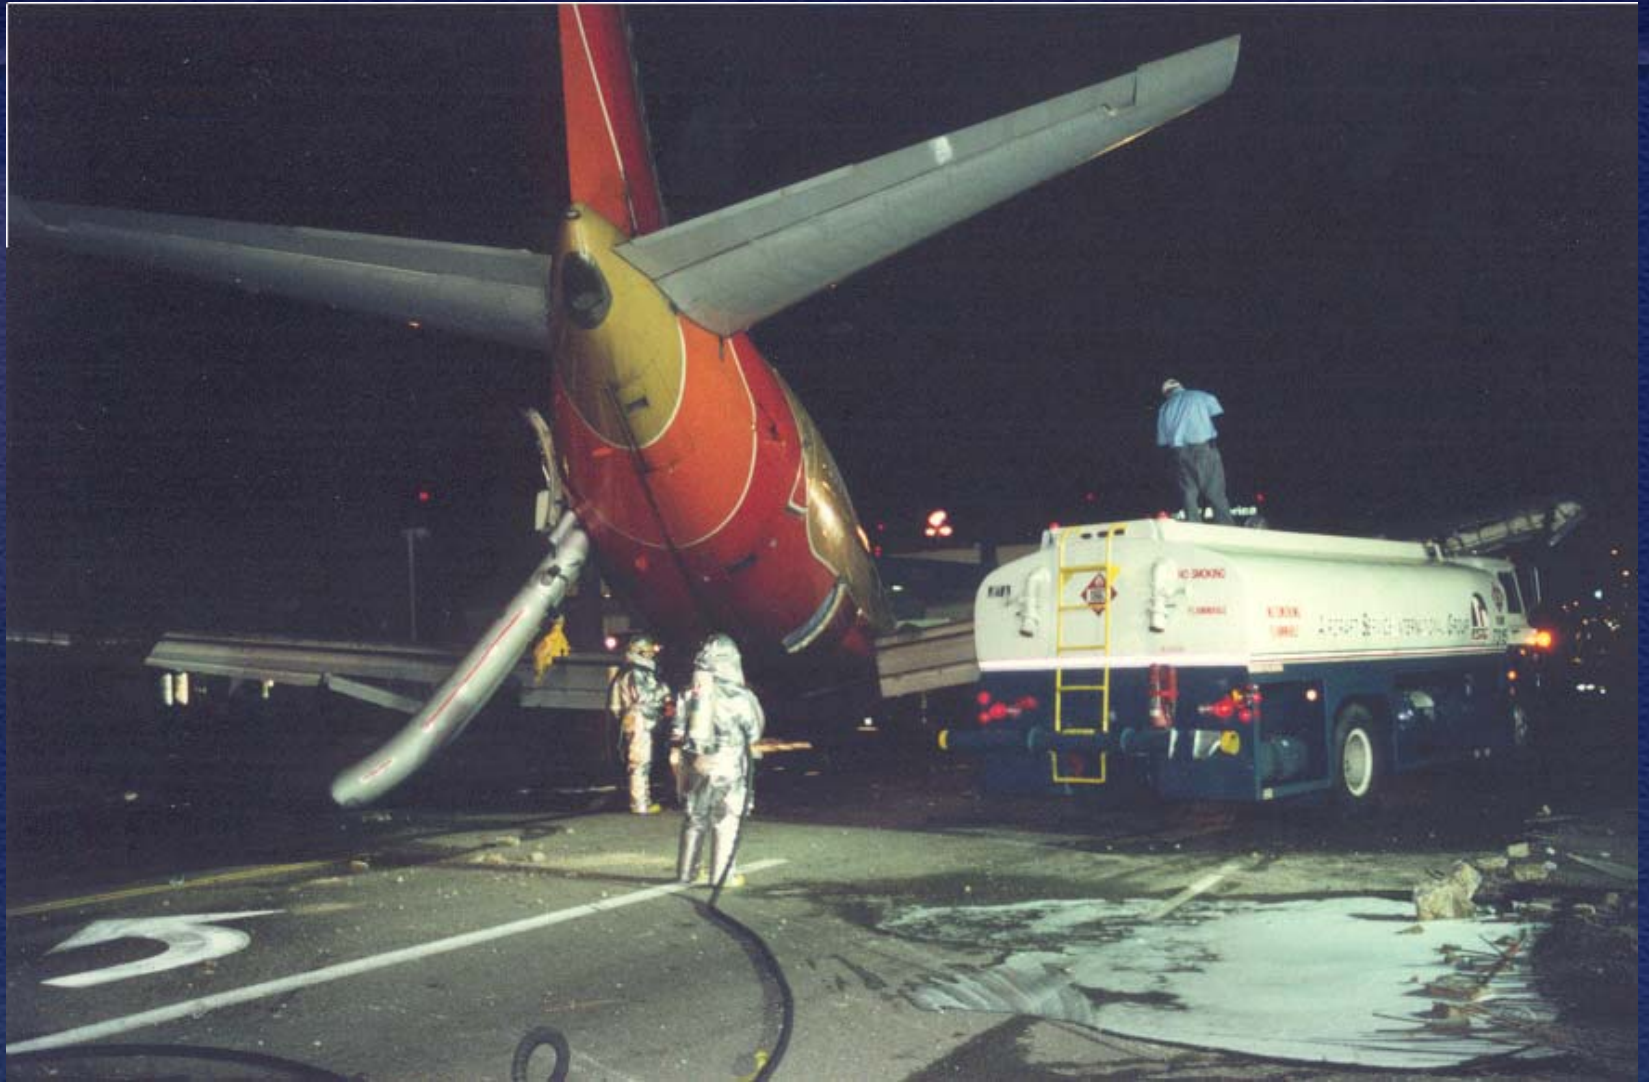
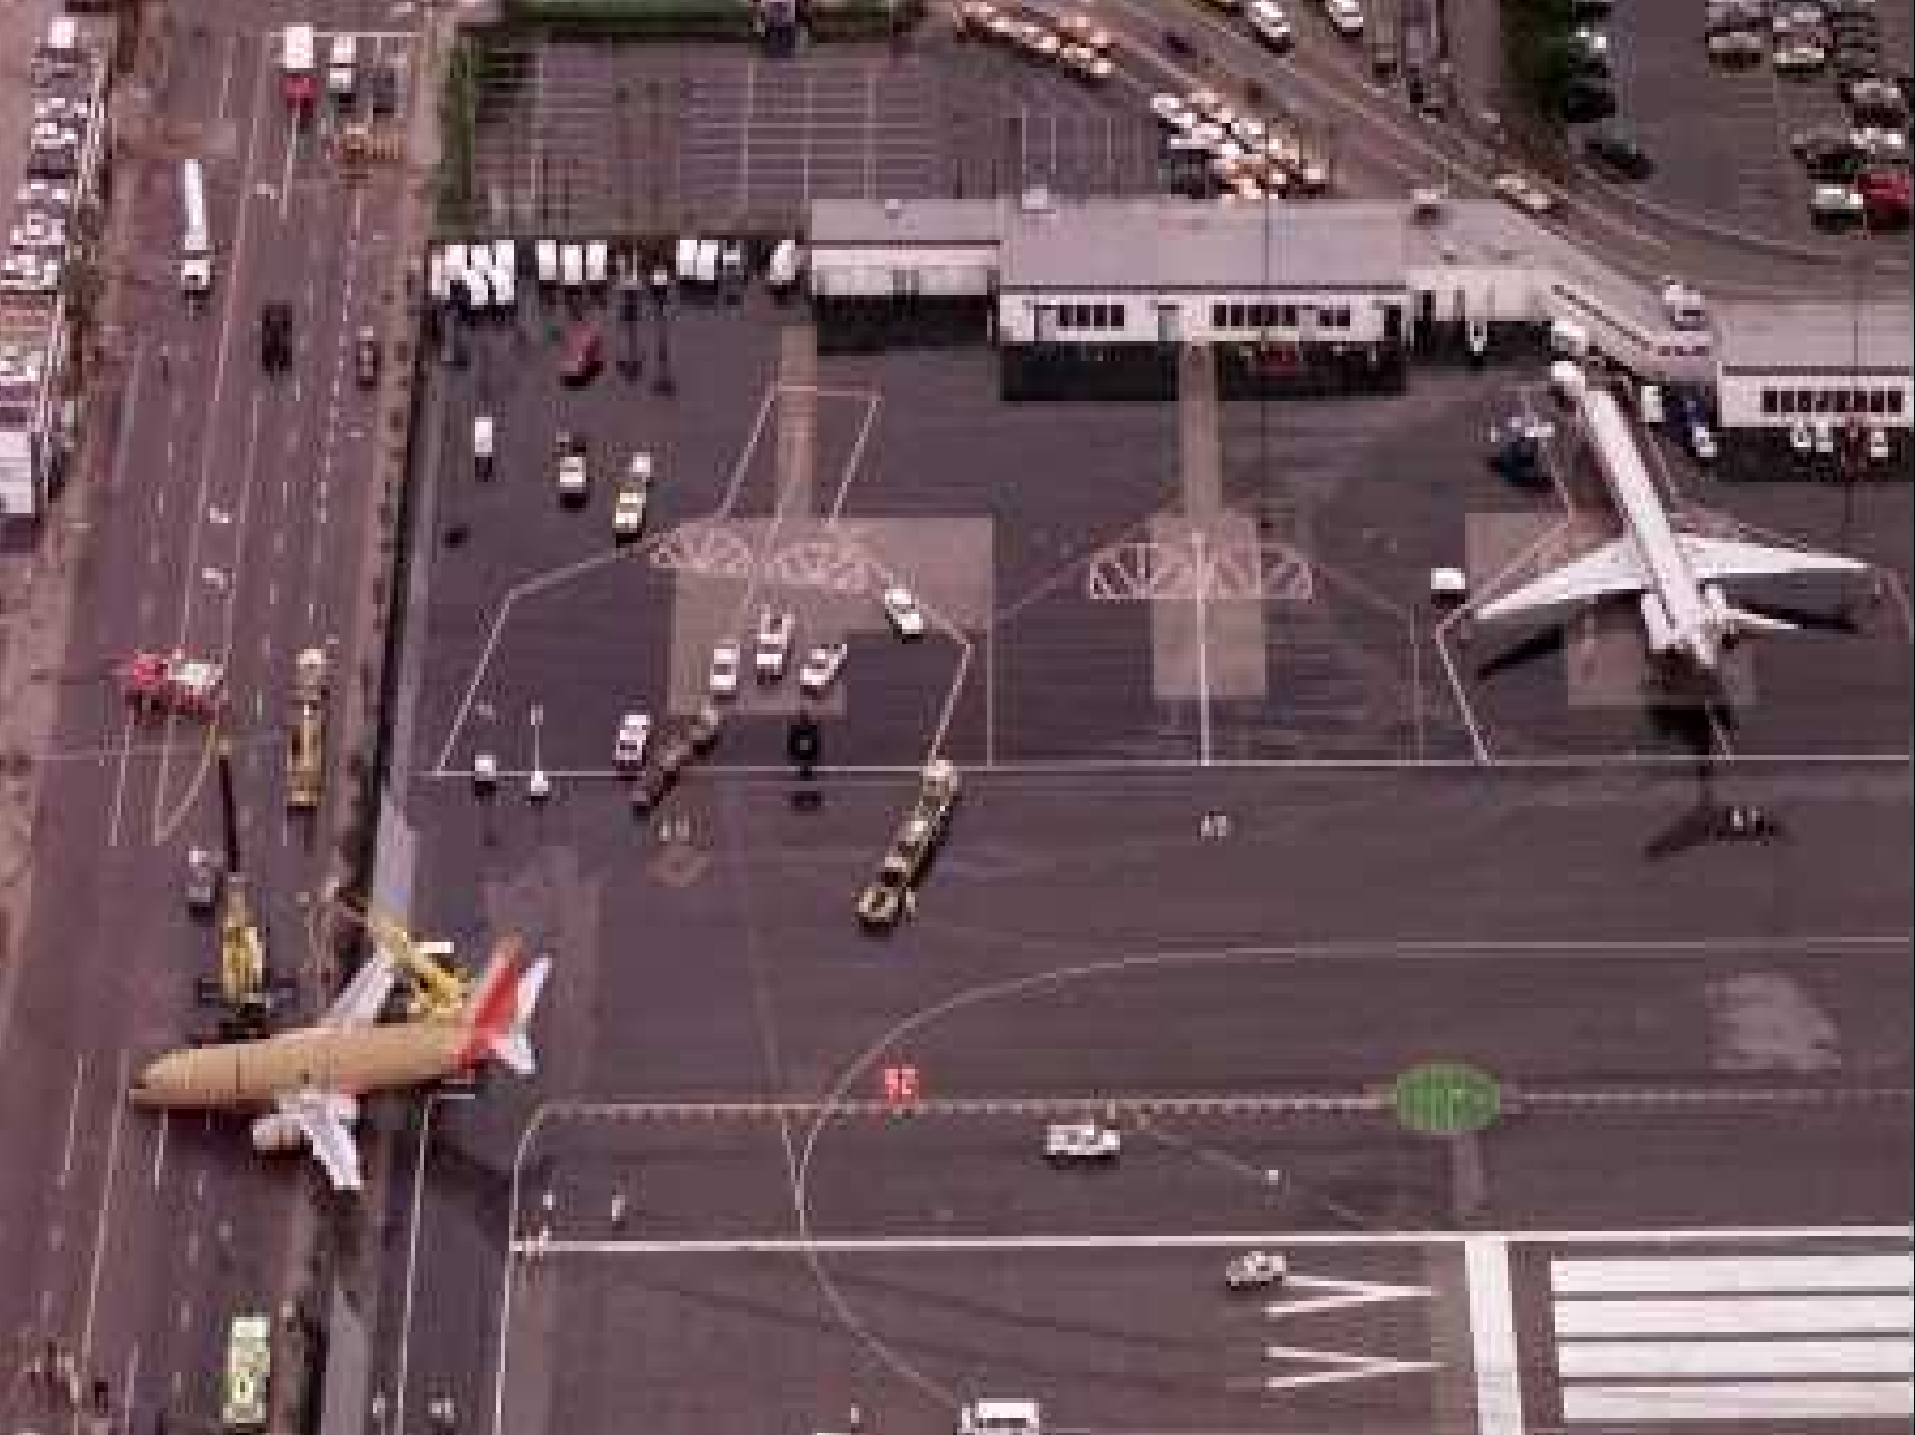
- March 5, 2000, Burbank, CA
- 1811 PST, Boeing 737-300,
- Over ran runway 08, and collided with an airport blast fence and airport perimeter wall. The airplane left the airport property, and came to rest on Hollywood Way Boulevard.
- 137 passengers, three flight attendants, and two flight crew
- 94 passengers and four crewmembers - no injuries
- 41 passengers and one flight crewmember - minor injuries.
- 2 passengers - serious injuries.
- Non-standard lateral and longitudinal runway safety areas

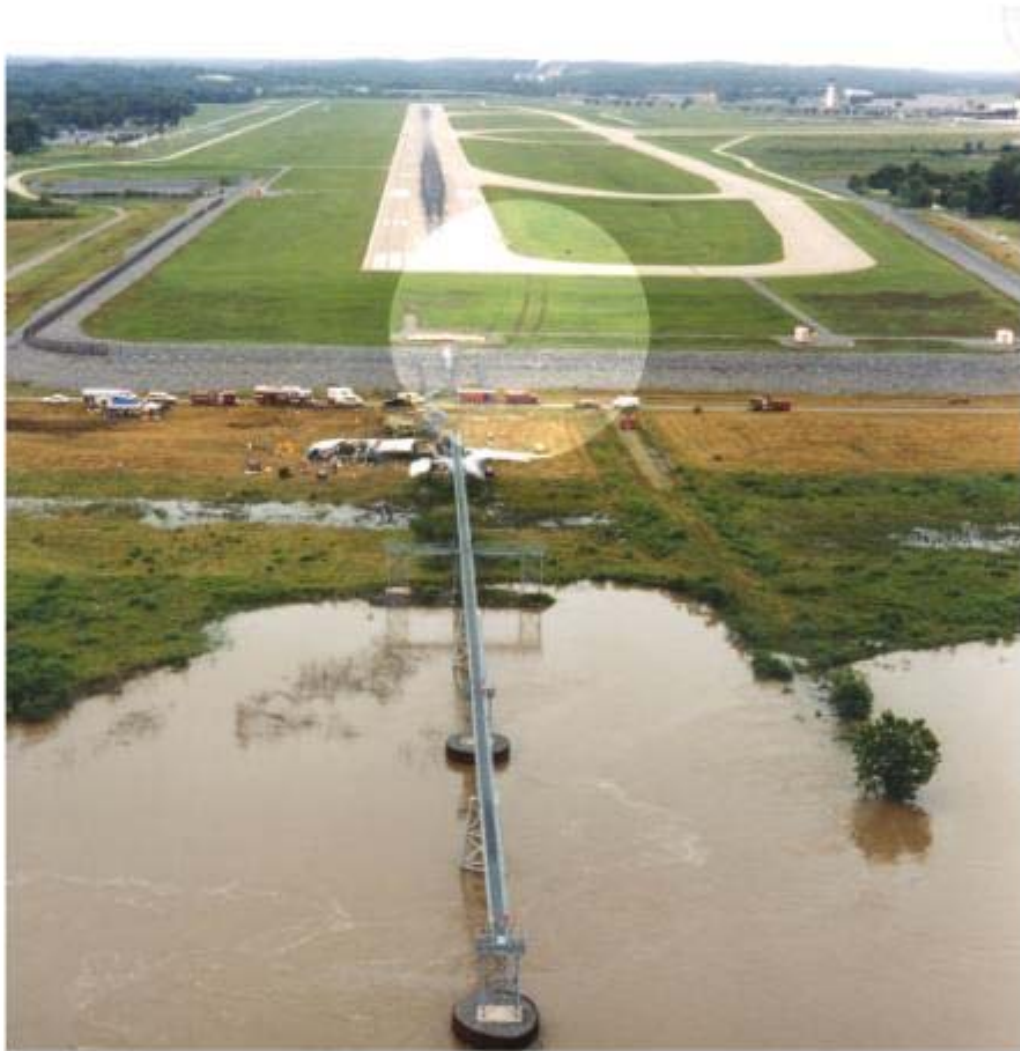
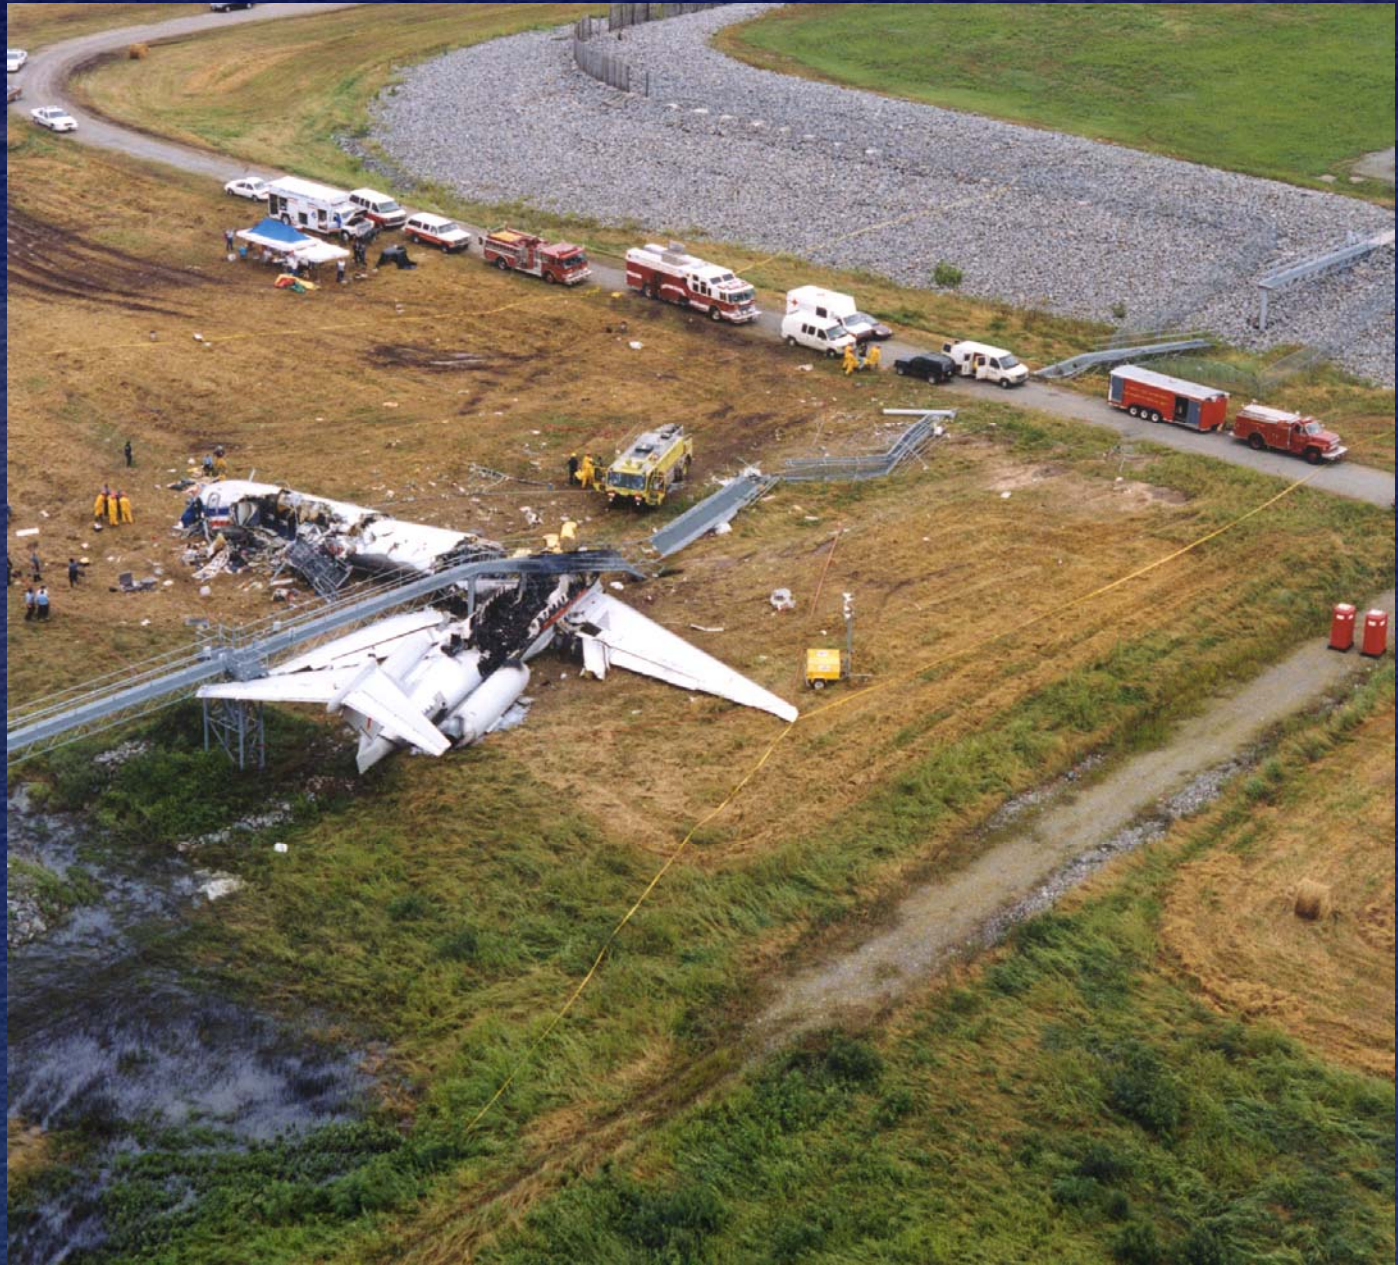
- June 1, 1999, Little Rock, AR
- 2351 Central Daylight Time (CDT),
- McDonnell Douglas MD-82,
- Overran the end of runway 4R and collided with the approach lighting structure
- The captain and 10 passengers - fatal injuries
- 110 passengers and crew - various injuries
- 24 passengers – no injuries.

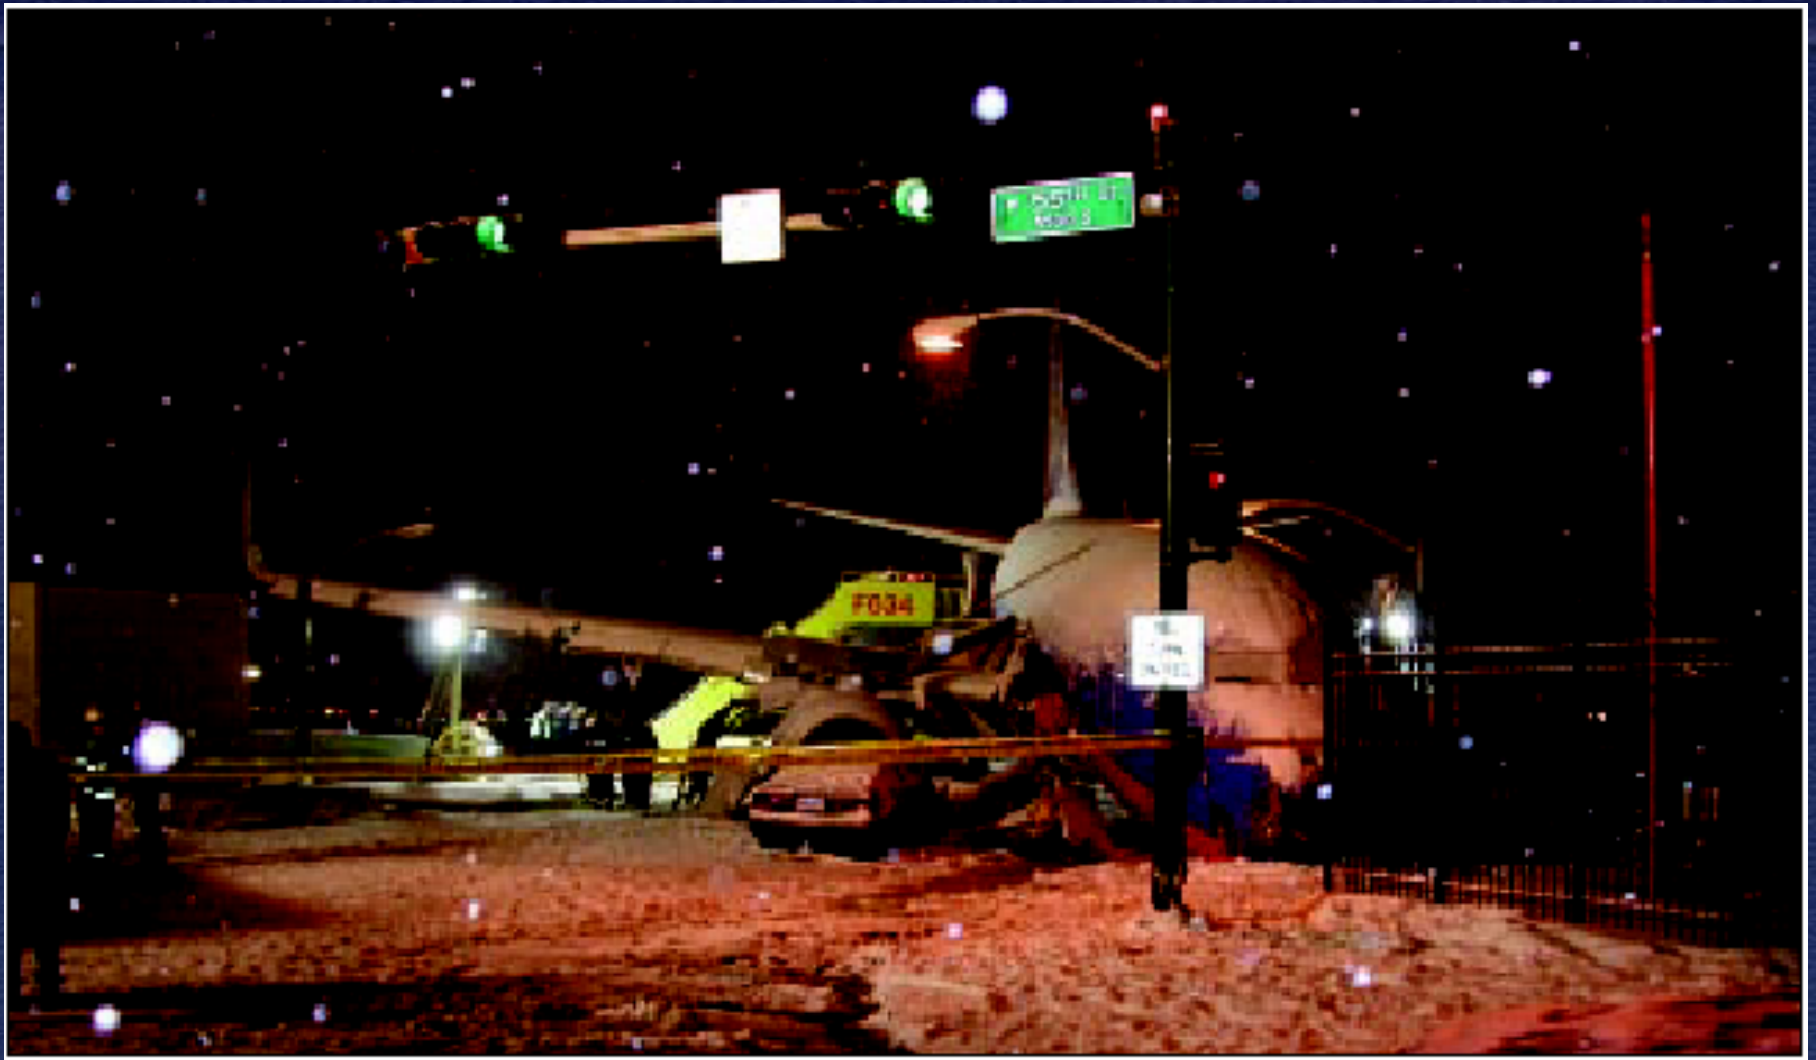
- December 8, 2005
- Overran Runway 31C at Midway Airport, Chicago, IL
- Departed the end of the runway, exited the airport, and struck an automobile
- Several minor injuries among the 98 passengers and 5 crewmembers on board
- One ground fatality and several other ground injuries
- Moderate snowfall

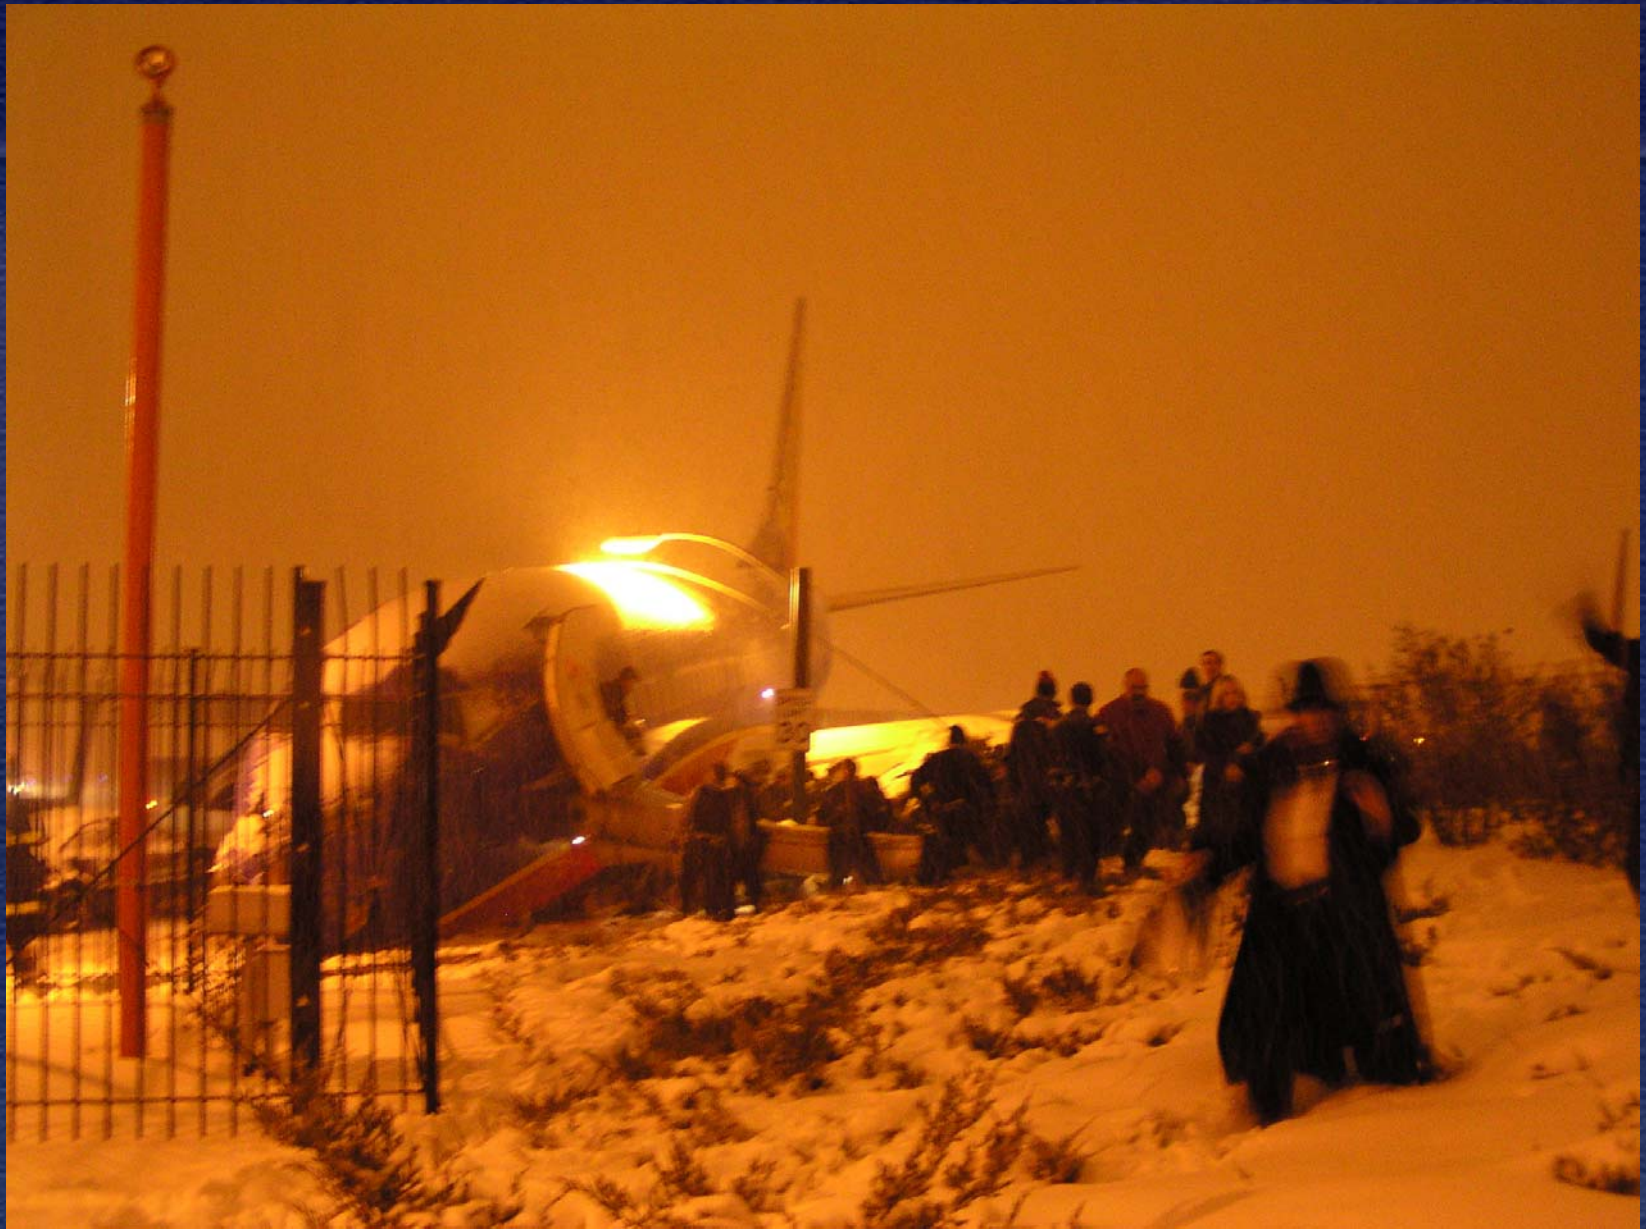
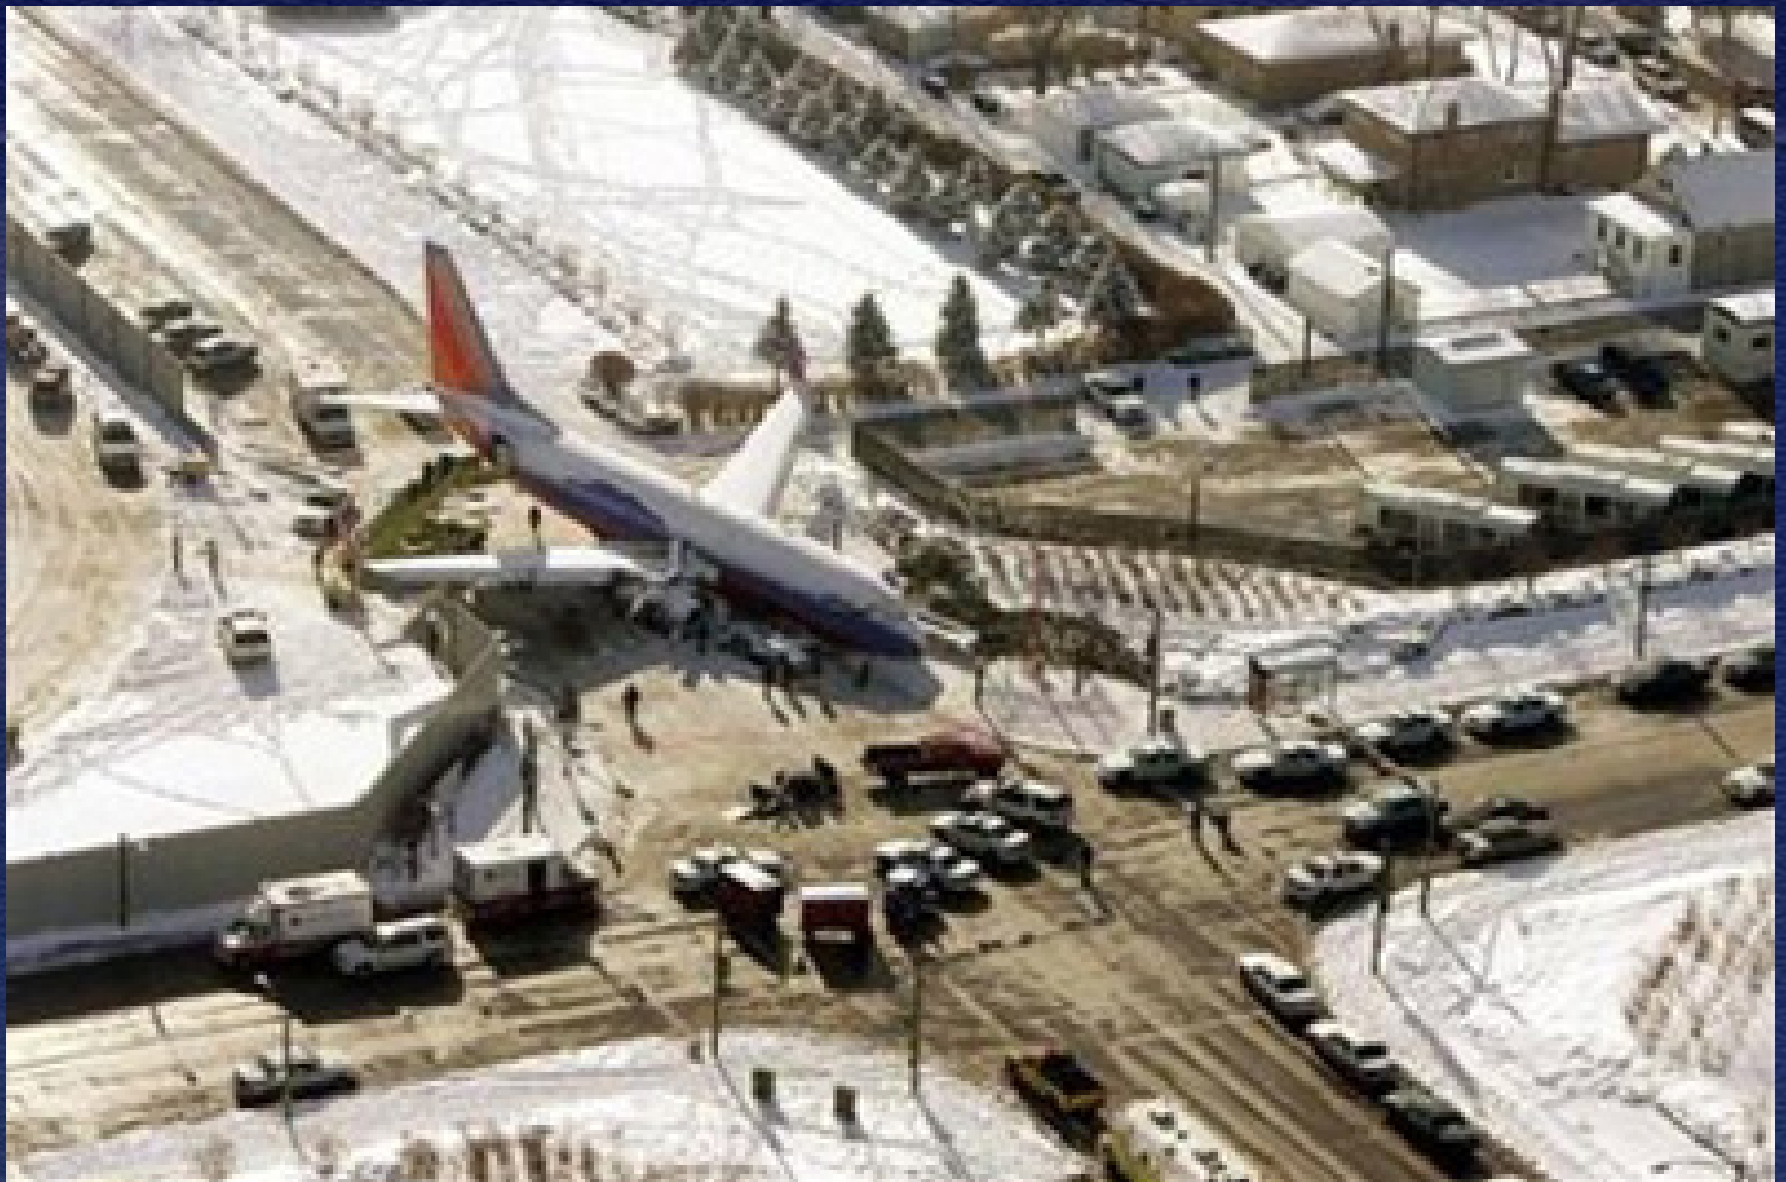
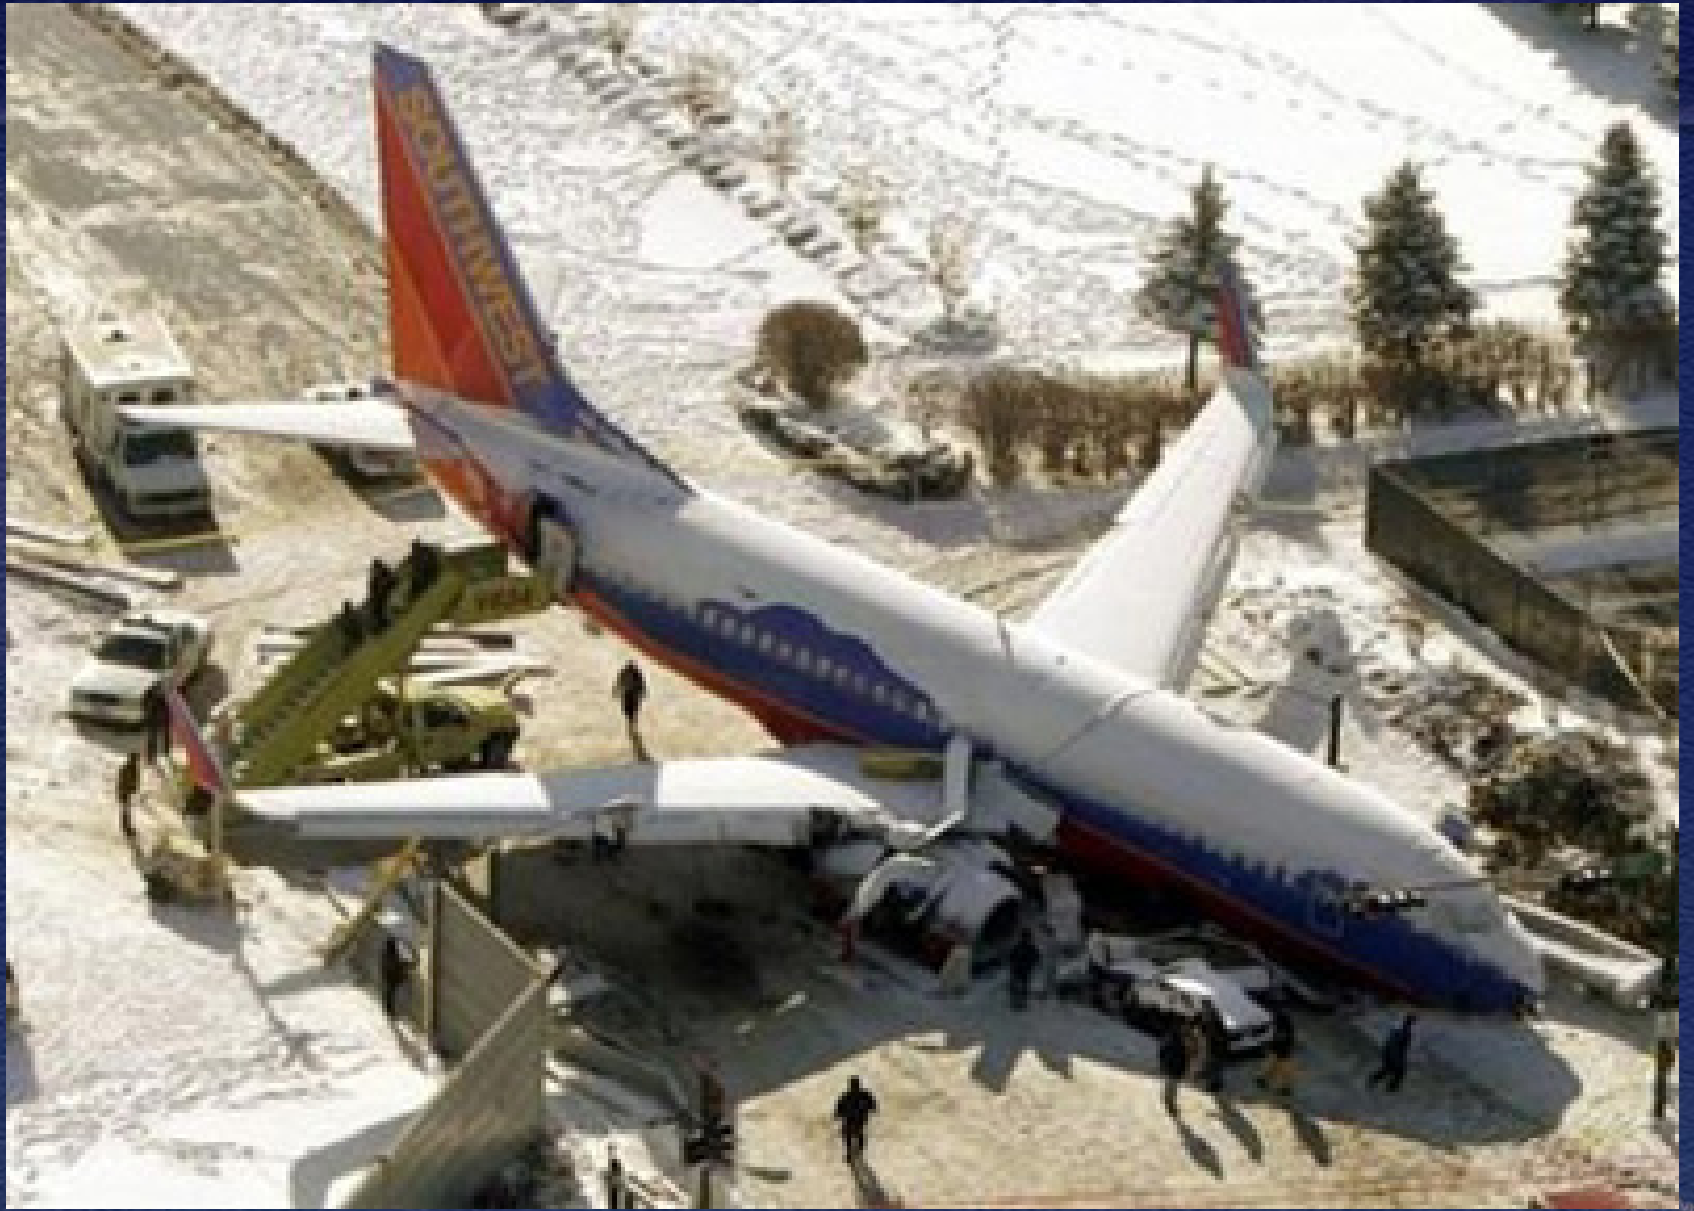
- Crew did an arrival landing calculation using OPC (not required)
- Crew was getting “fair/poor” (one “good/poor”) braking action reports
- Used “fair” for calculations, got positive stopping margin
- Plugged in “poor” and got an uncomfortably small positive number
- Decided to use autobrakes for the first time ever
- Did not realize that autobrakes were not authorized at that time
- Did not realize that thrust reverser use was included in their numbers
- Did not realize that SWA policy required them to use the most restrictive BA report (“fair/poor” = “poor”)
- Knew that landing with “poor” BA and a tailwind > 5 knots was prohibited
- After landing, did not immediately deploy thrust reversers
- Probably distracted by autobrakes
- FO deployed reversers ~ 18 seconds after landing

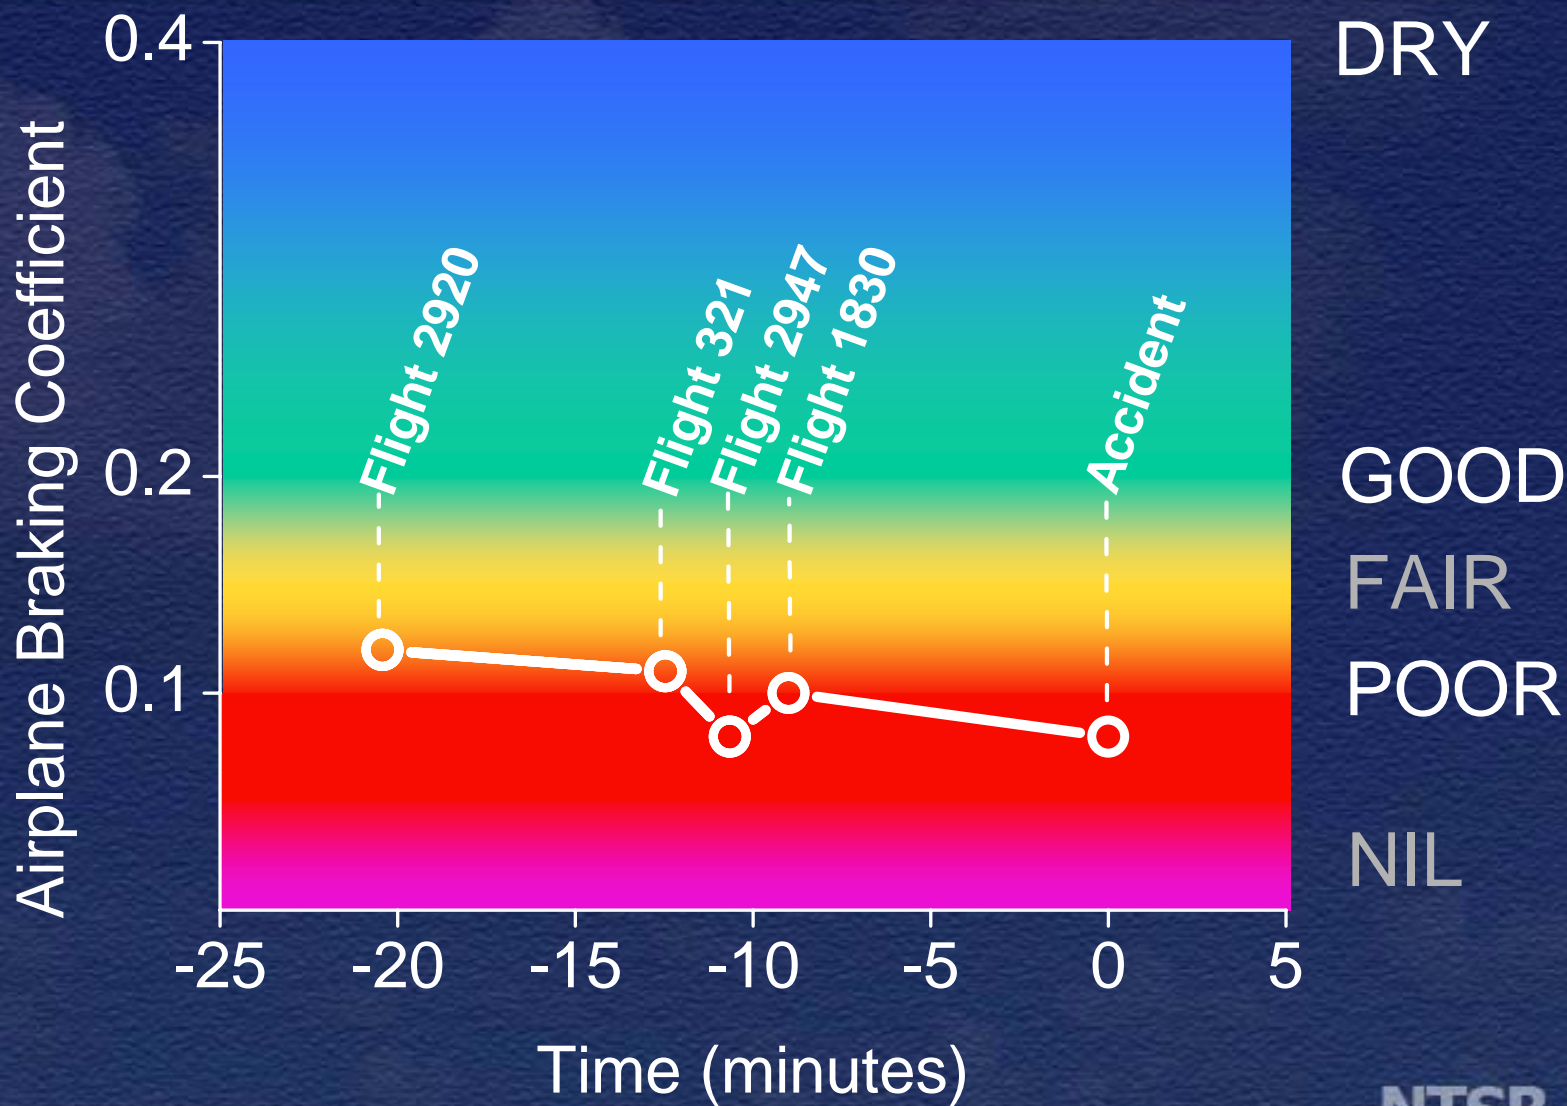
# Runway Surface Conditions
