23<sup>rd</sup> Annual Airport Conference

# Survival Factors/Airport Accident Investigation

Mark H. George,  
Survival Factors Investigator

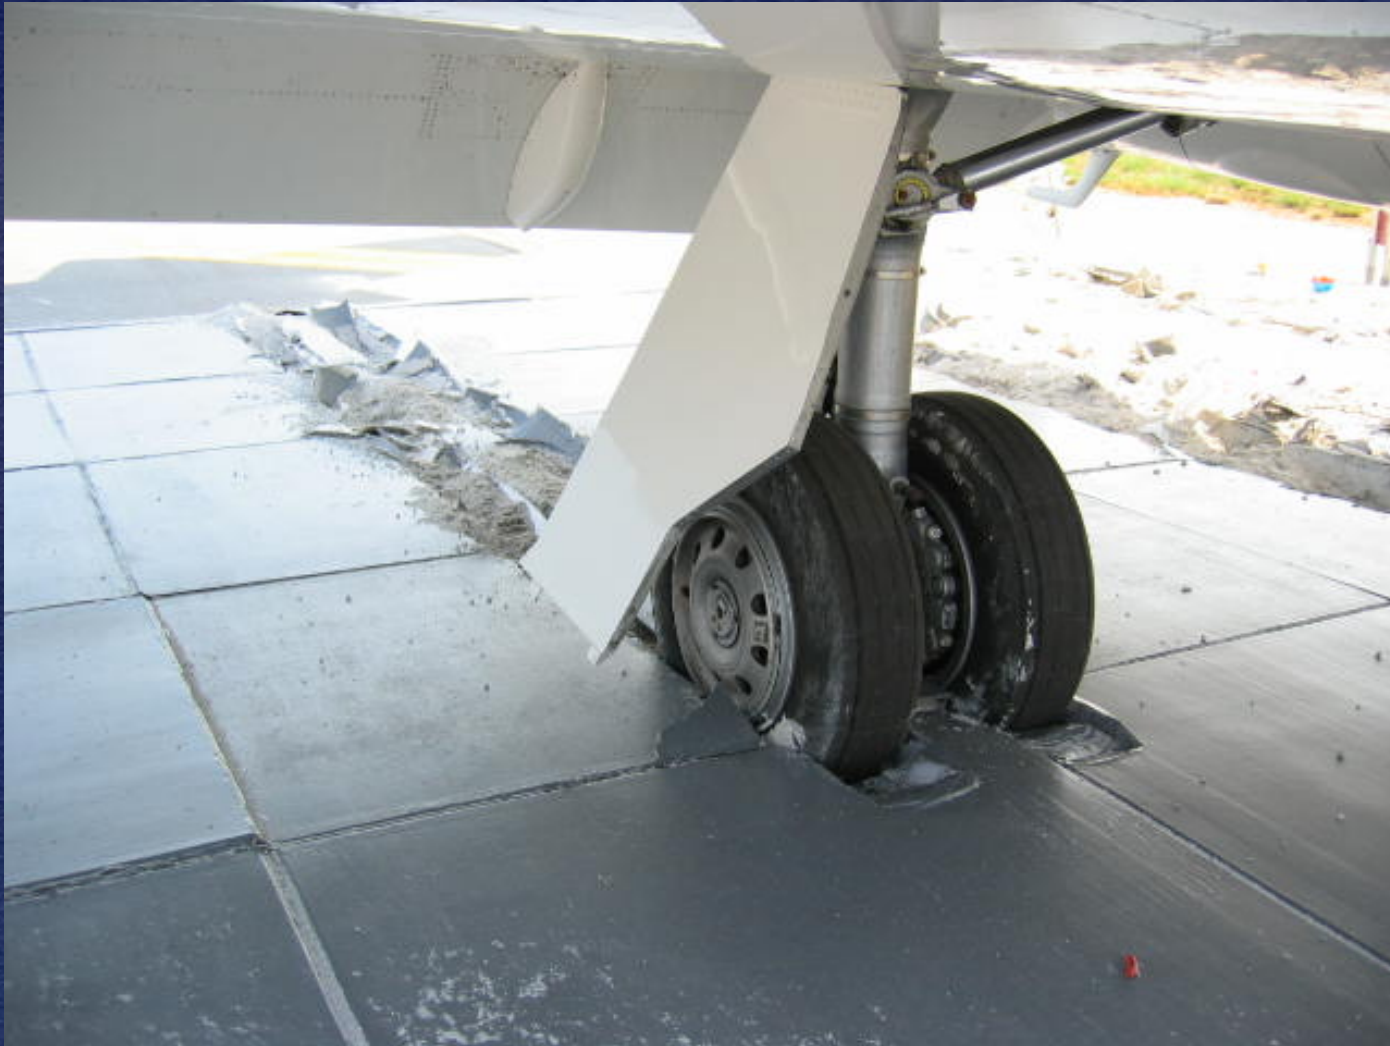
- Engineered Materials Arresting System
  - Crushable concrete blocks
  - Attenuates energy as the airplane crushes the blocks
  - Tunable for “design” airplane and available space
  - Standard EMAS – 70 knot exit speed
  - Non-standard EMAS – 40 knot exit speed

# Runway Safety Areas - EMAS
