DOT/FAA/AR-99/7

Office of Aviation Research
Washington, D.C. 20591

Small-Engine Uncontained Debris Analysis

February 1999

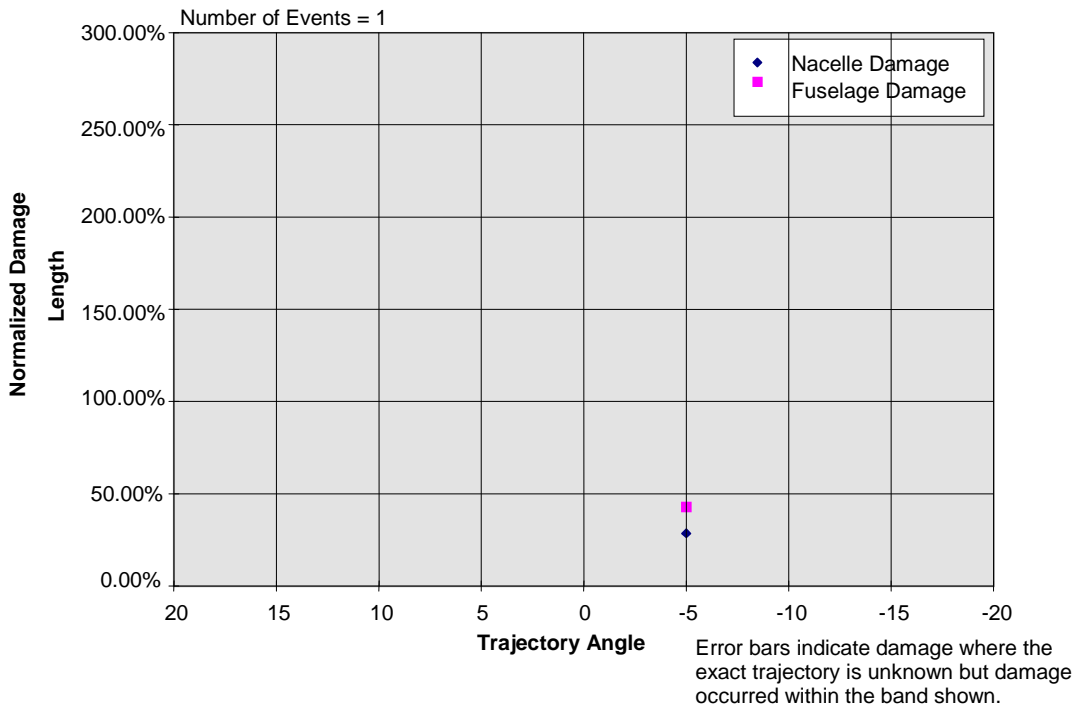
FIGURE 3. COMPRESSOR DISK TRAJECTORY PLOT

COMPRESSOR FAILURES. There are five incidents with compressor failures. Three of the events were rim failures with one blade and disk failure respectively. Damage and trajectory data are provided for two of the events (figure 2). Of these two events, one was a disk event (figure 3) and one was a rim event (figure 4). All of the damage was reported at a -5 -degree trajectory angle. The damage ratio is less than 50% of the disk diameter in all cases.

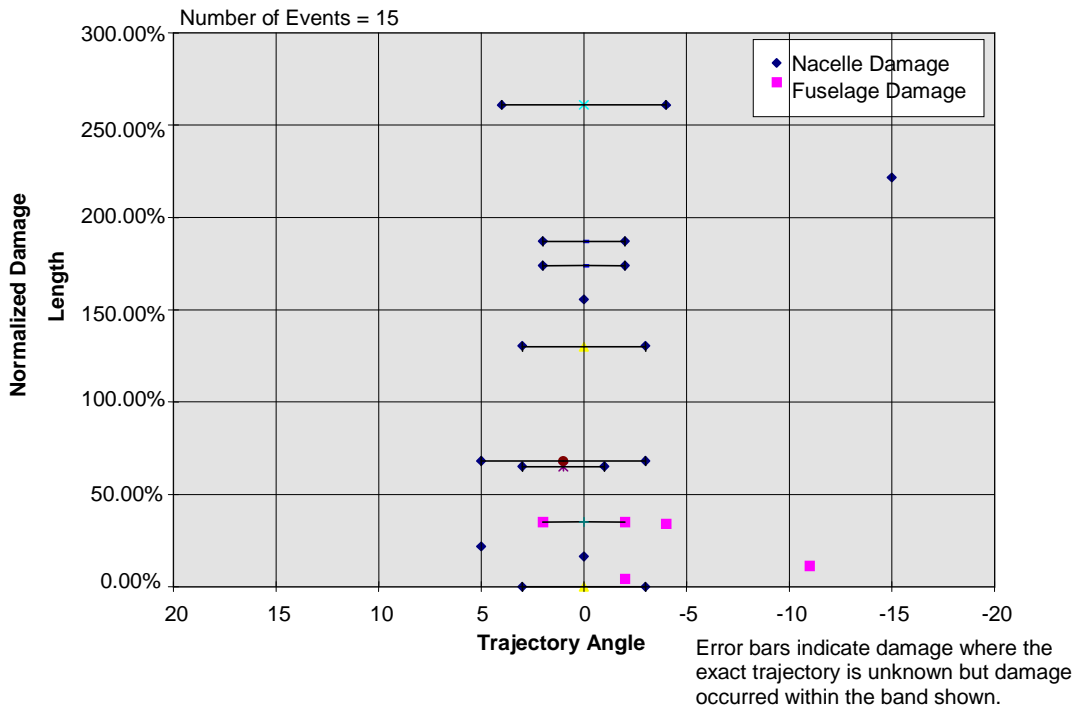
TURBINE FAILURES. The majority of the incidents reported were from turbine failures, 34 uncontained events. Fifteen were turbine rim failures, and 13 were turbine disk failures. Of the 34 events, only 15 reports contain trajectory and damage data (figure 5). Seven of these reports include the general forward and aft spread angle that the debris exited the nacelle. The majority of the data falls within a ± 5 -degree spread angle. Damage to the nacelle has been reported as large as 2.60 times larger than the disk diameter. Fuselage damage was reported as less than 50% of the disk diameter in all cases. Trajectories for the debris damage to the nacelle ranged from 5 degrees forward to -15 degrees aft. Damage to the fuselage ranged from 2 degrees forward to -11 degrees aft.

FIGURE 5. TURBINE EVENT TRAJECTORY PLOT

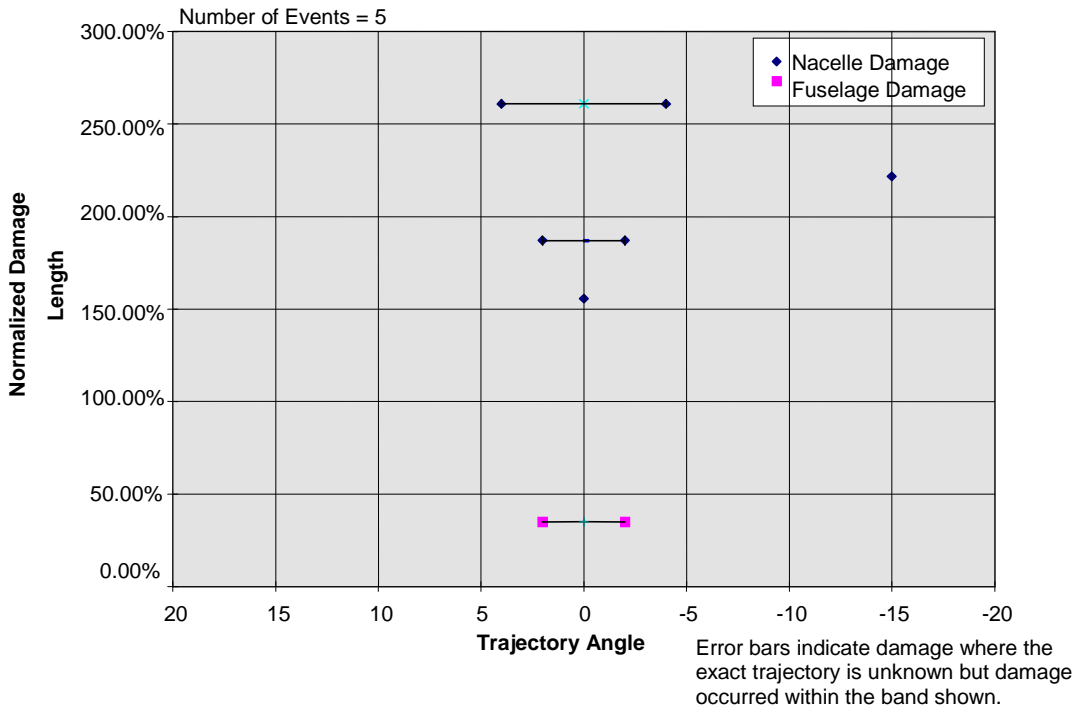
Five turbine disk events were recorded with only one reporting damage to the aircraft fuselage (figure 6). In this case, damage was reported with a trajectory spread of ± 2 degrees. The trajectory spread for the turbine disk fragments is ± 4 degrees with an outlying point located at -15 degrees.

FIGURE 6. TURBINE DISK EVENT TRAJECTORY PLOT
