APPENDIX B

Transportation and Circulation Memorandums

MEMORANDUM

Date:March 11, 2008To:Gary Banks, LBNLFrom:Sam Tabibnia and Ellen RobinsonSubject:Helios Driveway Access Assessment

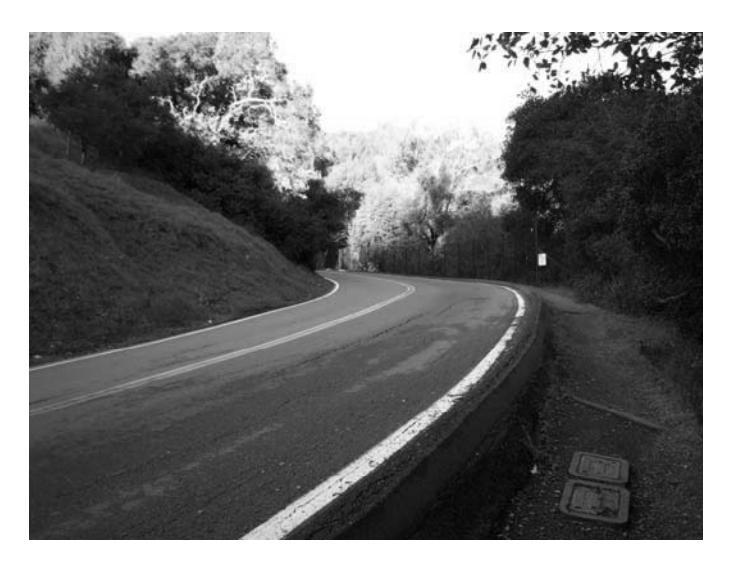
Figure 1 - Pedestrian path near proposed driveway location

The proposed driveway would provide access between Centennial Drive and the proposed Helios Energy Research Facility Project (Helios Project). The new driveway would be located about 1,000 feet southwest of the signal-controlled pedestrian entrance to the University of California Botanical Garden, and about 300 feet east of the Fire Trail parking lot and trail head. Centennial Drive is a winding road in the hilly, heavily wooded eastern portion of the University of California's Berkeley campus. Centennial Drive provides one travel lane in each direction and a posted speed limit of 25 miles per hour. For one half mile from the proposed driveway location in either direction, Centennial Drive has a grade of approximately ten percent, with no shoulder lanes. A gravel pedestrian path extends along the southeast side of the roadway, separated from the vehicle lanes by a small asphalt berm (see figure 1).

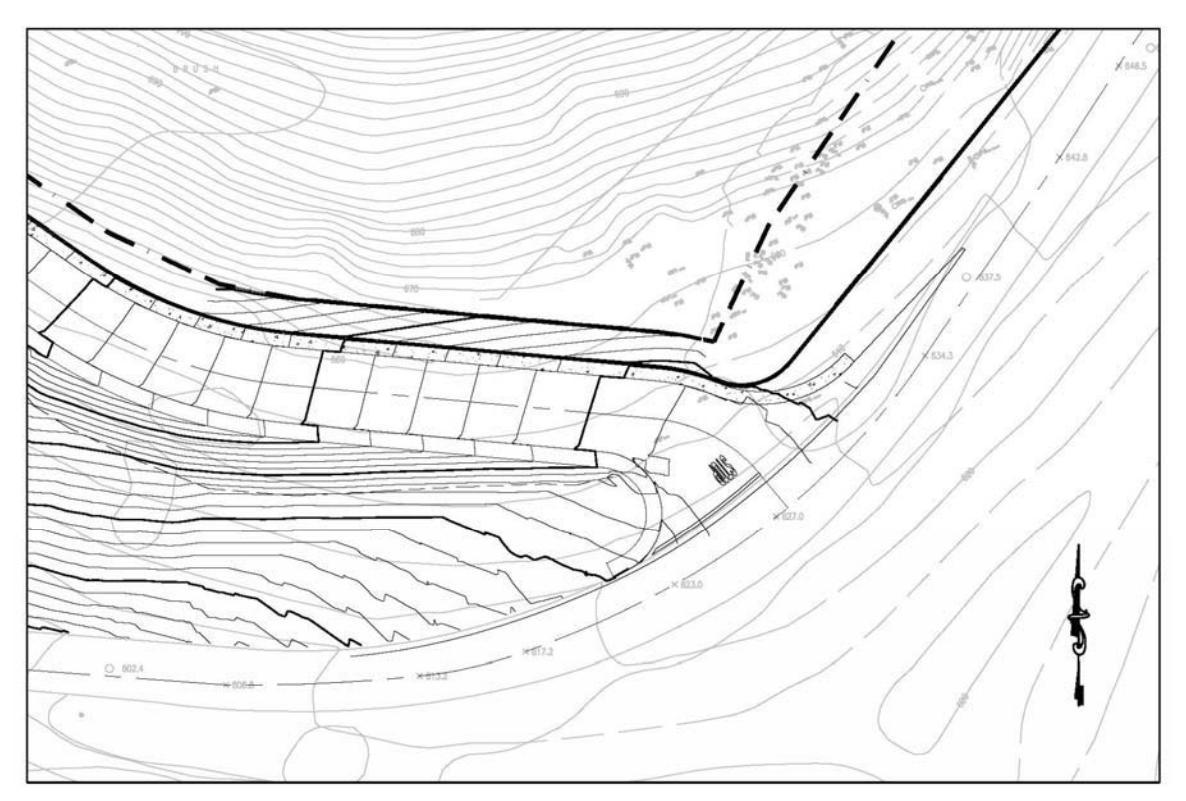
Figure 3 - Proposed Driveway

Figure 3 shows the proposed new driveway. The proposed roadway would provide access to the proposed Helios Project and 50 new parking spaces. A vehicular turnaround area would be provided at the end of the roadway to facilitate bus turnaround. The proposed new roadway would provide one 12-foot vehicle travel lane in each direction and a 4-foot pedestrian path on the east side of the roadway. Vehicular access would be controlled by a card-activated gate located about 225 feet west of Centennial Drive.

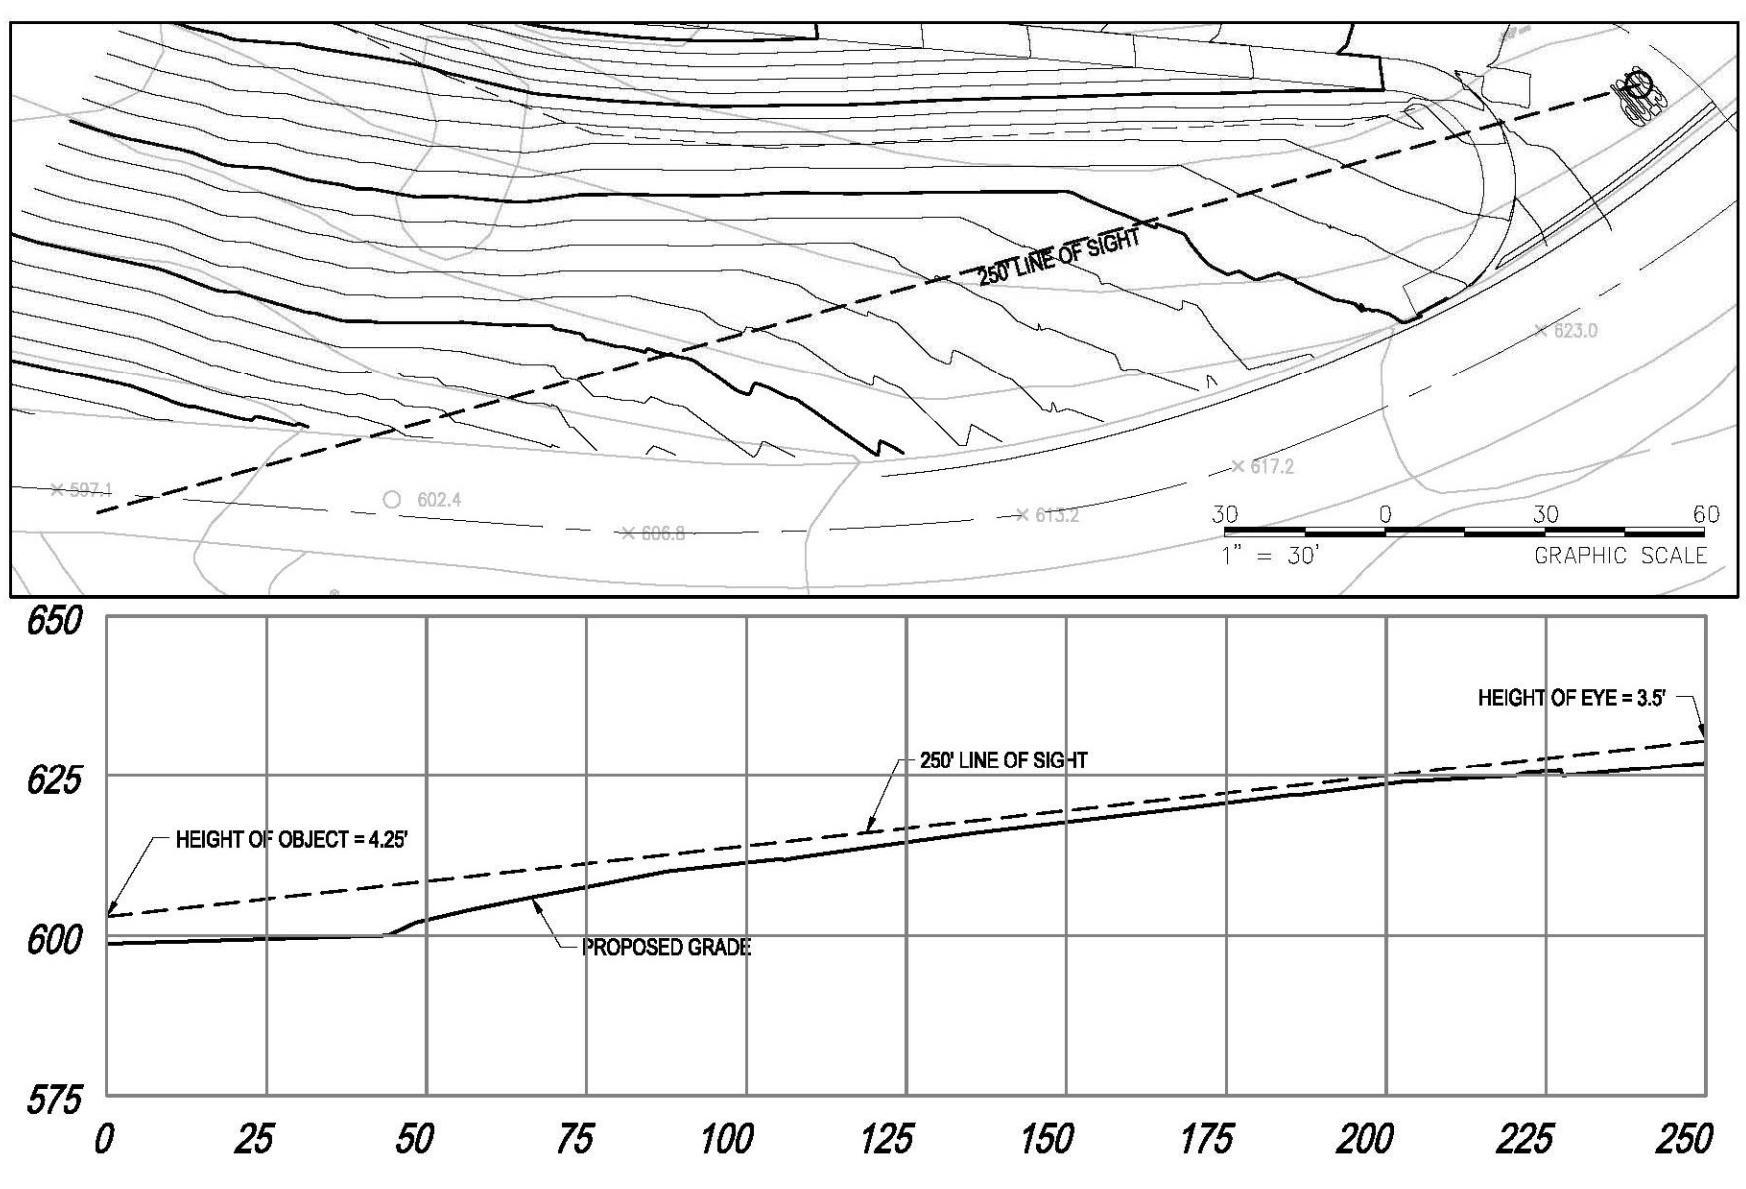
Figure 4 - Sight Distance Plan and Profile Looking West from Driveway

The proposed driveway design has been analyzed, and sight distances in all three directions are adequate for stopping sight distance per requirements of HDM. Landscaping adjacent to the intersection should be minimal and regularly maintained to continue to provide adequate sight distance. Figures 4 through 6 illustrate the lines of sight.

a major road with a design speed of 35 miles per hour, this sight distance is 385 feet. HDM also recommends increasing this distance by 20 percent on downgrades of greater than 3 percent sustained for at least a mile. Centennial Drive meets these conditions at the proposed driveway location. Therefore the recommended corner sight distance for the proposed driveway is 462 feet looking east (at a driver coming downhill) and 385 feet looking west. Due to the vertical and horizontal curvature of the roadway, along with the topography of the site, neither of these sight distance requirements can be met.

The HDM section 405.1 (2) (b) states that when the cost to achieve the recommended, 7.5 seconds corner sight distance is excessive, the minimum corner sight distance for an intersection shall be equal to the stopping sight distance. Stopping sight distance is defined as "the distance required by the driver of a vehicle, traveling at a given speed, to bring the vehicle to a stop after an object on the road becomes visible" (HDM section 201.3). For a major road with a design speed of 35 miles per hour, the stopping sight distance is 250 feet, with a recommended 20 percent increase for steep, sustained downgrades. Therefore the required stopping sight distance for the proposed driveway is 300 feet looking east, and 250 feet looking west. Stopping sight distance of 250 feet must also be provided for drivers traveling from the west, approaching drivers waiting to turn left into the proposed driveway.

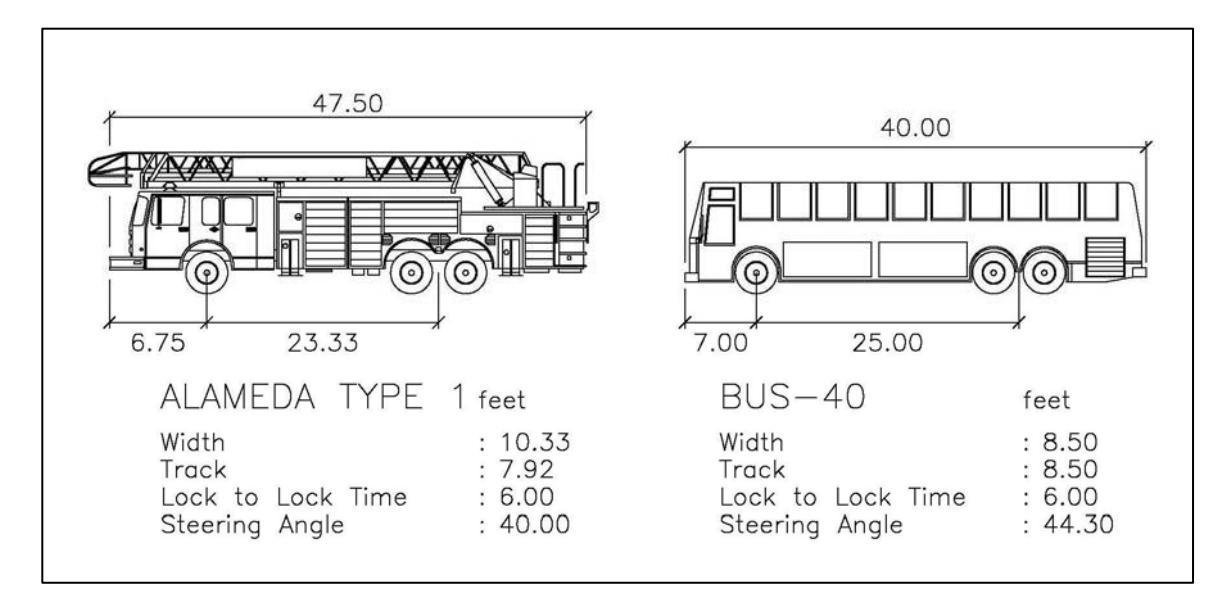
Figure 7 - Design Vehicles

The driveway design was assessed for adequate access by buses and fire engines using AutoTurn, a CAD-based program which simulates vehicle turning maneuvers. The design vehicles used in this assessment are a 47.5 foot ladder fire apparatus and a 40-foot bus. The dimensions of these vehicles are shown on figure 7, below.

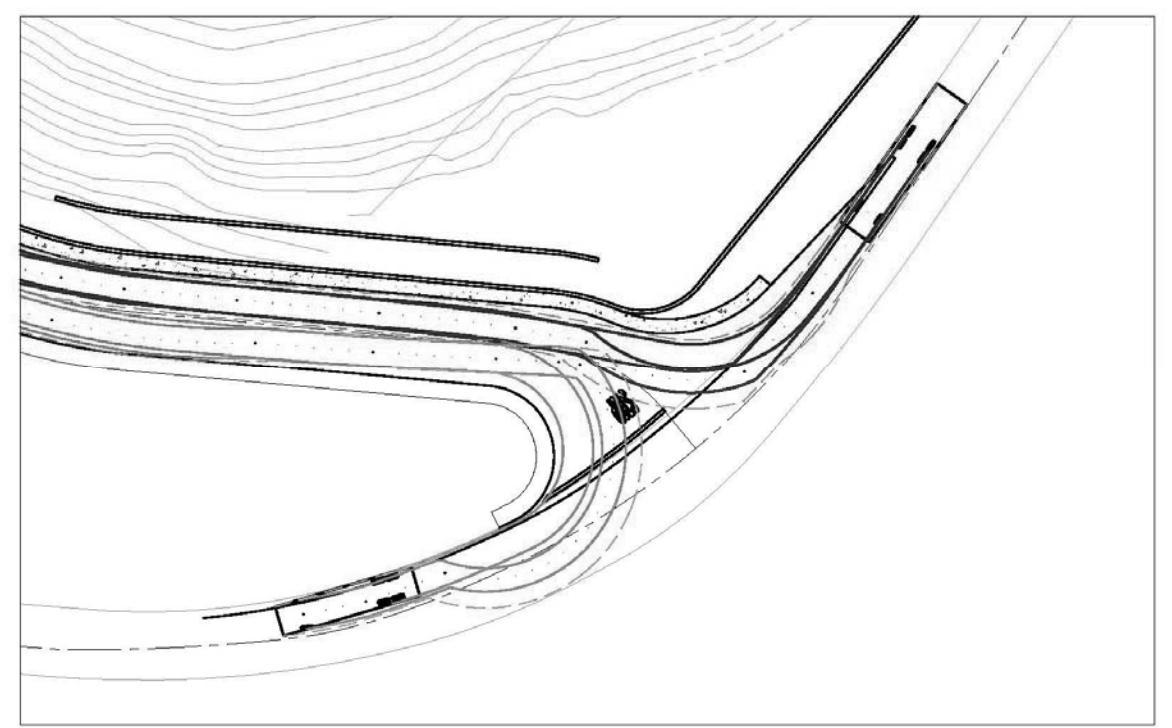
Figure 8 - Fire Engine Access

Figures 8 and 9 show the path of the fire engine and the bus entering and exiting the site, respectively. The dashed lines outlining the vehicle path represent the outer envelope of the vehicle, and the solid lines represent the wheel paths.

As shown in the figures, the fire engine and a 40-foot bus must fully occupy the opposite travel lane on Centennial Drive when turning right from the driveway. Thus, both vehicles must wait for gaps in both uphill and downhill traffic flow before completing a right-turn. However, both vehicles would have adequate sight distance in both directions. Furthermore, fire engine use of the driveway is expected to be minimal and occur during emergencies only. The 40-foot design bus represents a typical charter bus that may occasionally use the driveway. Typical LBNL or UC Berkeley shuttles, which are smaller, would navigate the driveway more easily. If feasible, the curb radius should be widened to improve right-turn from the driveway to Centennial Drive by larger vehicles.

Both fire engines and buses are also able to travel the entire length of the driveway and complete a 180-degree turn on the site.

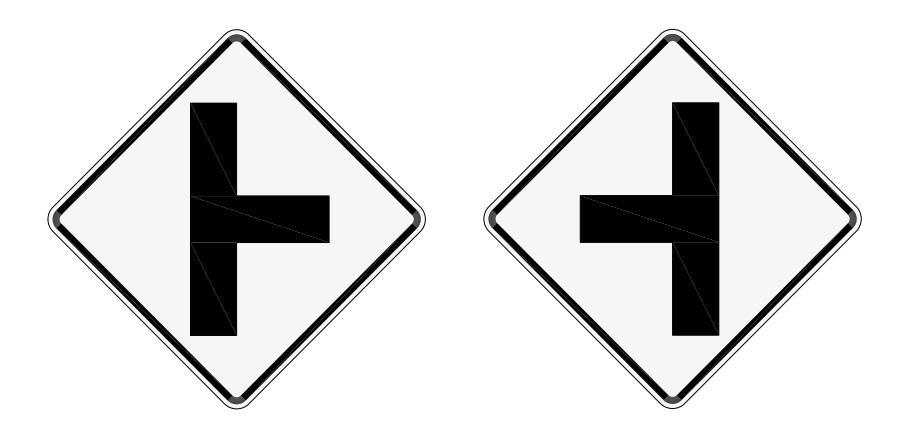
Figure 10 - W2-2R and W2-2L

Installation warning signs with flashing lights on Centennial Drive would improve safety at the proposed driveway. MUTCD standard warning signs W2-2R and W2-2L (see figure 10), should be installed on the Centennial Drive approaches to the driveway. One W2-2L sign is posted on Centennial Drive, north of a driveway between the Botanical Garden entrance and proposed new driveway location. These signs should be installed approximately 100 feet in advance of the driveway on the eastbound approach, and 125 feet in advance of the driveway on the westbound approach, to provide adequate stopping distance for drivers, after reading and comprehending the signs.

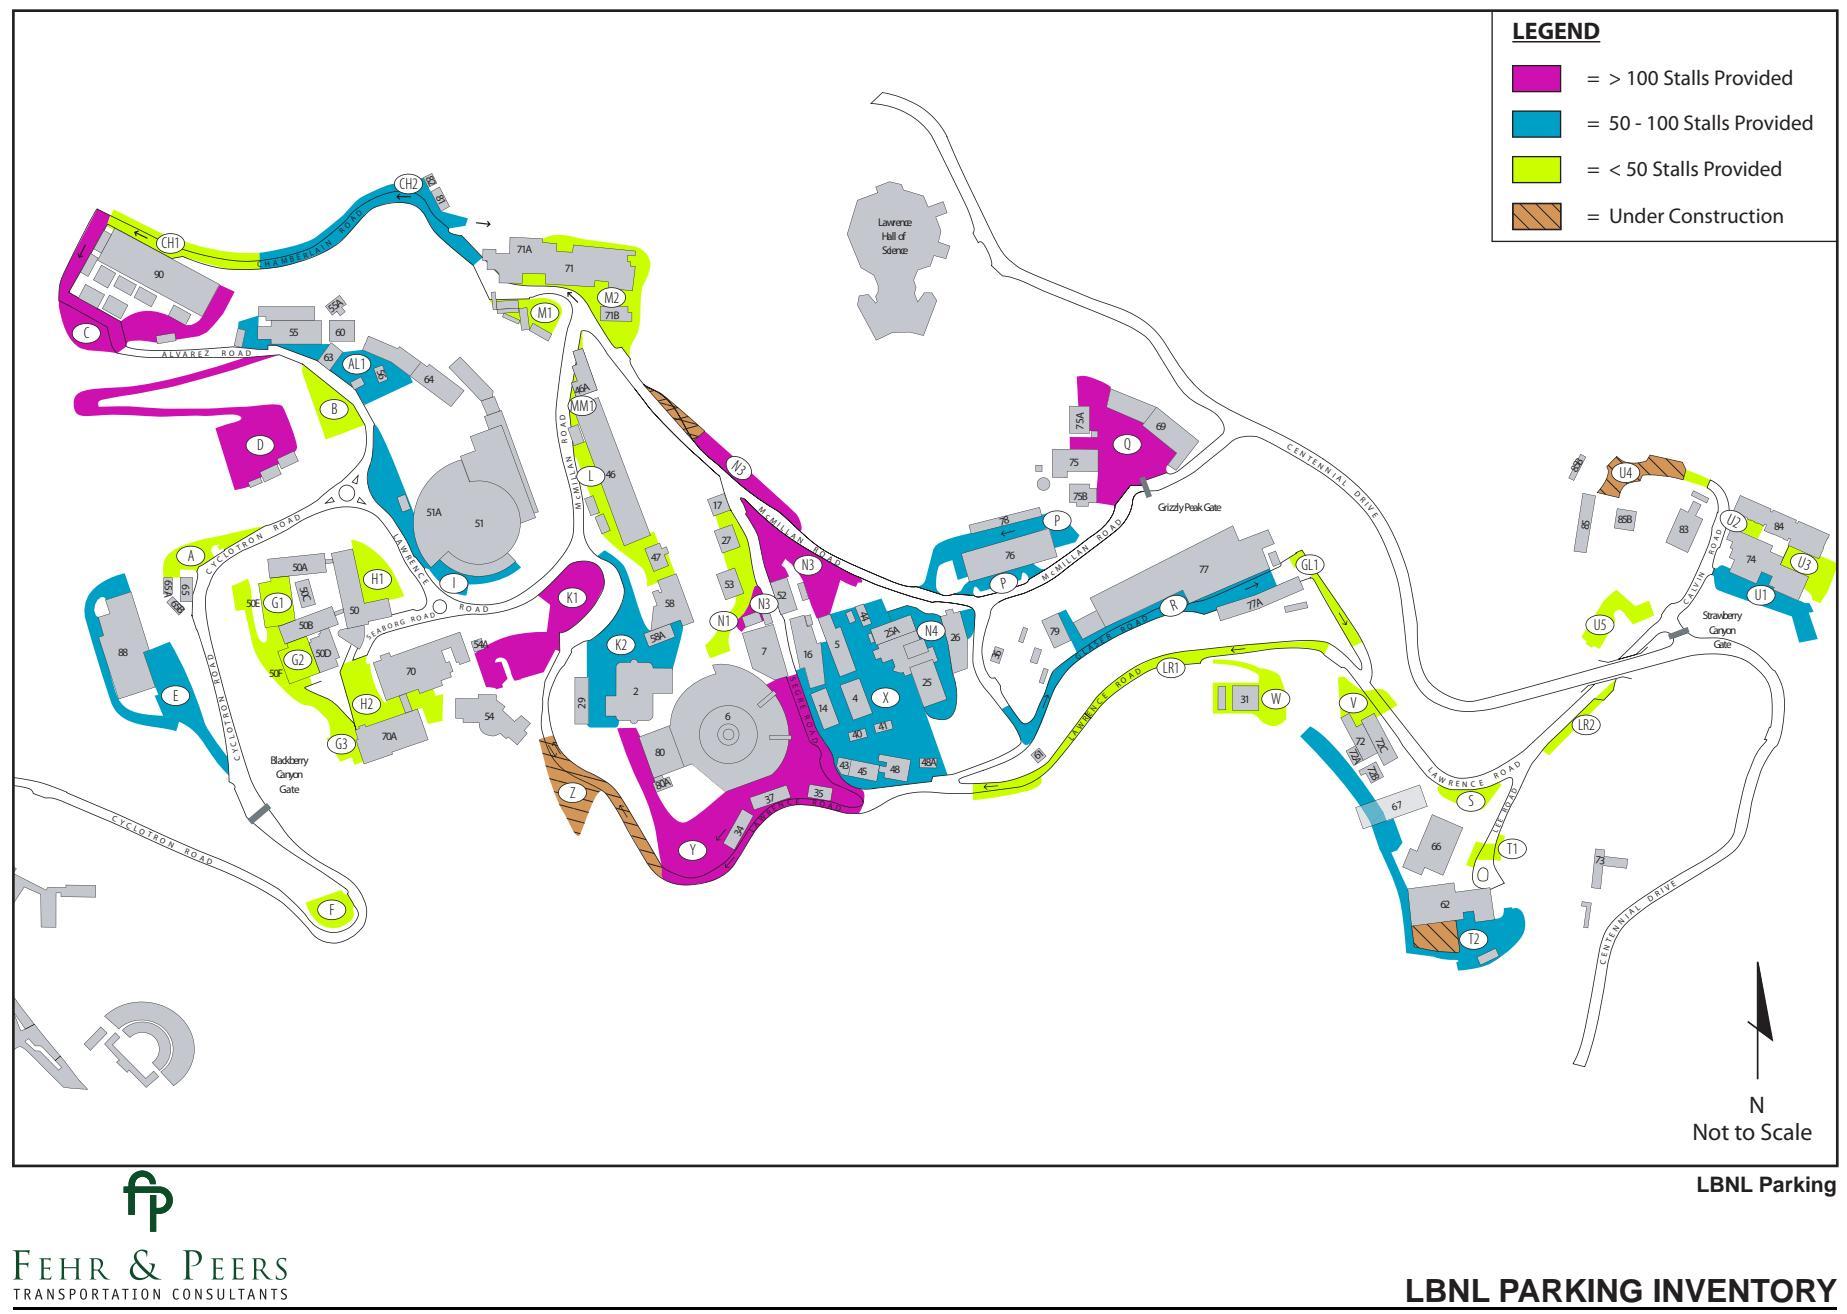
September 2007 WC07-2488_1

An electronic file showing the location and designation of all parking stalls at LBNL was provided by LBNL staff. Based on a site visit on September 12, 2007, we verified and noted the changes in the location and designation of parking stalls. Most parking stalls are provided in small lots adjacent to individual buildings. There is also a number of larger lots and parking along on-site roadways. Figure 1 shows the location of parking facilities and approximate number of stalls at each facility. Table 1 shows the number of stalls by designation at each parking facility.

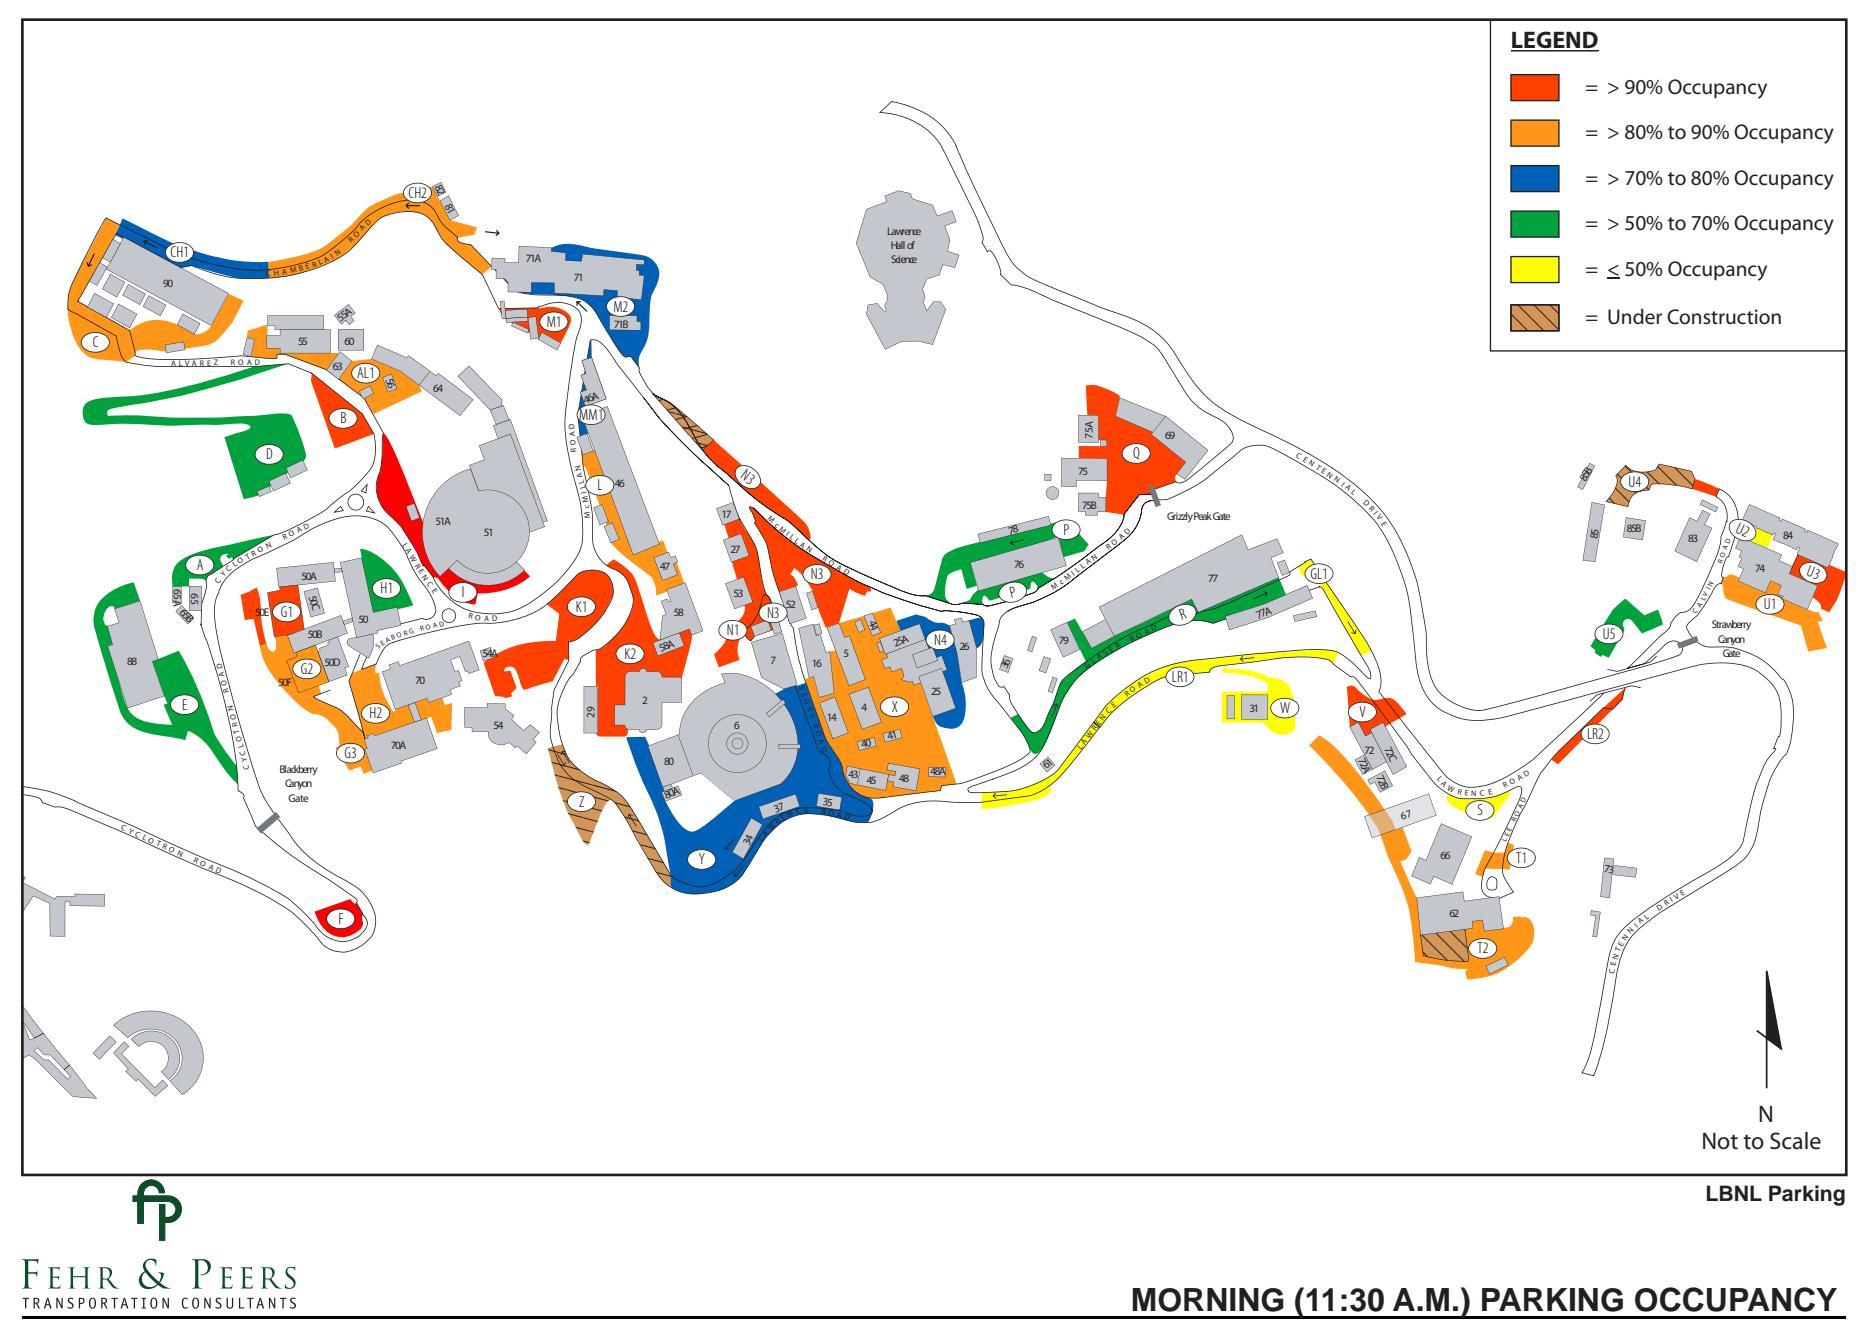
September 2007 WC07-2488_2

Overall, about 80 percent, or 1,722 stalls were occupied in the morning peak period. In the afternoon peak, 1,757 stalls or 81 percent were occupied. In general, parking lots were more full in the central area of the site and less full in the more remote locations of the site. Figures 2 and 3 show the morning and afternoon parking occupancy by facility, respectively. Tables 2 and 3 show the morning and afternoon parking demand by facility and designation, respectively.
