MOTORCYCLE IMPACTS INTO ROADSIDE BARRIERS – REAL-WORLD ACCIDENT STUDIES, CRASH TESTS AND SIMULATIONS CARRIED OUT IN GERMANY AND AUSTRALIA

Paper Number 05-0095

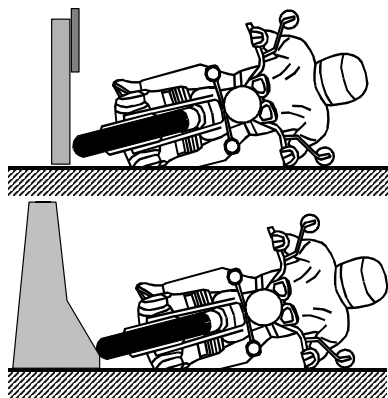
Figure 4. Test where the motorcycle impacted the barrier skidding on its side

Two impact scenarios were chosen for the full-scale crash test program as a result of the findings from the real-world crash study. In the first impact scenario the motorcycle was driven in an upright position (Figure 3) prior to impact. In the other scenario the motorcycle struck the barrier while skidding on its side (Figure 4).

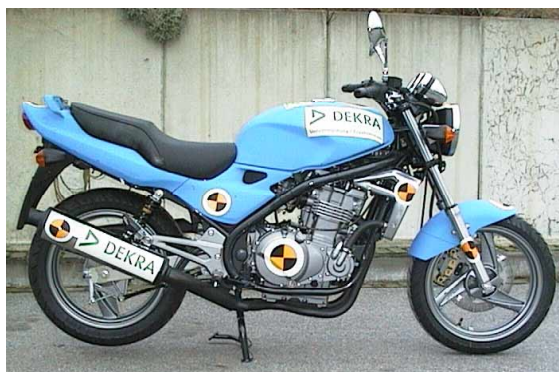
All tests were carried out with the same make, model and type of motorcycle being a Kawasaki ER 5 Twister (Figure 5.). The mass of the motorcycle itself was approx. 180 kg and approx. 272 kg with the dummy sitting on the motorcycle and wearing standard protective clothing.

Figure 5. Motorcycle Kawasaki ER 5 Twister as used for all crash tests

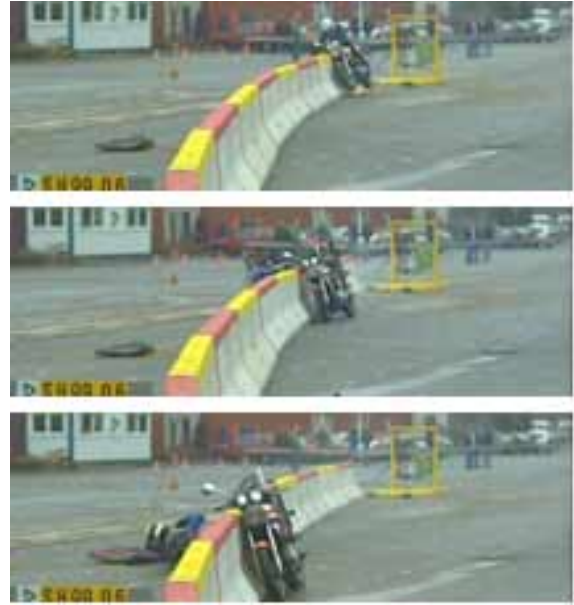
The concrete barrier (Figure 8) does not have any aggressive open shaped parts as in the case of the steel-based systems. In this crash test the motorcycle left the sled at 60 km/h prior to impacting the barrier. This was followed by the dummy flying over the top of the barrier. The dummy reached its final rest position on the opposite side of the barrier (Figure 8 and Figure 9). The distance of the final rest position from the point of first contact primary impact location was 26 m for the dummy and 38 m for the motorcycle.

Figure 8. Full-scale crash test of a motorcycle impacting a concrete barrier protection system in an upright position prior to impact moving

Table 2. Measured dummy loads for the full-scale test shown in Figure 8

The measured dummy loads again do not indicate any life-threatening injury risk (see Table 2.). The right femur is subjected to a compressive load of 4.5 kN being clearly below the injury limit of 10 kN.

Analysis of the film revealed that the motorcycle and the rider were effectively not decelerated during contact with the concrete barrier. As a consequence of this the risk of being deflected by the barrier into oncoming-traffic on the road is clearly higher than for a barrier protection system made from steel. Another disadvantage of concrete barriers is that during an impact they do not dissipate as much kinetic energy via deformation as the systems made from steel.

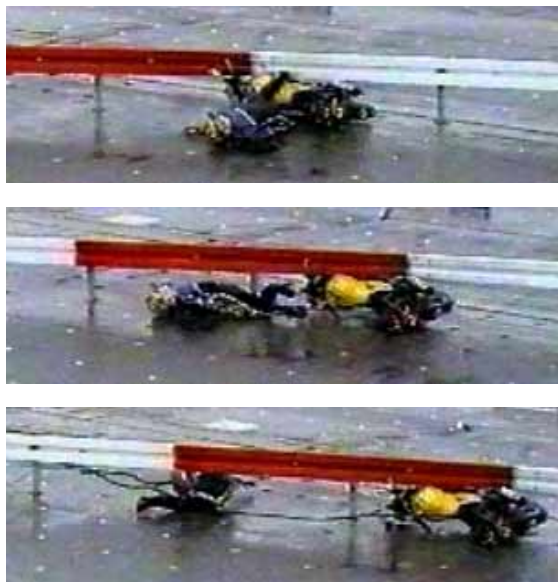
Figure 10 shows the test where the motorcycle slides-on its side and impacting the so called “einfache Schutzplanke” ESP (Figure 1).

Figure 10. Full-scale crash test where-the motorcycle impacts the protection system “Einfache Stahlschutzplanke” ESP by sliding into the barrier

The motorcycle’s velocity leaving the sled was 60 km/h. It directly impacted a sigma post at 47 km/h that broke and was bent down to the ground. Immediately after this first primary impact the motorcycle was stopped and remained stuck underneath the guard rail. The dummy separated from the motorcycle and collided with a sigma post. The distance between the location of the primary impact point and the final rest position was 2 m for the motorcycle and 5 m for the dummy.

Table 3 gives an overview of some of the dummy loads measured at the point of first impact onto the protection system and from the second impact onto the ground. Very high loads above the biomechanical limits were measured for the head during the first contact primary impact. Due to the hard impact into the post, the left shoulder joint of the dummy was broken.

Table 3. Measured dummy loads for the full-scale test shown in Figure 10

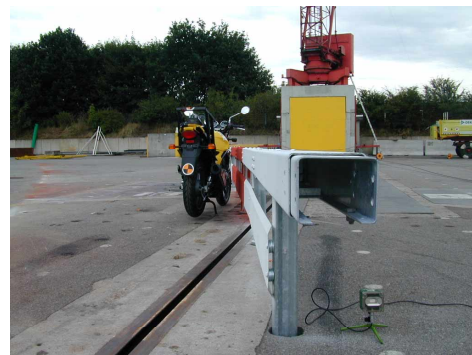
Figure 14 provides some information in regards to structure and the geometry of the modified system. The system is a so called “Schweizer Kastenprofil” consisting of sigma posts and a closed box-shaped profile at the top. An additional underrun protection board was mounted near to the ground to prevent both the direct impact onto a post and movement of the motorcyclist underneath the barrier protection system.

Figure 14. Modified guard rail system with respect to better protection for impacting motorcyclists

In summary, the results from the crash tests show that the risk of injury for a motorcycle rider is much lower when impacting the modified system. The additional underrun protection board eliminated snagging of any parts of the impacting dummy. The additional board also absorbed kinetic energy as a result of its deforming during impact. However, the motorcycle was not redirected away from the protection system after initial impact. Hence, further improvements are still necessary to ensure the underrun protection board does not break and that the severity of the secondary impact onto the ground is reduced. Further questions arise whether the biofidelity of the Dummy Hybrid III is sufficient to accurately predict all injury risks a motorcyclist may be exposed to when impacting a roadside protection system and any subsequent impacts onto the road surface.

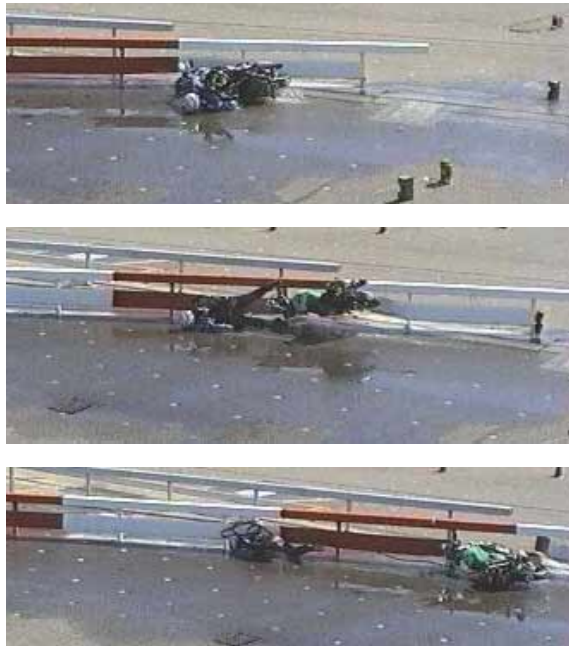
Figure 17 shows the crash test where the motorcycle and dummy slides on the road surface. The motorcycle left the sled at 60 km/h and impacted the barrier at 54 km/h. Due to the impact the underrun protection board broke and the motorcycle struck a Sigma post. The dummy separated from the motorcycle immediately after the initial primary impact and then the helmeted head struck the underrun protection board.

Figure 17. Full-scale crash test where the sliding motorcycle impacted the modified steel guard rail system

Table 6 gives an overview of measured dummy loads related to the primary impact and to the secondary impact. For the primary impact into the protection system all measured dummy loads were clearly less than their corresponding injury tolerance limits. However the measured 3-ms-96 g head acceleration during the secondary impact is above the tolerance limit of 80 g. Also the HIC in the secondary impact with a value of 510 but clearly beneath the limit of 1,000 is relatively severe.

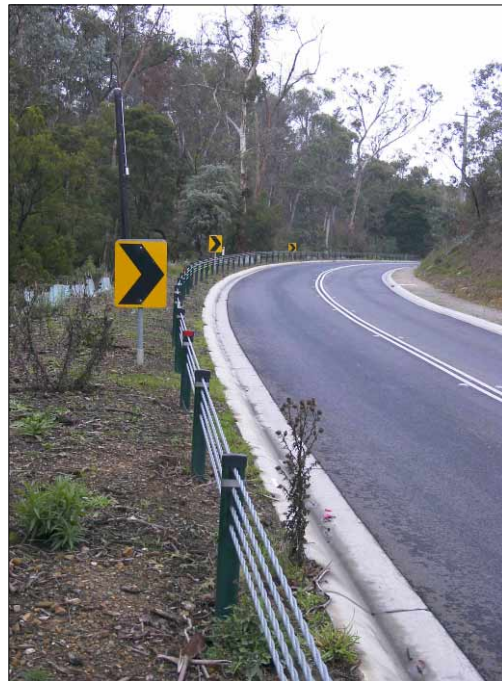
The wire rope barrier model was based on an actual installed system (Figure 20 and Figure 21). This barrier consisted of seven posts that supported the four wires of the barrier. The wires of the barrier that were modelled are made up of three high tensile steel cables woven together with an assumed yield stress of 500 MPa. They have a combined circumference of 60 mm and were represented in the model by a TRUSS2 finite element with a cross sectional area of 280 mm² for each cable. The wires had an initial tension setting of 5 kN. Ellipsoids were used to model the support posts being 2 mm thick.

Figure 20 Four rope wire rope barrier
