TIMBER FRAMERS GUILD JOURNAL OF THE TIMBER FRAMERS GUILD Number 72, June 2004

Historic Kingpost Trusses

NOTES & COMMENT	2
TTRAG PROCEEDINGS 2004	4
MEDIEVAL ROOF CARPENTRY: CHARPENTE LAMBRISSÉE Lynn T. Courtenay	8
HISTORIC AMERICAN ROOF TRUSSES	16

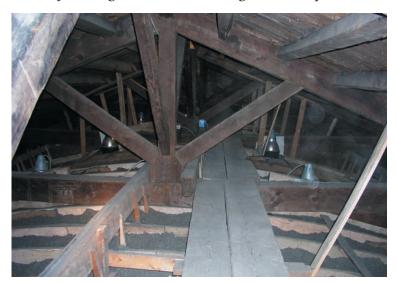
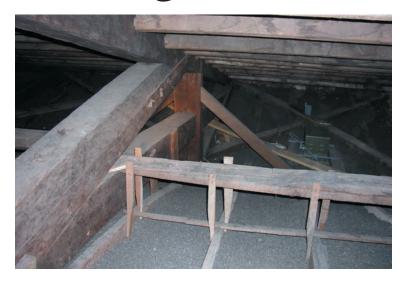
St. John's Church, Portsmouth, N.H., 1807, designed by Alexander Parris. Roof framing combines a kingpost truss above the collar beam (below) with arch braces beneath, and posts apparently extended into the attic from the galleries below (above right). Iron straps abound.

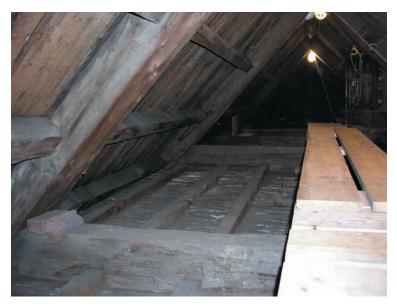
View under one side of the M-roof, with heavy collar beams carrying ceiling joists for the chambers below. Catwalk gives access to area seen in photo below.

Soon protected by a cap that turned the M-roof into a gambrel form, its original frame survives complete with shingles in the inner valley, replaced only at the base of the original cupola because of water damage. In fact, the volume enclosed under the chevron of the M permits an attic story of four rooms (three of them heated by fireplaces) and a large hallway, lighted by dormers. The double roofs sit above the collar beams, with the joists between supporting the plaster ceiling of the attic.

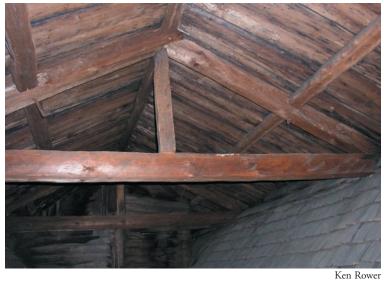
View under the triangular cap that made the roof a sort of gambrel. Original shingles remain on formerly exposed pitch.

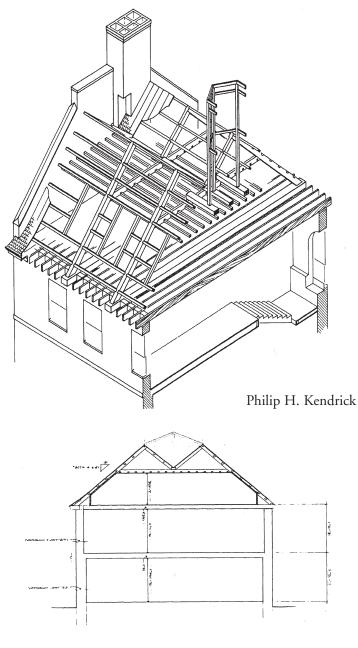
Original valley drained through downspouts fixed to the end walls of the house.

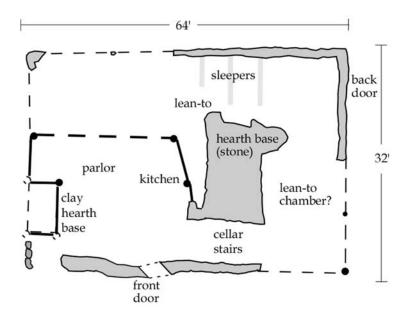
Plan for the 1664 Chadbourne house.

The Chadbourne house initially consisted of a hall and parlor, with a lean-to, lean-to chamber, and chambers on the second floor. Over time, a series of outbuildings were connected to this main building, forming an enclosed compound. In size and shape the Chadbourne homestead more closely resembled an English manor house with courtyard rather than a typical 17th-century New England home. Results of the ongoing excavation of the site can be seen at www.salemstate.edu/~ebaker/chadbourne.htm.

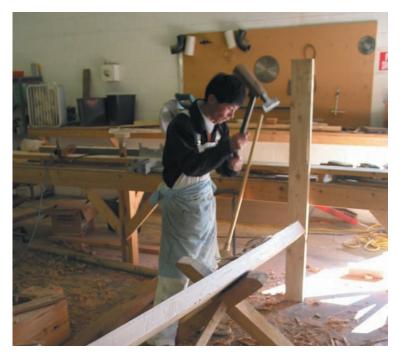
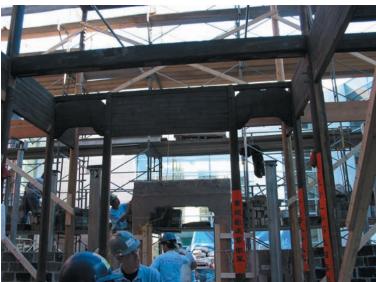
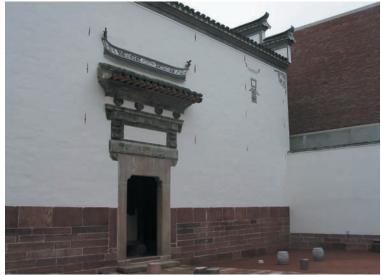
At top, Cheng Hui using the Chinese adze cross-grain to form a tenon on a 3x12 connecting beam held by three-legged Chinese ma (horse). At middle, looking outward from set of entry columns absent big doors to come (the spirit screen) toward stone framing of the main entry; ceremonial red banners mark successful raising of frame. Above, exterior view of main entry and plastered-brick and sandstone façade.

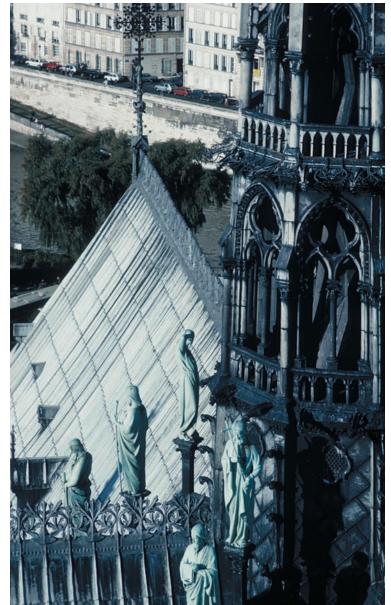
All photos Lynn T. Courtenay unless otherwise credited Fig. 1. Spire and roofs of Notre-Dame de Paris (primary construction dates, 1155-1240). Framing of nave and choir roofs is medieval; spire and transept roofs were rebuilt under the direction of Viollet-le-Duc in the mid-19th century. Figures represent Apostles; Viollet-le-Duc (in profile facing the spire) is portrayed as the Apostle Thomas, the carpenter.

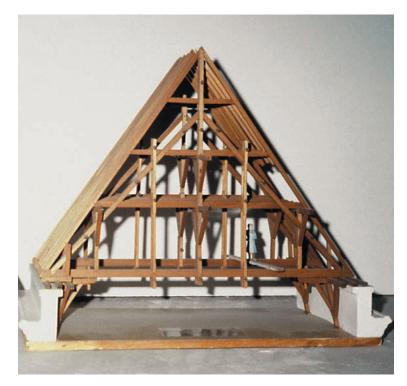
Fig. 2. Notre-Dame de Paris: nave model by Henri Deneux (1916), at the Centre de Recherche des Monuments Historiques (CRMH), Paris. The carpentry dates primarily to the first quarter of the 13th century. Timber is all oak, of uniform scantling, and the framing powerfully though lightly built considering the cathedral's overall scale; the internal span is about 43 ft. This is one of the earliest northern European roofs known to comprise multiple hangers and axial bracing (roof plates) in an integrated design. The careful seating of the roof is noteworthy in the carpenter's use of saddle brackets to brace the tie beams from below, three wall plates per side with the ties notched over them and diagonal struts from the wall posts to the innermost wall plate that oversails the masonry parapet (lower left). Clearly the master carpenter was concerned about stability and the creation of a frame that could support workers and materials for the construction of the masonry vaults below.

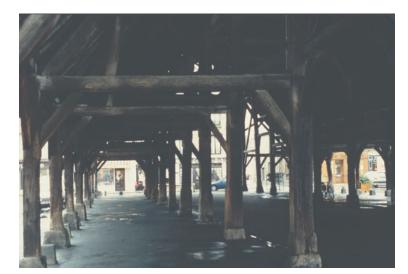
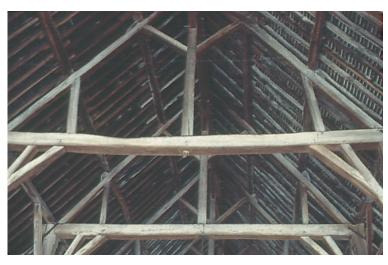
Fig. 3. Market hall, Milly-la-Forêt, 1479, with three-aisle basilican layout and double-framed "Latin Truss" roof with multiple purlins.

to be used in French roofs into the later Middle Ages, they never appear below the surface of a masonry vault. Conversely, the Vstruts or lateral braces attached to kingposts that frequently appear in open roofs or those above vaults do not appear below the vault surface in roof-vault hybrids, a fact that seems not to have been observed previously (cf. Fig. 3 lower and Fig. 11).

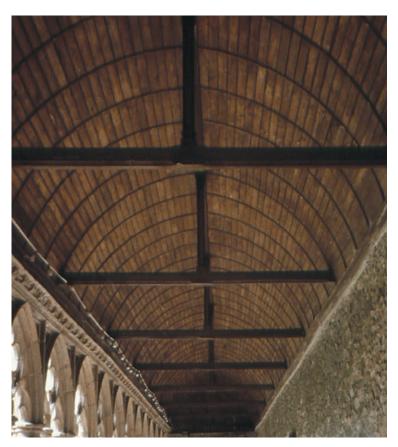
Fig. 4. Fifteenth-century cloister vaults at Tréguier Cathedral in Brittany, illustrating typical charpente lambrissée with intermediate kingpost trusses.

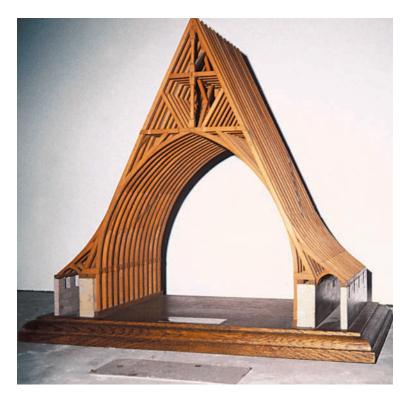
Fig. 6. Deneux's model (CRMH, Paris) of the roof of the upper hall of the Château de Sully-sur-Loire, 1401-1460. Framing is of uniform scantling, in the northern European tradition, and closely spaced.

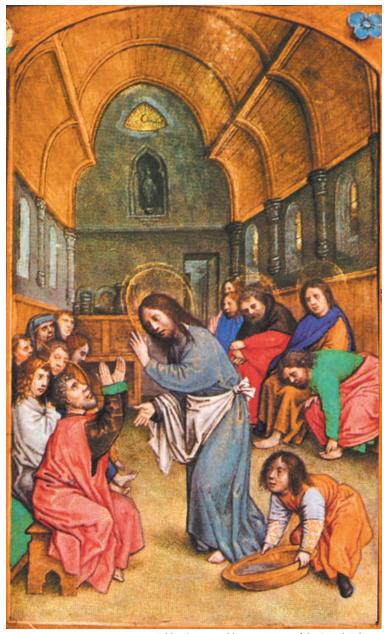
Add. 54782, used by permission of the British Library Fig. 7. Illustration of Christ washing the disciples' feet, from a Flemish book of hours in the British Library, ca. 1480.

The two examples selected from a variety of book illustrations and panel paintings illustrate the two major types of timber vaults used: one, with only the vault, and the second, a vault combined with a prominent tie beam truss. The first miniature is from a Flemish Book of Hours (The British Library) depicting Christ washing the disciples' feet (about 1480), possibly produced in Ghent for Edward V of England (Fig. 7).

This miniature shows an unusual but significant example of an upper floor hall in which the vault design is based on a cusped trefoil very similar to the mid-13th-century *charpente* at the hospital of Byloke in Ghent (Fig. 8). The hall depicted is a room with masonry walls, round-headed, glazed windows and corbelled colonnettes with capitals between the windows, which serve visually and perhaps structurally to support the primary trusses and ribs of the timberwork. The moldings (roof plates?) that divide the vault longitudinally on either side are exactly analogous to the double roof plates in the structure at Byloke.

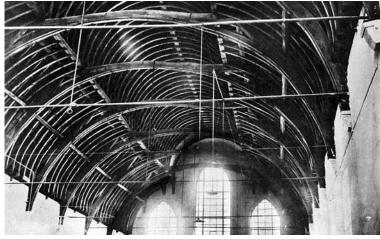
Commission royale des monuments et des sites (Belgium), 1962 Fig. 8. Trefoil roof design of the main ward of the Cistercian hospital of Byloke in Ghent, dated by dendrochronology to 1255. The roof type is an aisled-hall derivative composed of "short principals" and resembles base crucks that developed in England and the Low Countries during the 13th century. The east end retains some of its original paneling or lambris; the tie-rods and corbels date to the 17th century.

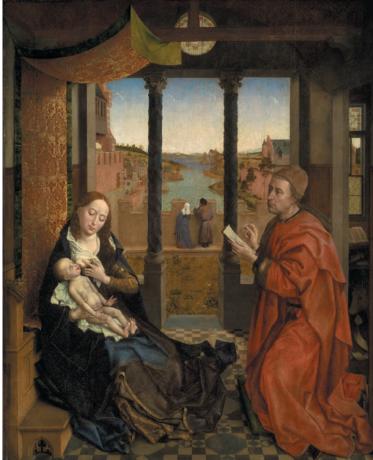
Fig. 9. St. Luke Drawing the Virgin, 1435-1440, by Rogier van der Weyden. The connection of kingpost to tie beam is visible against the lighted circular window at the top of the painting. Careful study will reveal the corbels supporting the tie and the profile of a timber vault.

popular medieval subject that usually takes place in a private, secular chamber and thus reveals an intimate, well-furnished interior (Fig. 9 facing page). While the miraculous portrait sitting is entirely imaginary, in the hands of Flemish artists of this period everything is represented as tangibly real. In the Boston panel, the Virgin, humbly seated on a low bench, suckles the infant Jesus while Luke in close proximity draws her portrait. The iconography, combined microscopic and telescopic perspective, as well as Rogier's style and oeuvre per se, have fascinated art historians; however, our interest is the charpente, namely the vault and the relatively heavy kingpost truss that divides the chamber into two bays and from which the embroidered canopy of honor for the Virgin is conveniently hung. The tie beam is supported on masonry corbels just beneath the wall head where the curve of the low timber vault begins and forms a semicircular arch that rises just above the bull'seye window in the end wall of the chamber. Given the artist's interest in the primary subject and its setting-an interior juxtaposed with the fascinating view to the exterior garden, parapet walk with figures and the expansive landscape beyond-the wooden vault (in deep shadow) is hardly a focus of artistic interest. Yet, despite its pictorially minor role, the vault and its profile are clear enough, and here we can appreciate exactly how the charpente lambrissée extends the height of the chamber. One only has to imagine the same interior ceiled at tie beam level to comprehend how the trussvault combination worked spatially. The fact that the timberwork has nothing to do with the iconography, unlike the enclosed garden, Luke's writing desk or the Virgin's cloth of honor makes its rendering a convincing document of a potentially real early 15th century chamber that is very similar to Rogier's Annunciation (Alte Pinakothek, Munich).

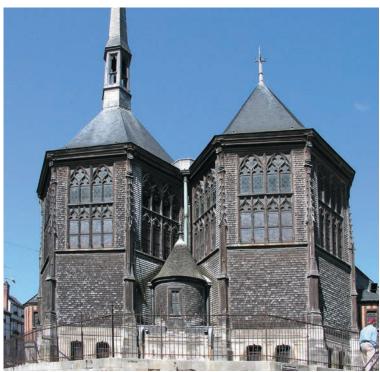
Fig. 10. Twin apses at Ste. Catherine's Church, Honfleur (Normandy), late 15th century. Timber-framed church is clad mostly in shingles.

Although influenced by Anglo-Norman building traditions and allegedly built by ship's carpenters, the pointed tunnel vaults with an open truss are firmly rooted in northern French carpentry. Ste. Catherine's is not only a hybrid structure that combines a vault form with timber-framed aisled construction, but it is also a building that links vernacular and elite architecture, as was often the case with parish churches.

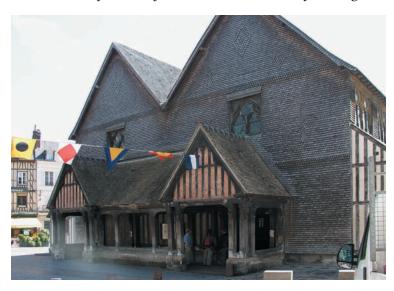
Fig. 11. Twin porches and double nave at Ste. Catherine's. Exposed colombage visible at right on lean-to addition amd porch pediment.

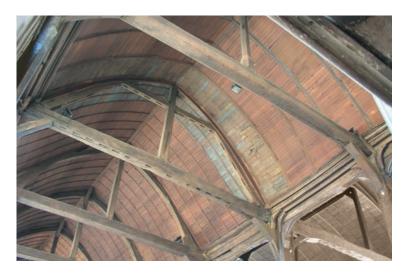
Fig. 12. One of two vaults at Ste. Catherine's. Empty mortises, patched lambrissée and change in rib centers indicate historic alteration.

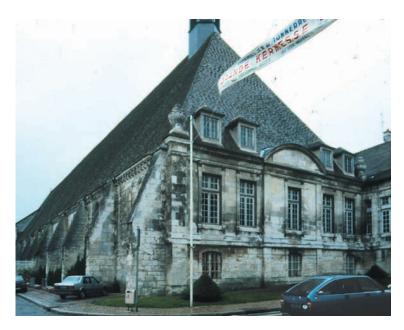
Fig. 13. The Maison Dieu in Tonnerre (1295). The vast roof, originally covered with glazed tiles, measures some 4500 sq. meters.

the silhouette of a barn or market hall with characteristically low walls in comparison to the great expanse of roof (Fig. 13).

Physically, the interior extends to two-thirds of the height of the building. The tied trusses and abutments permit the large windows to be placed high on the walls between the tapered buttresses, thus admitting more sunlight. The resulting light gain in the larger space at Tonnerre can be contrasted to the Byloke infirmary (Fig. 8) where the heavy short principals extend down the wall and the windows are placed proportionally lower. In Tonnerre's brilliantly designed interior, the master carpenter not only provided ample light but also space for an internal timber gallery originally at window level above the former alcoves for the beds (large wall sockets for the gallery braces still remain). The louvered windows of the ward were easily accessible for opening and closing by the attending sisters who reached them from the gallery. By such careful planning, staff and patients were accommodated in an efficient manner in keeping with medical practice of the period.

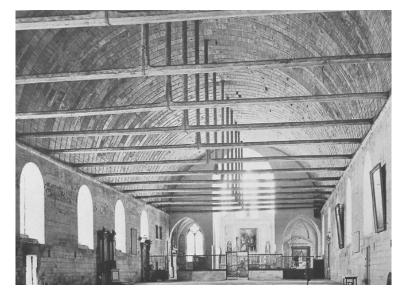
Fig. 14. The open ward of the Maison Dieu, with clear span and height to top of vault both about 60 ft.; design is based on equilateral triangle.

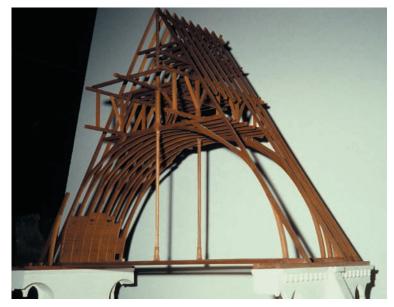
Fig. 15. Deneux's model (CRMH, Paris) of Tonnerre's roof framing. Height of vault is about 30 ft. Common rafter frames stand on 32-in. centers with ties at every fifth frame. Tapered, unscarfed rafters are 63 ft. long, 6x7 at the ridge and 8x10 at the plates.

The framing at Tonnerre was studied by Viollet-le-Duc, and later by Henri Deneux, whose model is in Paris at the Centre de Recherche des Monuments Historiques (Fig. 15). In the hospital museum, open to the public, there is a larger scale model built in 1988 by the Compagnons Charpentiers du Tour de France.

The chamfered tie beams measure nearly 69 ft. long, but the cross-sectional dimension is a scant 12x12 in., for a slenderness ratio of about 1:69 for the ties! When one subtracts the support given to the tie beams by the wall, the internal clear span is about 60 ft. The ties occur at every fifth frame, with the four intervening common rafter couples spaced 32 in. center to center. The rafters are unscarfed timbers (exceptional) 63 ft. long, 6×7 in. (breadth by depth) in section at the ridge and 8×10 in. at the wall plates. The common rafters are of the same scantling as the primary truss rafters, and thus produce a uniform-section roof essentially without bays.

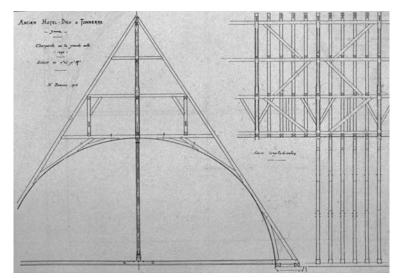
Fig. 16. Transverse and longitudinal sections (the latter from the interior) of the roof of the Maison Dieu at Tonnerre illustrating the tie beam truss with two upper collars and axial members framed into the hung kingpost. The rafters of uniform scantling are braced to form the profile of the semi-circular arch to which the timber panels are nailed. Section (D. 6990, 1916), by H. Deneux, CRMH, Paris.

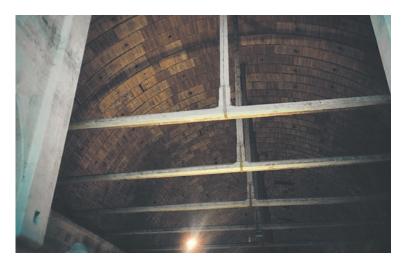
Fig. 17. Tonnerre, kingpost and tie beam assembly with vault paneling (some restored). Each panel spans about 26 in. of the vault surface.

The visible *charpente lambrissée* is formed by the addition of four curved braces. The vault surface (Fig. 17) comprises fitted riven panels (*lames*) tapered on one side and thus triangular in cross section. Each panel spans the distance between the common rafter couples, about 26 in., and is nailed to the common rafter. A projecting molding or *couvre-joint* hides the nailed ends of the panels, joined to one another by tongue and groove. In the 19th century, Viollet-le-Duc drew these panels and carefully recorded the ventilation openings cut in the shape of quatrefoils (Viollet-le-Duc 1862, VI, 111).

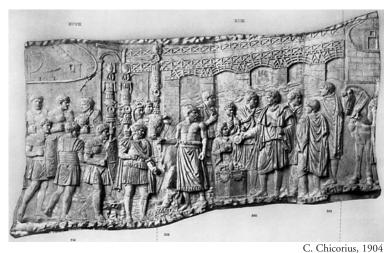
Panel from Trajan's column depicting Apollodorus's bridge (ca. 105) across the Danube. Trussed segmental arches spring from triangulated supports to carry the bridge deck. Triangulated railings may help.

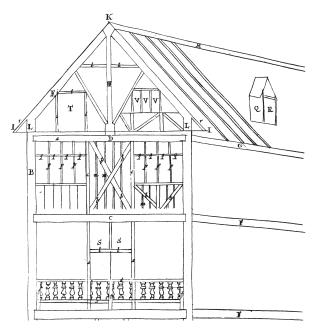
Fig. 4. Moxon's drawing of a kingpost truss, 1687, detail. Position of truss over fully studded gable wall may allow presenting normally disparate elements in one drawing.

By the 16th century, illustrations of trusses and more-or-less modern discussions of their behavior were available in numerous Italian publications and, by the early 17th century, such trusses were being built and written about in England as well. In Italy, the truss was called *trabo reticulari* or "beam in the form of a net," not unlike some modern engineers' descriptions of trusses as having chords and a web (Yeomans 1992). In 1678, Moxon's *Mechanick Exercises* illustrates a fully developed kingpost truss with a flared head and struts rising from joggles on the kingpost to the midpoint of the rafters—but, inexplicably, over a fully studded gable wall in an otherwise common rafter roof (Fig. 4).

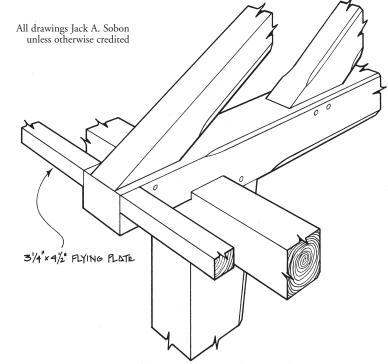
Fig. 6. Rafter, tie and plate joints, Lynnfield Meetinghouse, An English tying joint with outshot plate.

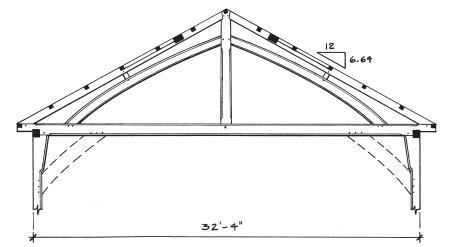
FIG. 5. LYNNFIELD (MASS.) MEETINGHOUSE ORIGINAL TRUSS, 1714.

The Lynnfield Meetinghouse has all the appealing characteristics of late medieval framing: everything is hewn or hand surfaced, all members either curve or taper slightly and the timber edges are decorated with a nonmechanical sort of easement that widens and narrows with irregularities of the hewn surface. Meant to be exposed, and well protected over time, the trusses have a beautiful patinated color. This roof system is in very good condition, particularly the older trusses.

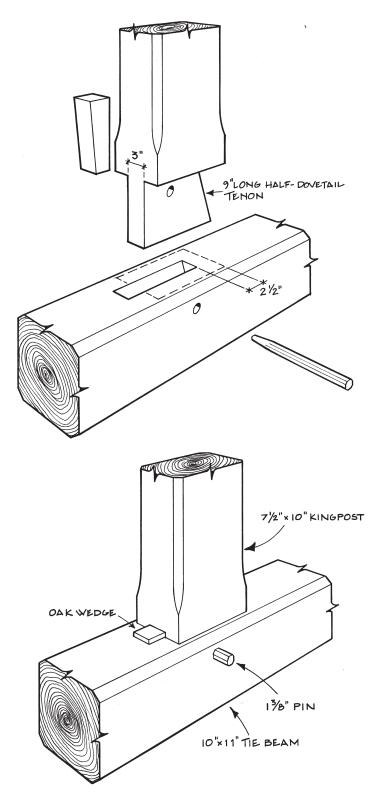
FIG. 7. KINGPOST-TO-TIE JOINT, ASSEMBLED AND EXPLODED VIEWS, LYNNFIELD MEETINGHOUSE. ORIGINAL TRUSSES ARE ENTIRELY OAK; LATER ONES USE PINE RAFTERS AND TIE BEAM.

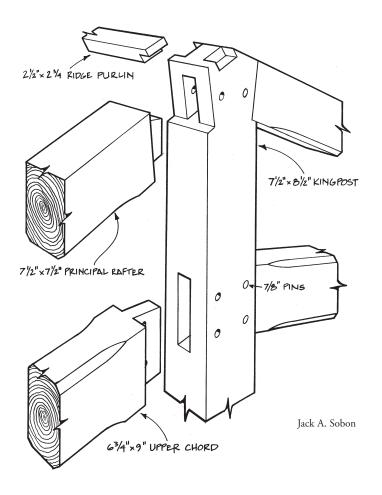
FIG 8. EXPLODED VIEW OF PEAK JOINT, LYNNFIELD MEETINGHOUSE. UPPER TRUSS CHORDS ARE INDEPENDENT OF ROOF RAFTERS.

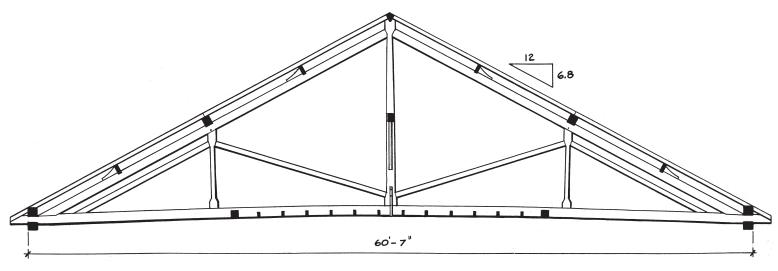
FIG. 9. CASTLETON FEDERATED CHURCH, 1833. LONG-SPAN KINGPOST TRUSSES ARE CONSIDERABLY STRENGTHENED BY PRINCEPOSTS IN TENSION.

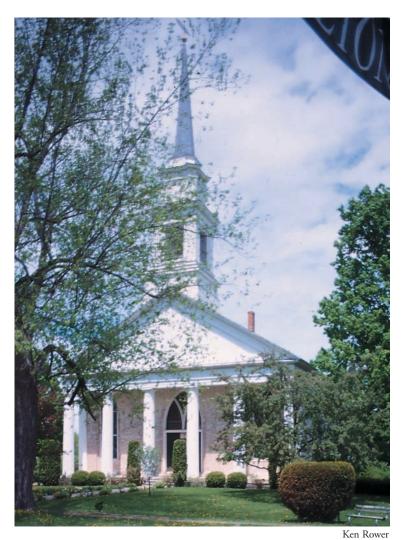
Castleton Federated, 1833, in Greek Revival style (though with Gothic arched windows), including colonnaded porch; tower is supported by front wall and sleepers over first three trusses.

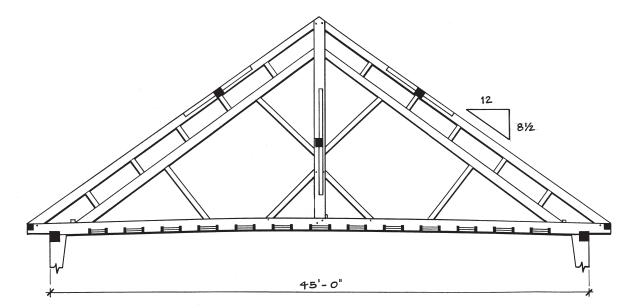
FIG. 10. WINDHAM, VERMONT, CONGREGATIONAL CHURCH, 1800. STRUTS AND UPPER CHORDS BEAR ON UNJOGGLED MORTISES.

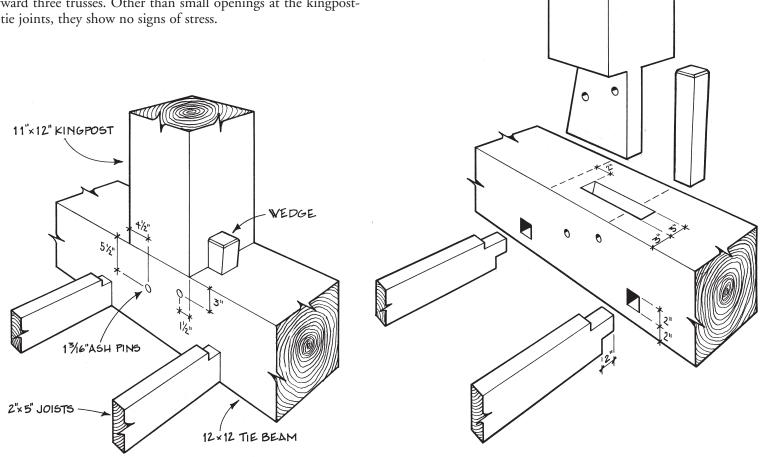
Fig. 11. Kingpost-to-tie joint assembled and exploded, windham Congregational Church, 1800. Joists are inserted at one end and swung into place at opposite end via pulley mortises, seen in truss elevation above.

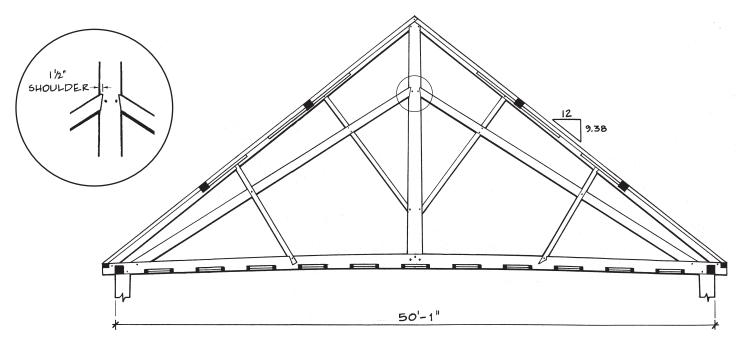
FIG. 12. STRAFFORD, VERMONT, MEETINGHOUSE, 1799, WITH DETAIL OF UPPER CHORD ABUTMENTS.

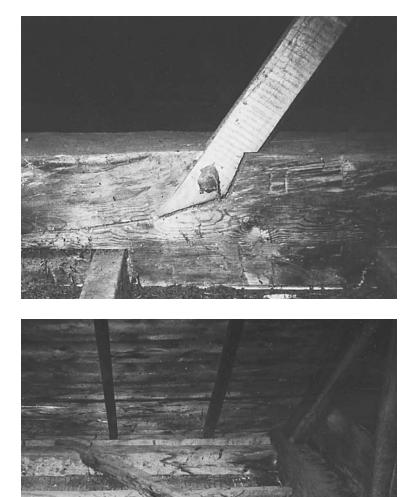
Jack A. Sobon At top, pinned dovetail lap at lower end of raking strut connecting tie beam with upper rafter at Strafford. Above, brace that helps support the interrupted flying plate spanning from tie beam to tie beam.

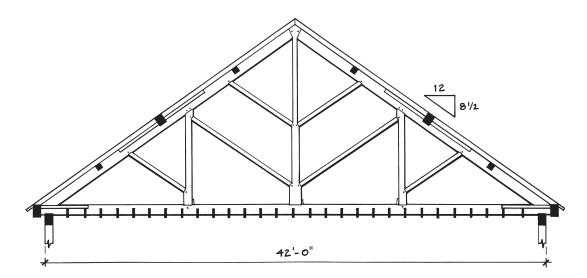
FIG. 14. UNION MEETINGHOUSE, 1870, APPARENTLY CLOSELY PATTERNED AFTER THE BUILDER'S GUIDE DRAWING BELOW.

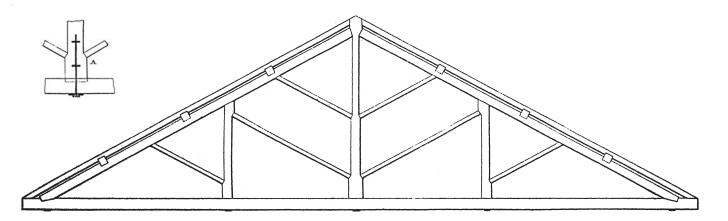
Fig. 15. Asher Benjamin's drawing of a kingpost truss with "queenposts," published in his *Practical House Carpenter*, 1839. Detail shows method of fastening posts with vertical bolts through the beam to captive nuts sunken in the posts.

In spite of Benjamin's assertion that this truss is of ancient lineage, the double strutting from double joggles is rare in practice or in the literature surveyed. There are minor departures in joinery between Benjamin and the Huntington truss. Benjamin, in 1839, recommends using the then-modern center drilled bolt to join the kingpost with the bottom chord. In this system, a long hole is drilled up through the end grain of the post, arriving at a square chisel-cut hole where a nut will await the bolt that also passes through the bottom chord (Fig. 15 detail). The possibility of turning or restraining the upper nut is provided by grooves filed in the sides of the square nut that can be hit with a cold chisel. Further, at Huntington, both the king and princes have wedged half-dovetails at their bottom chord joints and, in the case of the trusses helping to support the steeple, the princes are closely paralleled by 1-in. iron rods dropping from the rafters and passing through the bottom chord. The rods may be contemporary with the truss but could also have been installed during the next 50 years with no identifiable difference in their form or manufacture. In addition to the bolt, Benjamin's drawing also provides for a larger wooden shoulder at the principal rafter-to-tie point of bearing than that found in the Union Meetinghouse.

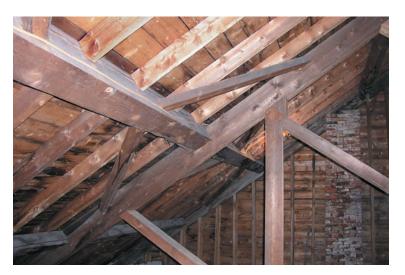
Huntington, upper part of truss with strutted princepost. Wind-braced principal purlins overlap the upper chords and connect the trusses.

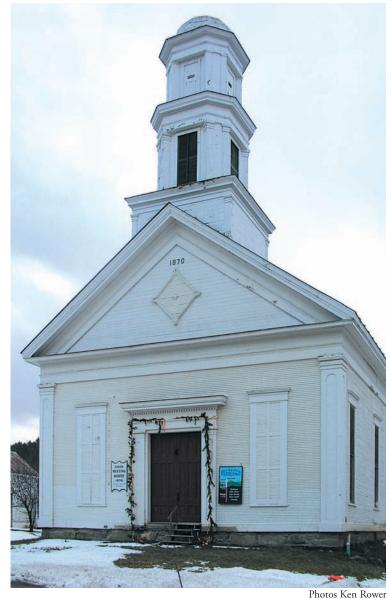
Union Meetinghouse, Huntington, Vermont, 1870, finished in late neoclassical style, now converted to a public library.

While the Union Meetinghouse truss appears similar to the Castleton Federated truss, Castleton's support of the princeposts is more fully realized: the latter are trussed themselves by struts, serving as small main braces, rising from kingpost and bottom chord on opposing sides (Fig. 9). The difference may be attributed to Castleton's greater span. At Huntington, the princes are strutted from the kingpost but depend on a shoulder and pins at their junction with the principal rafter to resist movement toward the eaves as the princes are pushed and pulled downward. Meanwhile, a strut rises from a joggle at the foot of the princeposts at Huntington to support the rafter at its lower quarter point, while the head of the prince supports the rafter near its middle. As is often the case in traditional framing, the purlin loads are not supported by posts or struts directly under them, so as to avoid weakening the principal rafters by excessive joinery at any one point.

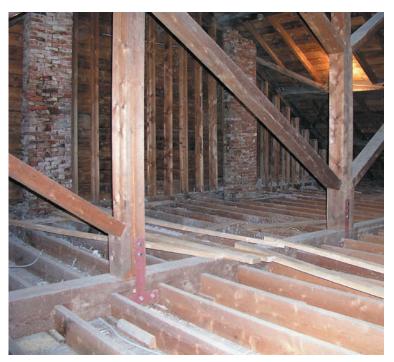
Lower part of truss. Toe-nailed 2x8 joists pass under the tie beams to set lath 2 in. below ties. Long-serving tension joints have been reinforced.

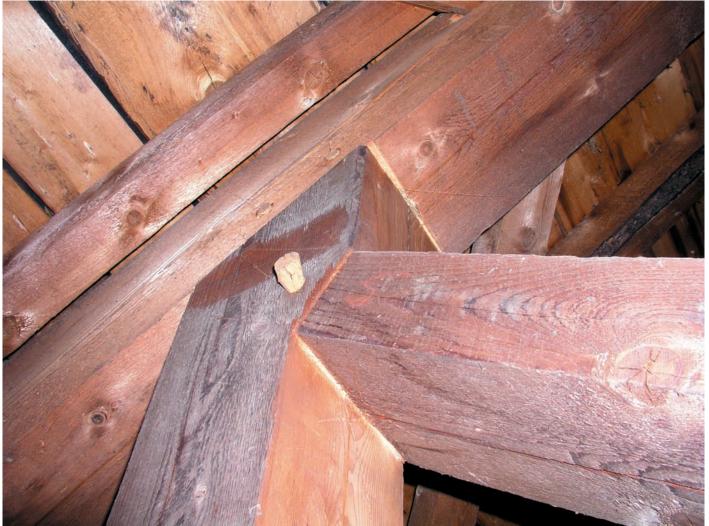
Union Meetinghouse, Huntington, Vermont, 1870, kingpost trusses with princeposts. A very tight strut-princepost-upper chord joint, skillfully cut and aided by the pressure of time. Note shrinkage ghosts of strut on post and post on chord. See page 16.
