# WABAMUN: A MAJOR INLAND SPILL

Ron Goodman  
Innovative Ventures (ivl) Ltd.  
Cochrane, Alberta  
Canada

## ABSTRACT

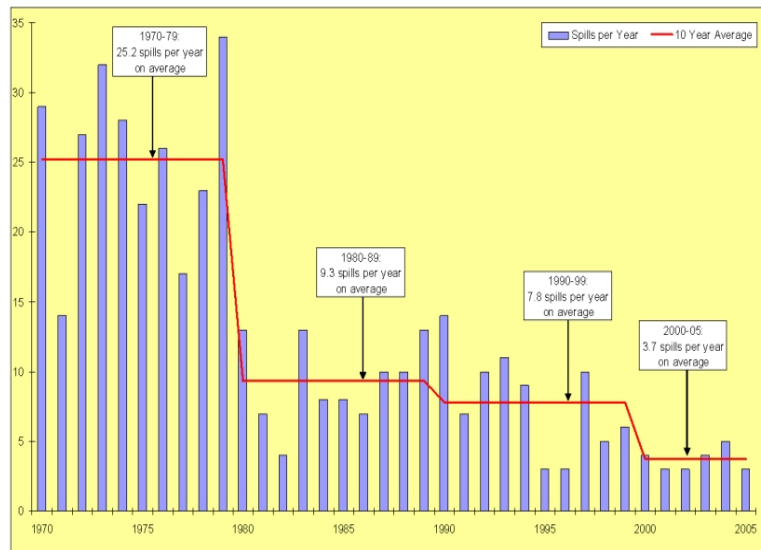
Figure 1 Oil-Spill Statistics from ITOPF (2006)

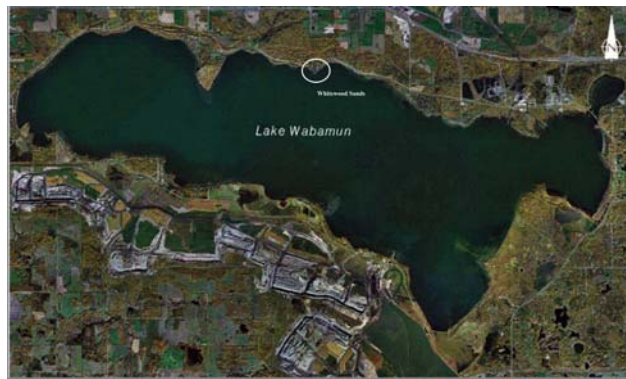
Figure 3 Whitewood Sands Spill Site

The derailment occurred on the north shore of the lake, in a subdivision known as Whitewood Sands as shown in figure 3. This is a residential area and the derailed cars were thrown onto the lawns of the residents. No houses were hit and there were no casualties.
