**National Status and Trends Program
for Marine Environmental Quality**

**Biscayne Bay:
Environmental History and Annotated Bibliography**

A. Y. Cantillo, K. Hale, E. Collins, L. Pikula and R. Caballero

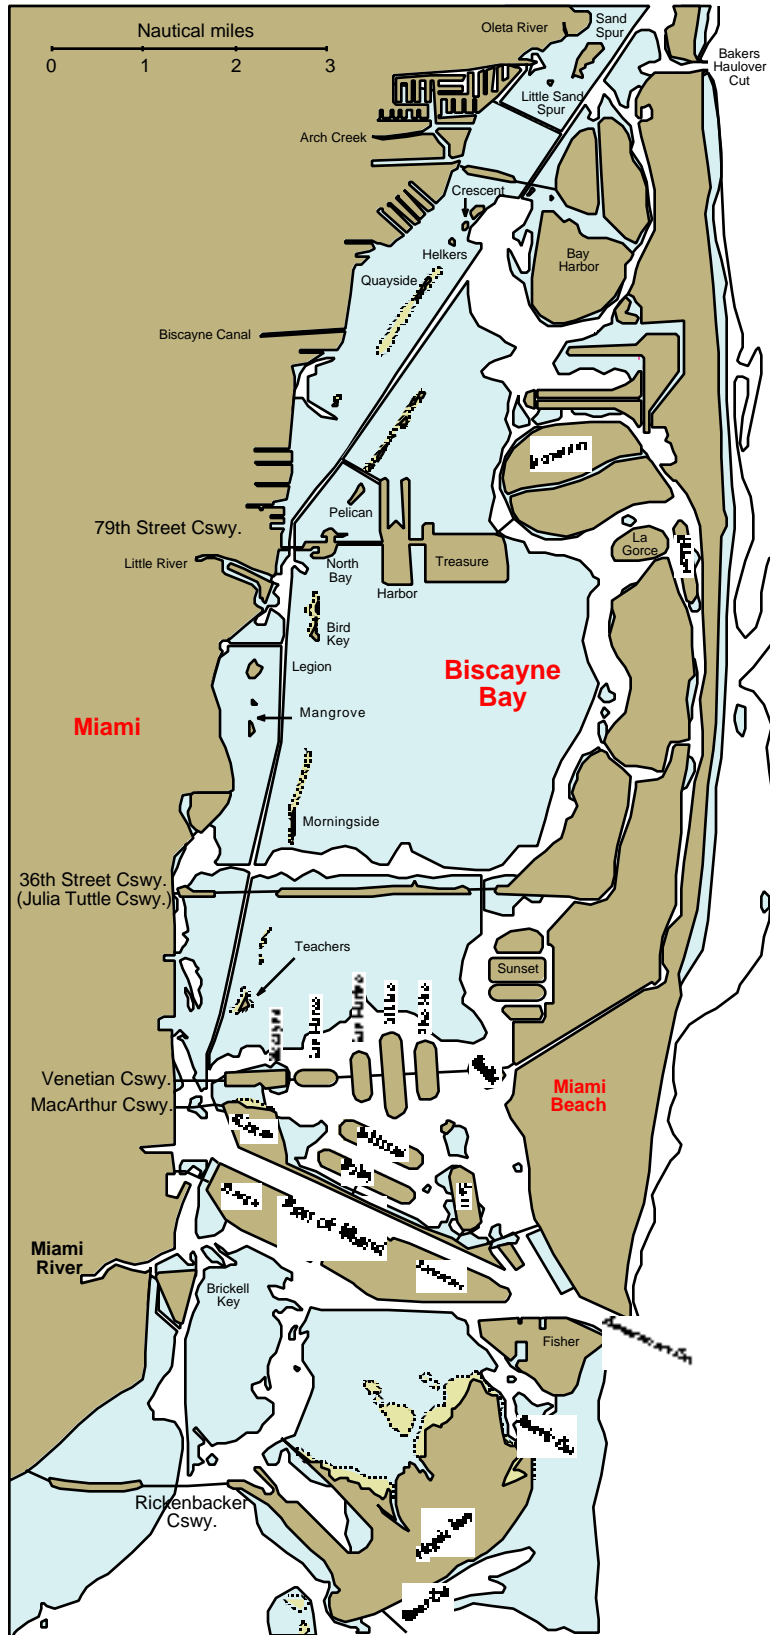
Figure 2. Northern Biscayne Bay.

North Bay is the heavily urbanized area extending from Broward County in the north to Rickenbacker Causeway, approximately 10% of the total Bay area (Figure 2). Five waterways drain to the northern part: the Oleta River, Arch Creek, the Biscayne Canal, Little River and Miami River. North Bay was estuarine prior to the construction of Haulover Cut. Exchange with ocean waters occurs at Bakers Haulover Cut, Government Cut and Norris Cut. There are numerous islands in North Bay. Only Belle Isle and Virginia Key are natural. A description of the construction and/or development of the islands in Biscayne Bay can be found in Kleinberg (1997). Most of the shoreline has been bulkheaded and very little remains as mangrove shoreline. Most of the bottom has been dredged and for many years lacked benthic vegetation.

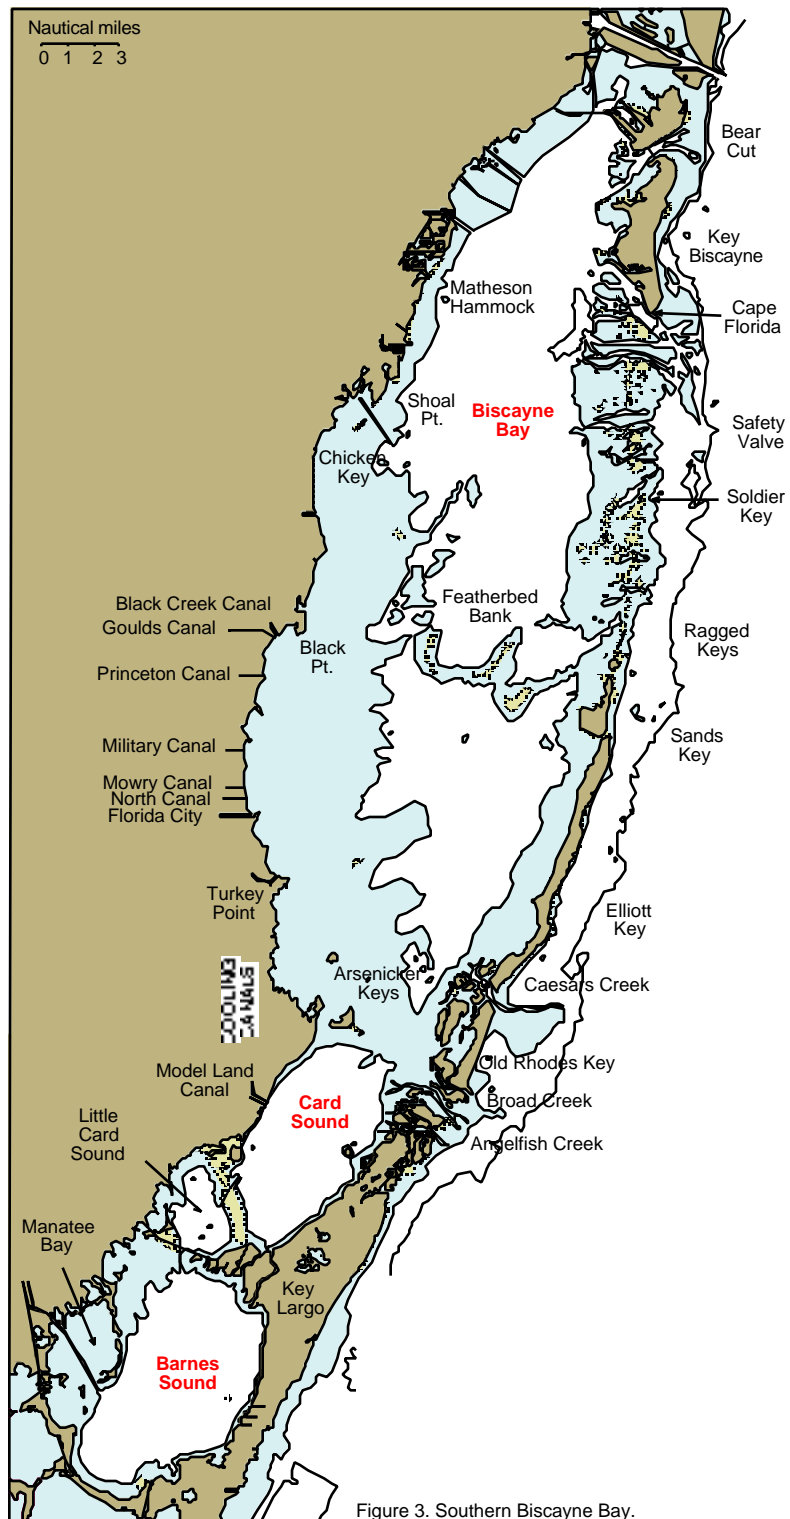
Figure 3. Southern Biscayne Bay.

The central area of the Bay ranges from Rickenbacker Causeway south to the boundary of Featherbed Bank just north of Sands Key (Figure 3). The Safety Valve, a series of shoals through which ocean tidal exchange occurs, serves as the eastern boundary. Three major canals, the Coral Gables Waterway, Snapper Creek and Cutler Drain, reach the Bay in this section. Moderate coastal development has occurred in the mainland portion of this area. Much of the mangrove wetlands in Central Bay remain intact. Seagrasses dominate the bottom vegetation. Chicken Key and Soldier Key are the only natural islands in this section of the Bay. A north-south area in the center of the Bay is barren but used to be vegetated by seagrasses (Harlem, 1979). Small areas of soft corals and sponges are found in the southern-most region of Central Bay.

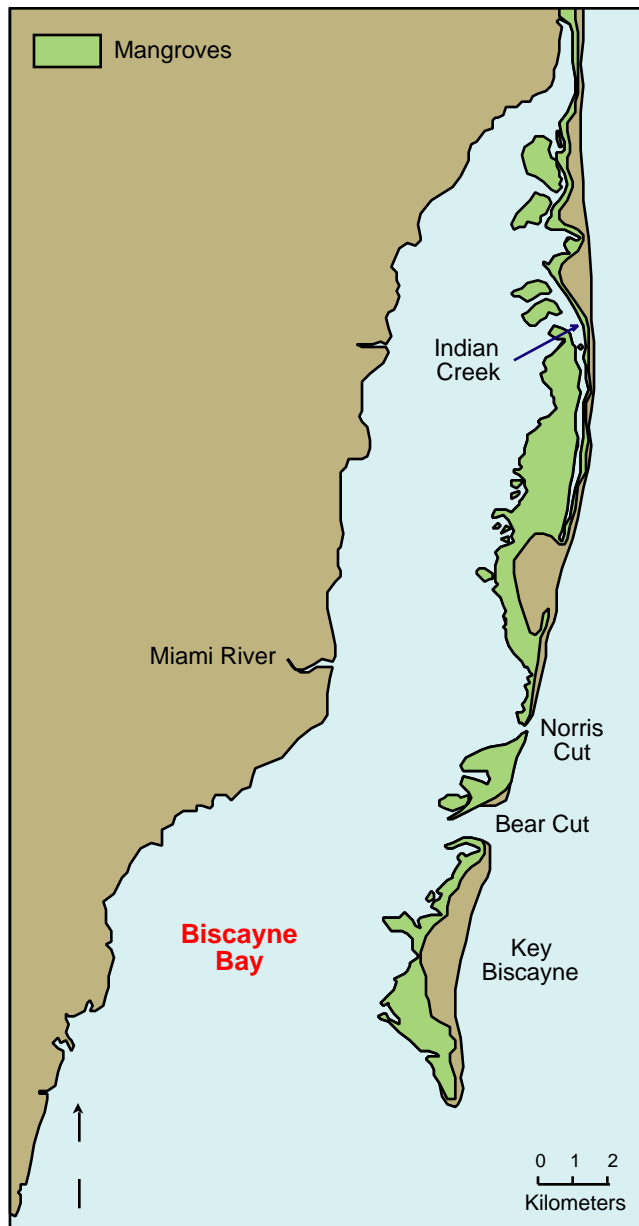
Figure 6. Northern Biscayne Bay in 1887. Adapted by Chardon (1978) from US Coast Survey charts. The area north of Norris Cut and south of Indian Creek may be evidence of a wash-over. [Redrawn from Chardon (1978).]

Chardon (1978) generated a chart of Biscayne Bay for 1887 from a series of US Coast Survey charts (Figure 6). By then, a hurricane had formed Norris Cut, probably the Hurricane of 1835 (Chardon, 1977), and the pass at Boca Ratones was no longer observed.

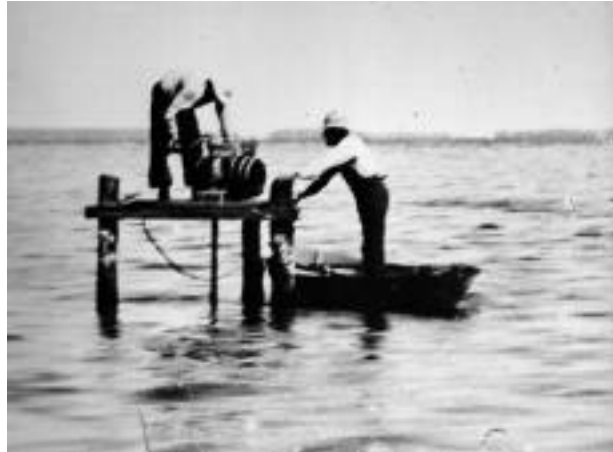
Figure 8. Mariners installed a pipe and built a platform to make water from a fresh spring in Biscayne Bay. [Photograph 117D. Munroe Collection, Historical Association of Southern Florida.]

* Freshwater springs have been observed intermittently in Biscayne Bay since the passage of Hurricane Andrew in 1992. The springs were last seen during the 1960s. The location of the springs has not been recorded (H. Wanless, University of Miami, personal communication, 2000).

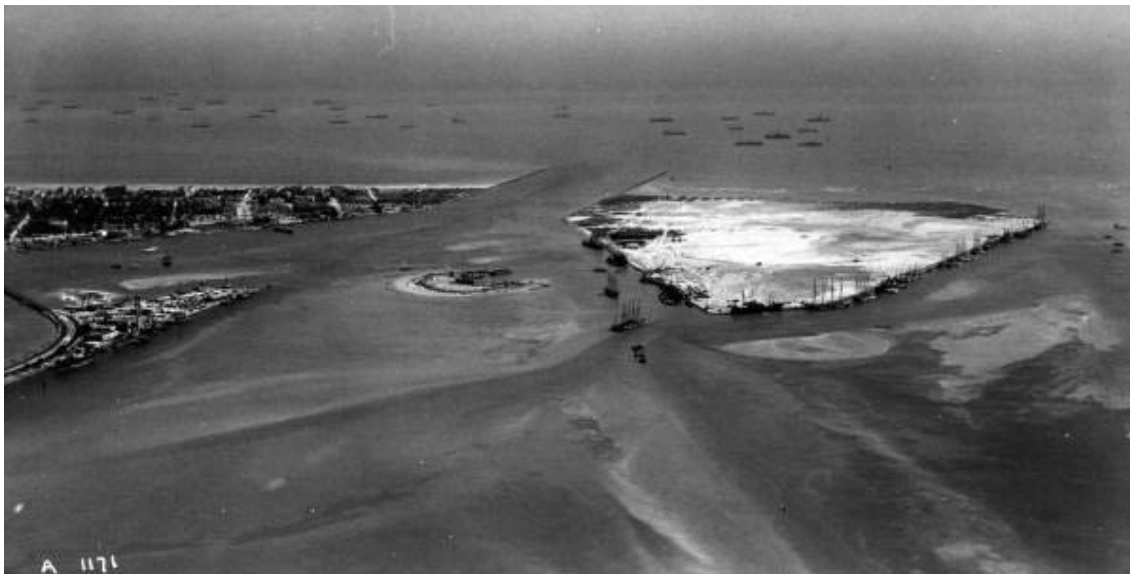
Figure 10. Fisher Island, Terminal Island and Government Cut (1918). (View is east towards the Atlantic Ocean.) [Photograph, black and white (5 x 7 in). WE164. Wendler Collection, Florida State Photo Archive. <<http://fpc.dos.state.fl.us/>>]

Development included simultaneous destruction of natural shorelines, cutting down of mangroves (Figure 9), construction of channels, cuts and artificial islands (Figures 10-12), filling in of tidal flats (Figure 11), bulkheading of shoreline, construction of bridges and causeways (Figure 13), construction of drainage canals, and building on land. Waterfront land was created by artificial islands composed of dredged Bay bottom material, a process which removed benthic cover from large areas of the Bay bottom. There was no legislation at that time to protect the Bay's natural resources or ecosystem.

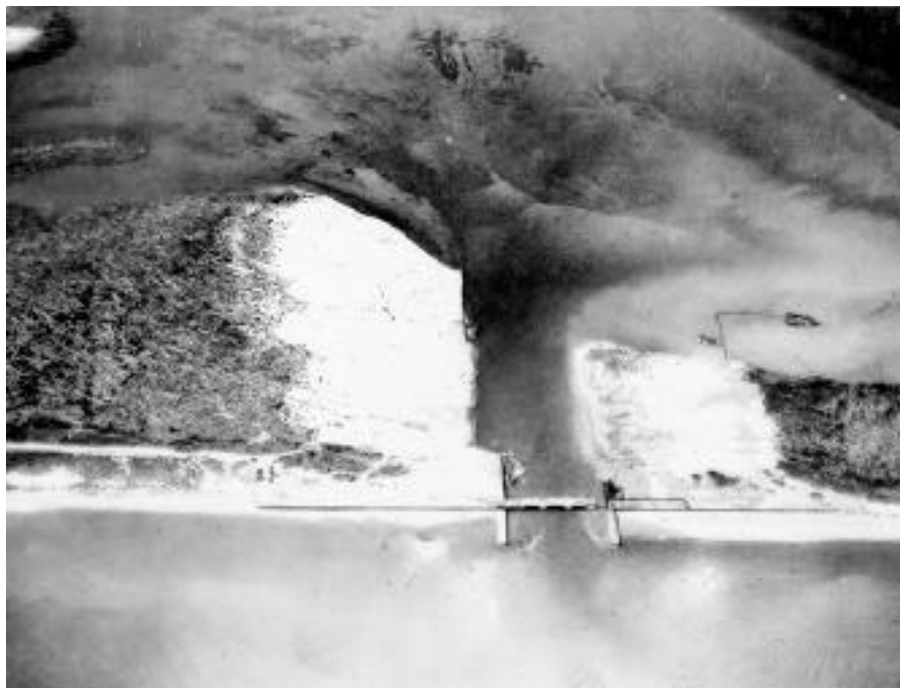
Figure 12. Aerial photograph of Haulover Cut, Miami Beach (1927). (Biscayne Bay is at the top of the photograph and Atlantic Ocean is at the bottom.) (Photo negative, black and white (4 x 5 in). NO35204. General Collection, Florida State Photo Archive. <<http://fpc.dos.state.fl.us/>>]

Bakers Haulover Cut was opened in 1924 (Michel, 1976). The results were changes in the water circulation of North Bay and deterioration of the beaches of Miami Beach. It is not clear why the Haulover Cut was made (see Section 6.1.2.5).

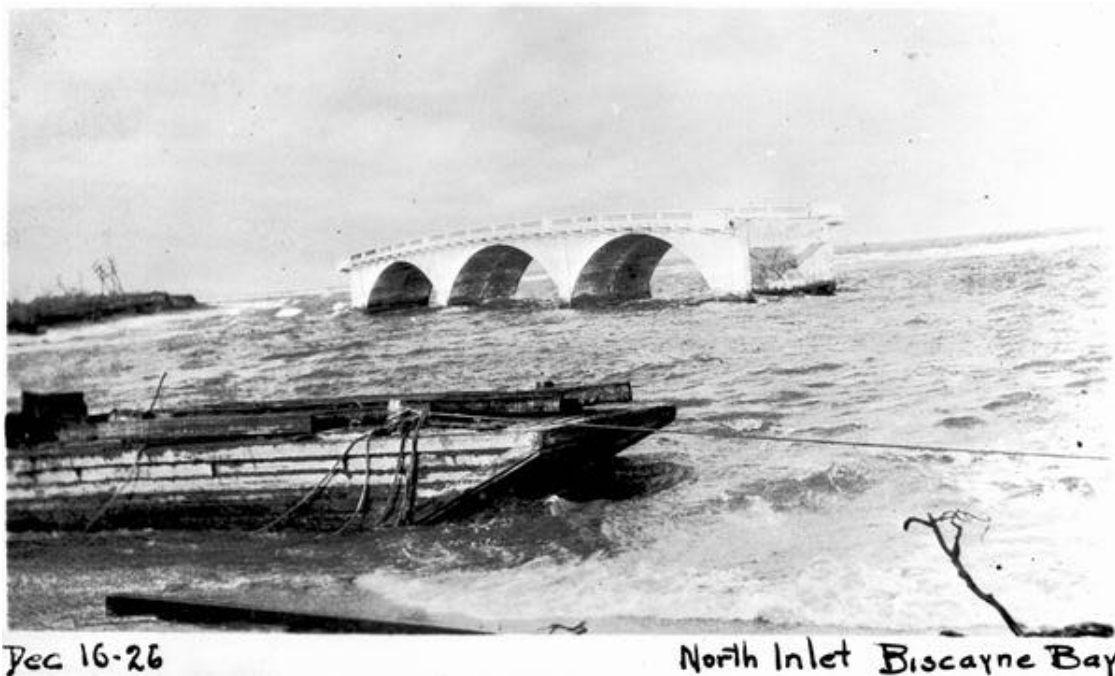
Figure 20. Remains of the bridge at Bakers Haulover Cut after the Hurricane of 1926. (See Figure 12 for aerial photograph of bridge before the hurricane.) [Photo negative, black and white 4 x 5 in. N031942. General collection, Florida State Photo Archive. <<http://fpc.dos.state.fl.us/>>]

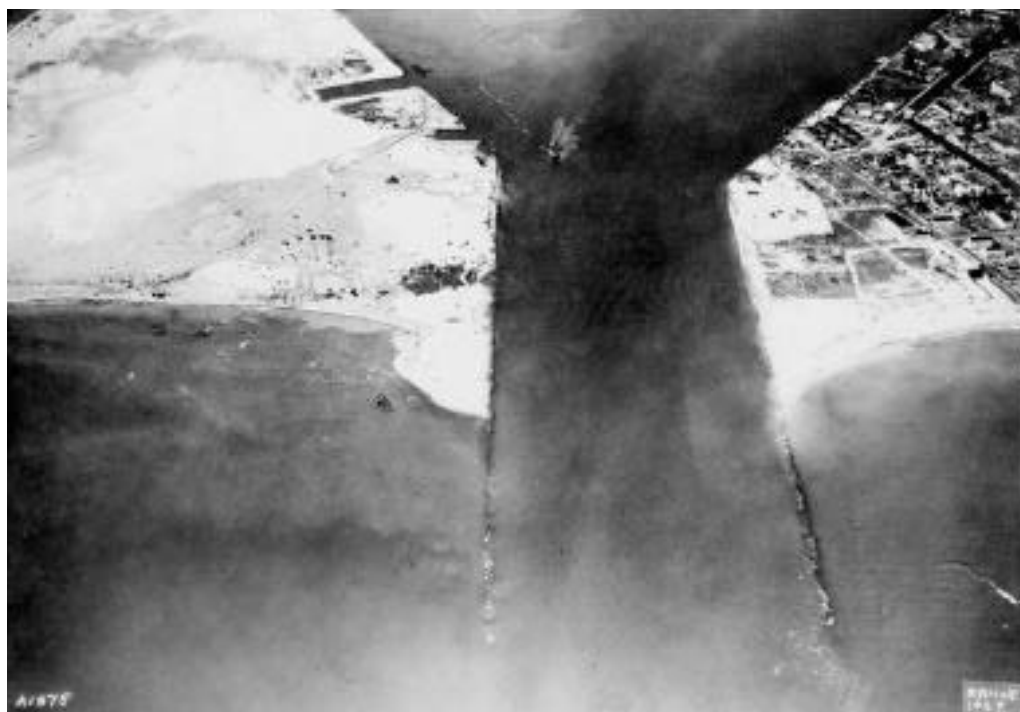
Figure 21. Aerial view Bakers Haulover Cut after the Hurricane of 1926 (December 1, 1927). (See Figure 12 for aerial photograph of bridge before the hurricane. Biscayne Bay is at the top of the image and Miami Beach is at the bottom. Note erosion of the sides of the Cut. Bridge destroyed during the hurricane has been removed.) [R. B. Hoit, photographer. Photo negative, black and white, 4 x 5 in. N035203 . General Collection, Florida State Photo Archive. <<http://fpc.dos.state.fl.us/>>]

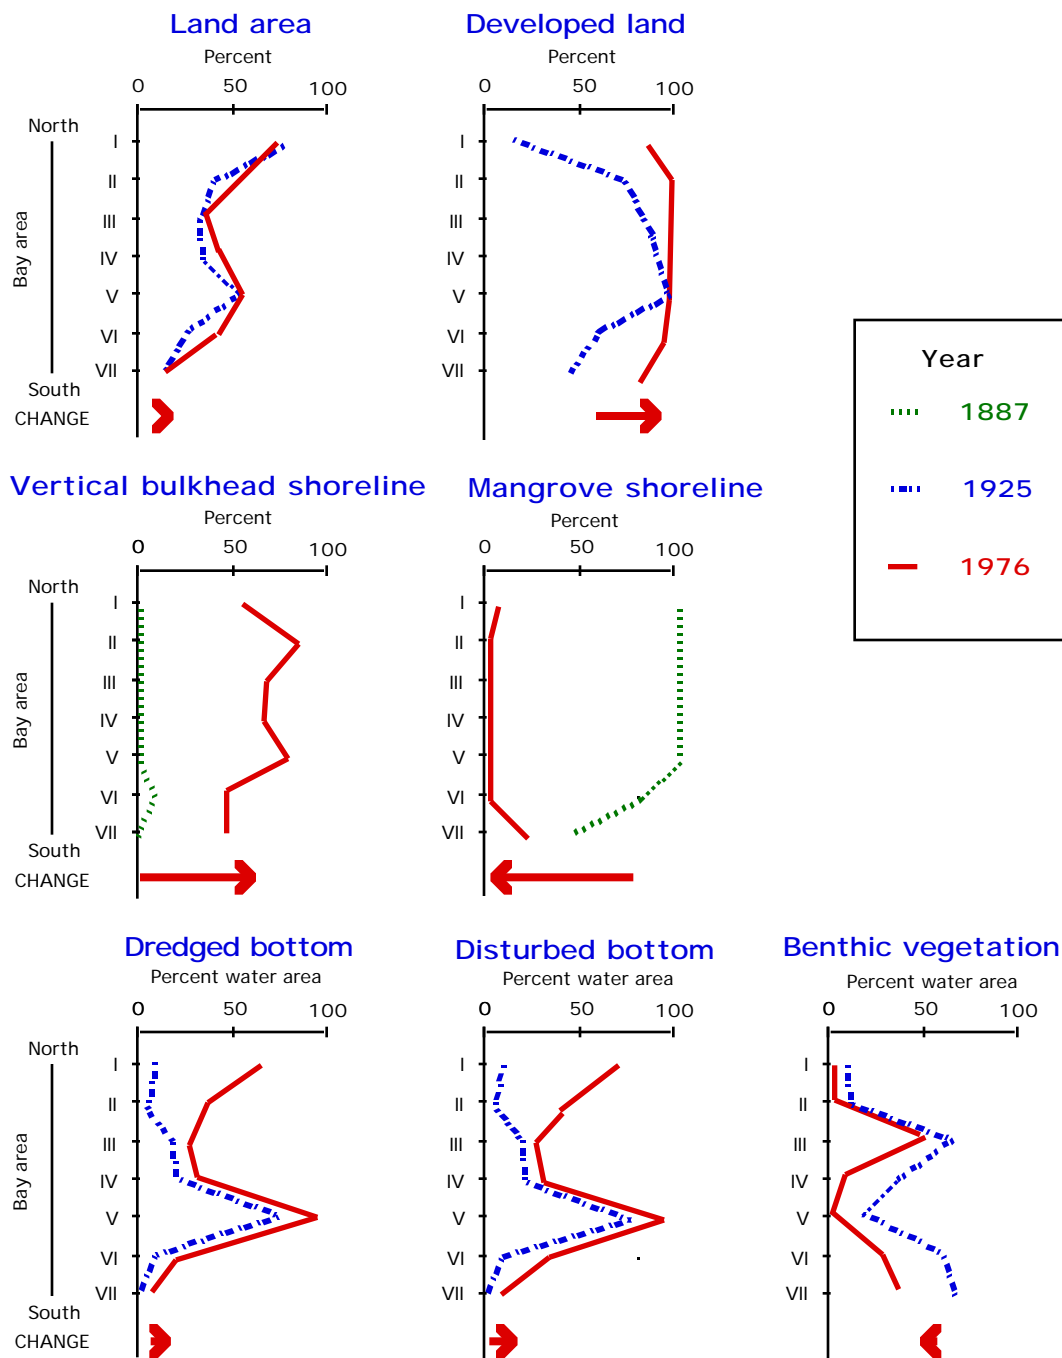
Figure 23. Percent change between 1887 or 1925 and 1976 of various characteristics of Biscayne Bay. (Redrawn from Harlem, 1976.) [Area I: North of Broad Cswy; Area II: from Broad to 79th St. Causeway; Area III: from 79th St. Causeway to Julia Tuttle Causeway; Area IV: from Julia Tuttle Causeway to Venetian Causeway; Area V: from Venetian Causeway to MacArthur Causeway; Area VI: from MacArthur Causeway to Rickenbacker Causeway; Area VII: from Rickenbacker Causeway south to the Safety Valve.]

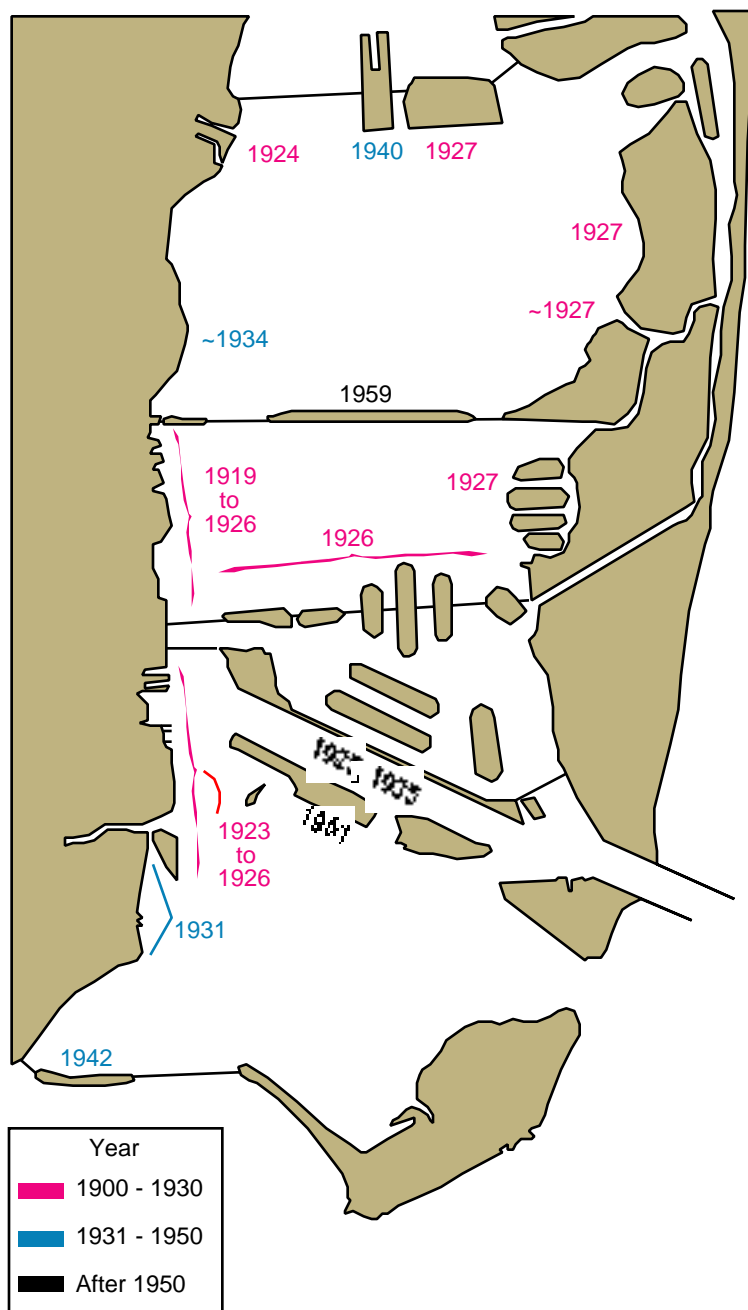
Figure 25. Years of major dredge and fill projects prior to 1970. [Redrawn from McNulty (1970).]

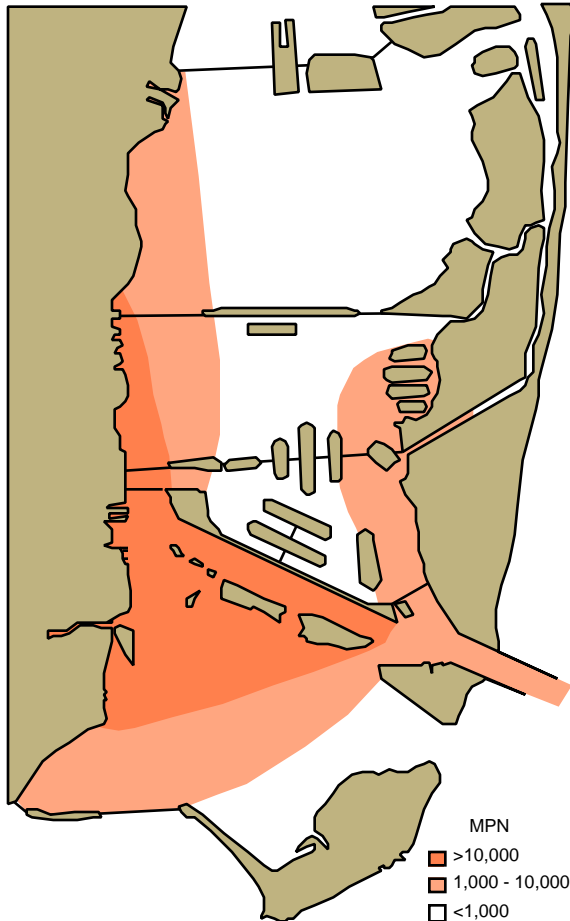
Figure 30. Distribution of mean coliform bacteria in 1949 (unpublished report by Minkin (1949). [Redrawn from McNulty (1970).]

Bay water be avoided thus threatening the tourist industry (Minkin, 1949; Moore *et al.*, 1955) (Figure 30). In response to public demands, the Virginia Key sewage plant was constructed, and public outfalls to the river and the Bay were sealed.

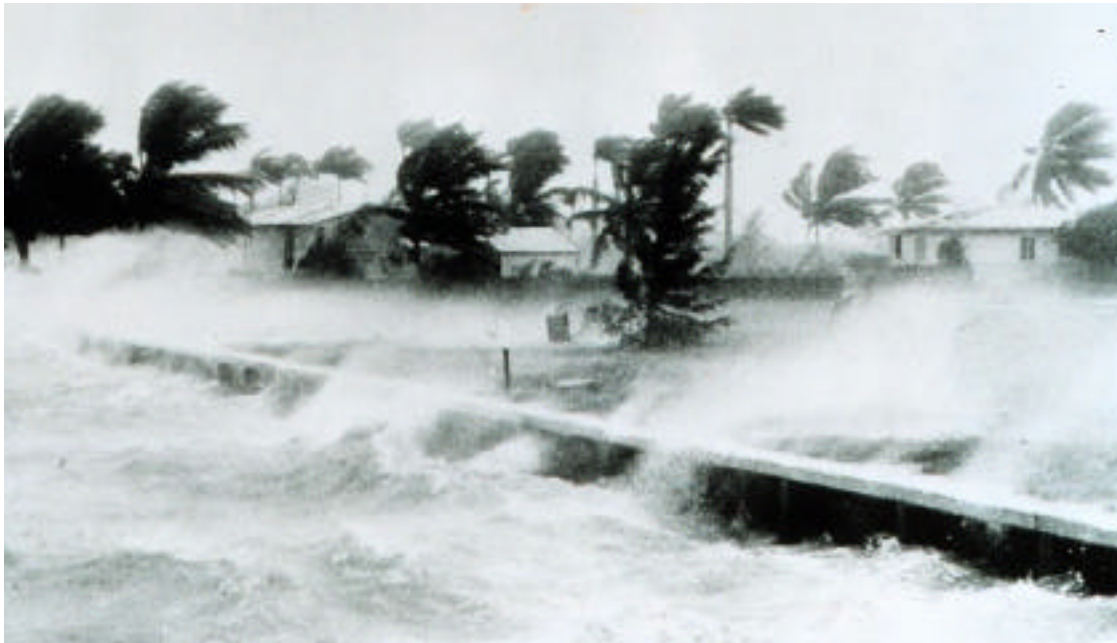
Figure 31. Wind-driven waves threaten to inundate homes. (American Red Cross, September, 1945. NOAA Photo Collection, NOAA Central Library, Silver Spring, MD. <http://www.photolib.noaa.gov/lb_images/historic/nws/wea00404.htm>.)

In September 1945, a massive hurricane passed through the area (Figure 31). The center passed almost directly over Homestead Army Air Base and Richmond NAS. The estimated maximum winds were approximately 275 kph on the east side of the storm (Gentry, 1974). Property damage in Dade County was \$50 million. Because of destruction caused by the storm, Homestead Army Air Base was shut down in December of that year.

The Hurricane of 1945, a category 4 storm, passed directly over Homestead Air Force Base on September 15 (Figure 31). Maximum sustained winds of 177 Kph were recorded at Carysford Reef Light, a few miles west of the point of entry to the coast but on the weak side of

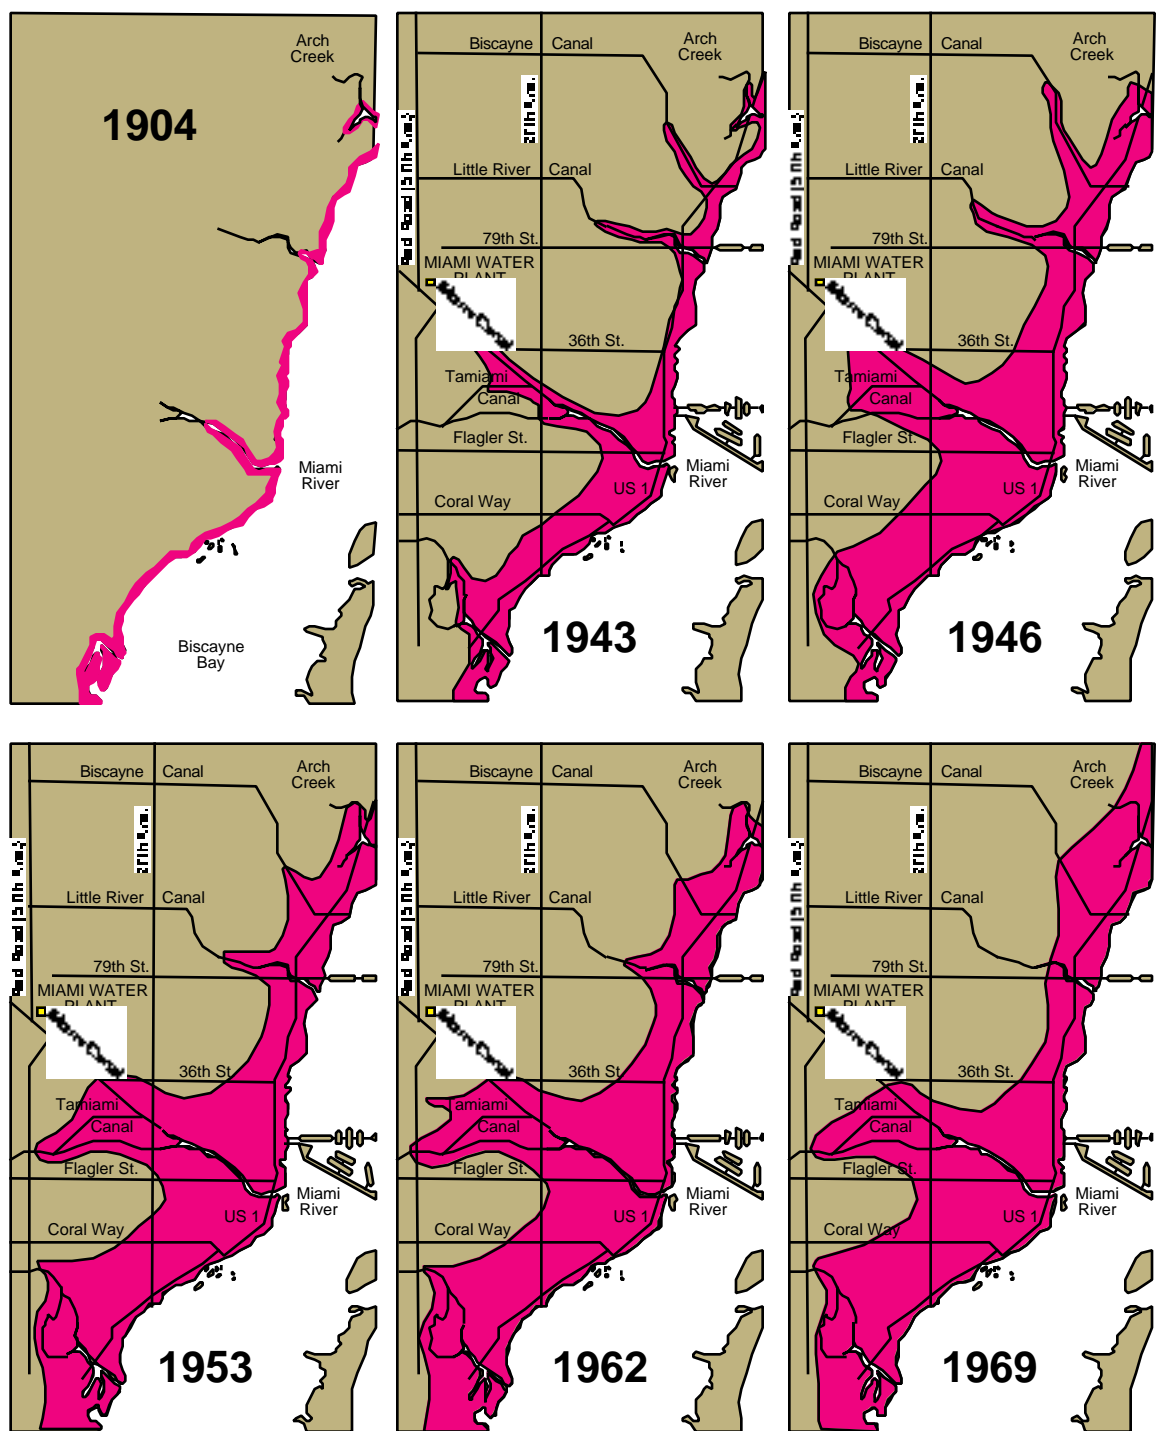
Figure 32. Seawater intrusion at the base of the Biscayne aquifer. [Redrawn from Leach and Grantham (1966) based on the work of Parker *et al.* (1955) and Kohout (1961).]

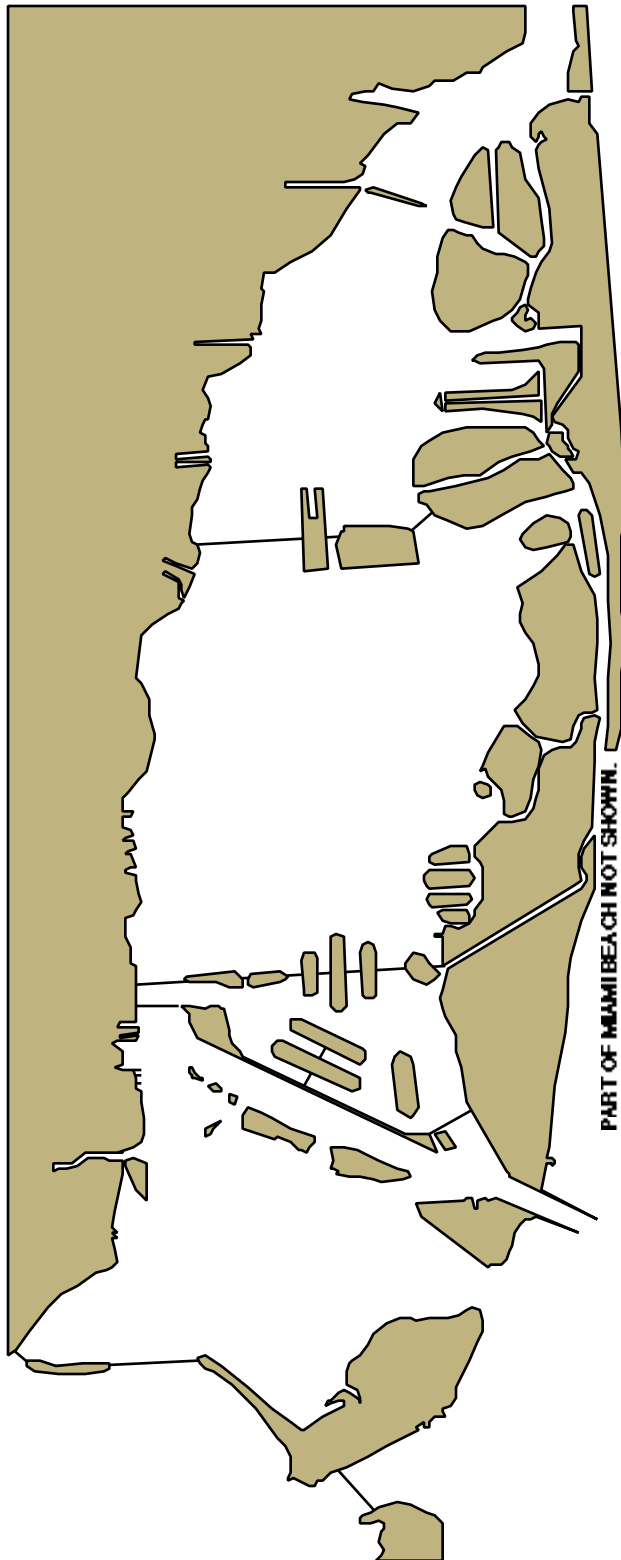
Figure 34. Biscayne Bay in the 1950s. [Redrawn from Moore *et al.* (1955).]

The decade of the 1950s brought a population increase and urban expansion as many servicemen who were stationed in the area during World War II returned to South Florida (Figure 22). The physical shape of Biscayne Bay did not change much during the previous decade (Figure 34).

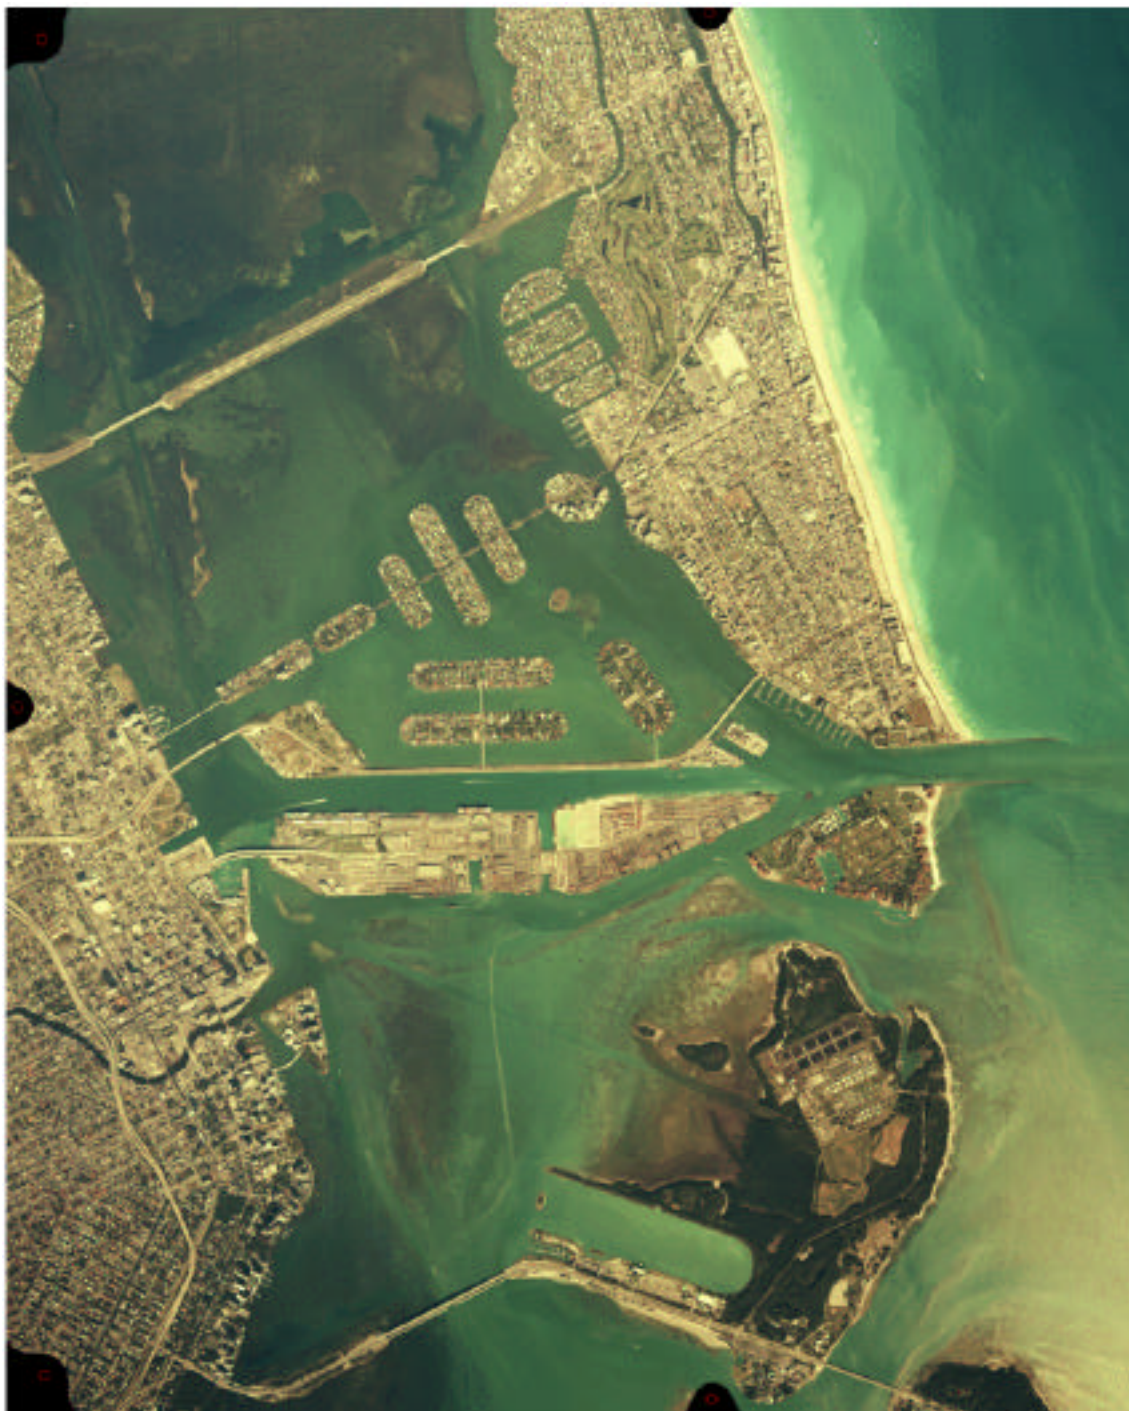
Figure 36. Central Biscayne Bay. [Some of the channels, such as the one between the Miami River and the Virginia Key Sewage Treatment Plant can be observed. The left-most rectangular indentation in the Port of Miami was home base to NOAA and University of Miami research vessels. The deep area north of the 36th Street Causeway is the dark colored area. Note seagrass bed at the top left of the image.] [Aerial photograph 5WGQ2987, 1992. Scale 1:48000, azimuth 191.1, 25.76833° N, 80.14556° W. (Coastal Aerial Photography, NOAA/National Ocean Service, <<http://mapfinder.nos.noaa.gov:80/mapfinderhtml3/surround/photos/photos.html>>, <<http://mfproducts.nos.noaa.gov/images/Photos/5WGQ2987.gif>>. Black areas are artifacts in original photograph. See Figure 2 for identification details.] See color version on p. 119.

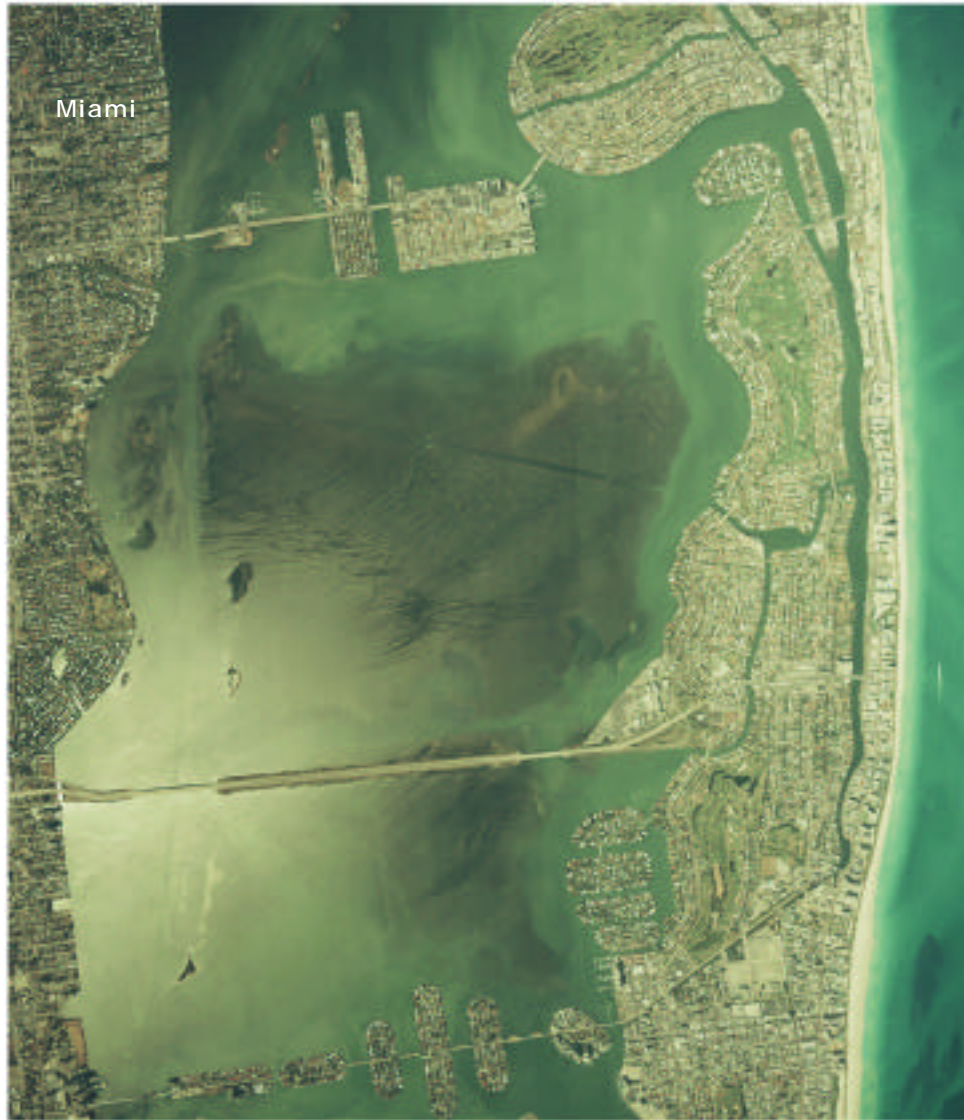
Figure 37. North Biscayne Bay. [Note seagrass bed north of 36th Street Causeway (Julia Tuttle Causeway).] [Aerial photograph 5WPA1338, 1999. Scale 1:39800, azimuth 186.1, 25.82484° N, 80.14796° W. (Coastal Aerial Photography, NOAA/National Ocean Service, <<http://mapfinder.nos.noaa.gov:80/mapfinderhtml3/surround/photos/photos.html>>, <<http://mfproducts.nos.noaa.gov/images/Photos/5WPA1338.gif>>. See Figure 2 for identification details.] See color version on p. 120.

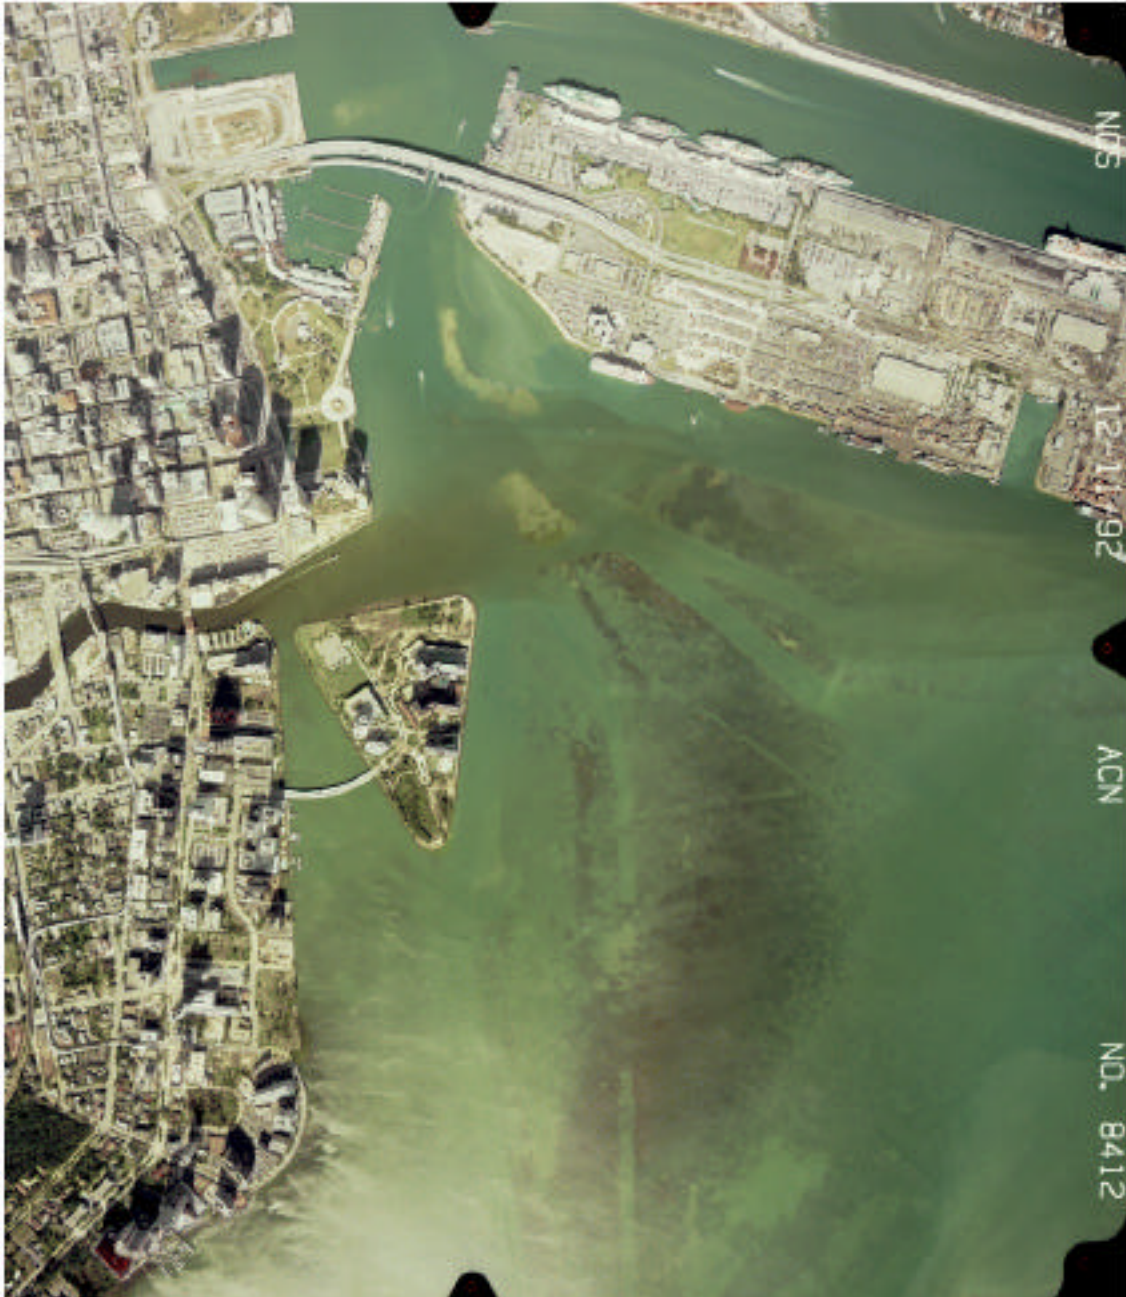
Figure 38. Miami River, Port of Miami, and Brickell Key (Note Miami river sediment plume. Some of the old channels are still visible to the east of Brickell Key.) [Aerial photograph 5WG68412, 1992. Scale 1:15000, azimuth 189.7, 25.77778° N, 80.17917° W. (Coastal Aerial Photography, NOAA/National Ocean Service, <<http://mapfinder.nos.noaa.gov:80/mapfinderhtml3/surround/photos/photos.html>>, <<http://mfproducts.nos.noaa.gov/images/Photos/5WG68412.gif>>. Black areas are artifacts in original photograph. Figures 38 and newb through newe were reduced to the same scale. See Figure 2 for identification details.] See color version on p. 121.

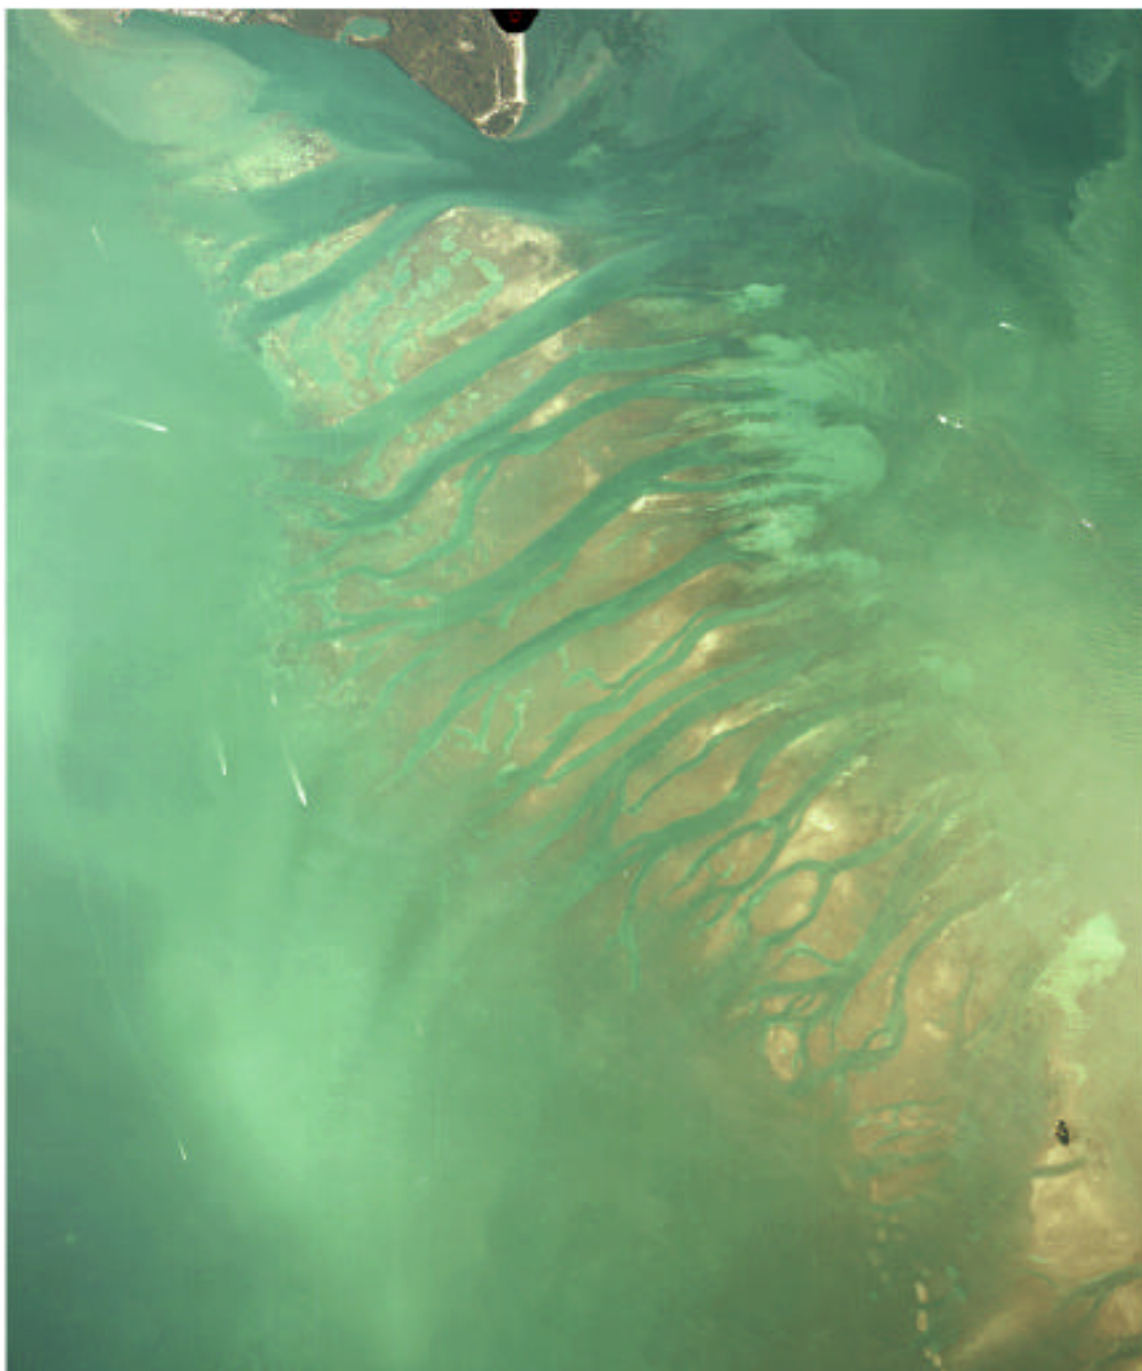
Figure 39. The Safety Valve. (The southern end of Key Biscayne is at the top. Soldier Key is at the bottom right.) [Aerial photograph 5WGS3280, Jan. 2, 1992. Scale 1:48000, azimuth 208.8, 25.62889° N, 80.17889° W. (Coastal Aerial Photography, NOAA/National Ocean Service, <<http://mapfinder.nos.noaa.gov:80/mapfinderhtml3/surround/photos/photos.html>>, <<http://mfproducts.nos.noaa.gov/images/Photos/5WQ2991.gif>>. Black area at the top of the image is an artifact in original photograph. See Figure 3 for identification details.] See color version on p. 122.

The Safety Valve is a complex carbonate tidal bar belt extending approximately 10 miles southward of Key Biscayne to Soldier Key (Figures 39 and 40). The belt is composed of about 10 east-west trending bars separated by tidal channels. Sediment thickness varies from 4-5 m in the north to 1 m in the southern end. Carbon dating indicates that the northern section began forming in the northern end about 3600 BP at about the time Biscayne Bay was reflooded by the rise in sea level (Plescia and Stipp, 1975). Stiltsville, a cluster of homes set on pilings, is located at the northern end of the Safety Valve.

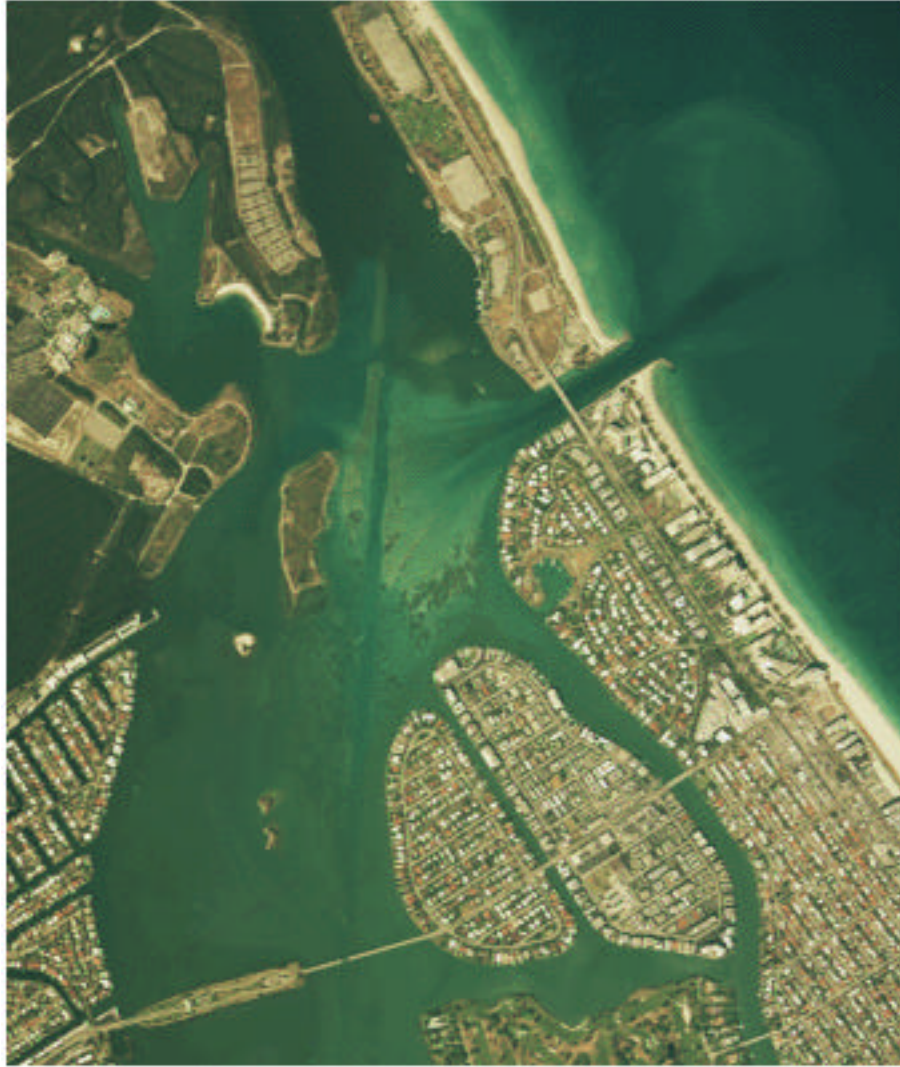
Figure 41. Bakers Haulover Cut. (The Oleta River is just off the image at the upper right. The Munisport Landfill site is almost directly east of Bakers Haulover Cut. Note sediment deltas on either side of the cut. Delta inside the Bay appears to have formed prior to dredging of the Intercoastal Waterway.) [Aerial photograph 5WPA1416, 1999. Scale 1:40000, azimuth 31.1, 25.88965° N, 80.16151° W. (Coastal Aerial Photography, NOAA/National Ocean Service, <<http://mapfinder.nos.noaa.gov:80/mapfinderhtml3/surround/photos/photos.html>>, <<http://mfproducts.nos.noaa.gov/images/Photos/5WPA1416.gif>>. See Figure 2 for identification details.] See color version on p. 124.

Bakers Haulover Cut, built in 1924 - 1925, connects North Bay with the Atlantic Ocean (Figure 41) (Michel, 1976; Toner, 1979). Prior to opening of the Cut, North Bay was estuarine. Reasons for construction of the Cut included decrease in the residence time of water in North Bay thereby decreasing bacterial contamination and faster access to the Atlantic Ocean.
