**National Status and Trends Program
for Marine Environmental Quality**

**Biscayne Bay:
Environmental History and Annotated Bibliography**

A. Y. Cantillo, K. Hale, E. Collins, L. Pikula and R. Caballero

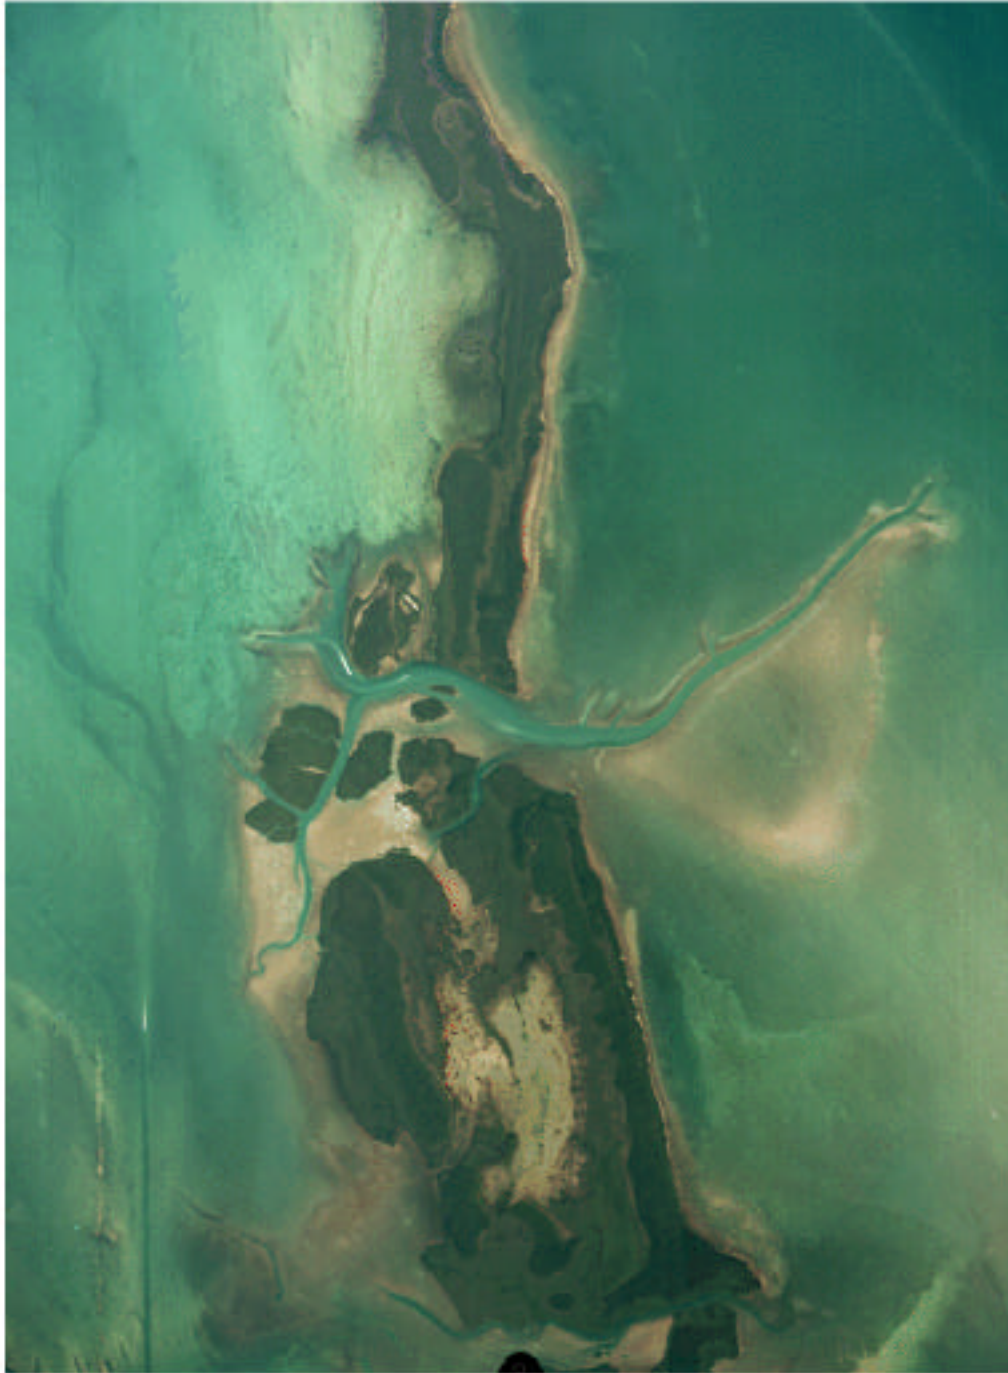
Figure 42. Elliott Key, Caesar's Creek and Old Rhodes Key. (Biscayne Bay and Card Sound are to the right of the image.) [Aerial photograph 5WGN2887, 1992. Scale 1:48000, azimuth 209.2, 25.37861° N, 80.23139° W. (Coastal Aerial Photography, NOAA/National Ocean Service, <<http://mapfinder.nos.noaa.gov:80/mapfinderhtml3/surround/photos/photos.html>>, <<http://mfproducts.nos.noaa.gov/images/Photos/5WGN2887.gif>>. See Figure 2 for identification details.] See color version on p. 125.

Caesar's Creek, Broad Creek, and Angelfish Creek provide tidal exchange for South Bay and Card Sound (Figures 42 and 43). These channels are shallow passages through the upper islands of the Florida Keys chain. Caesar's Creek was named after Black Caesar, an escaped African slave, who became a pirate and operated out of Elliott Key (Atkinson, 1970).

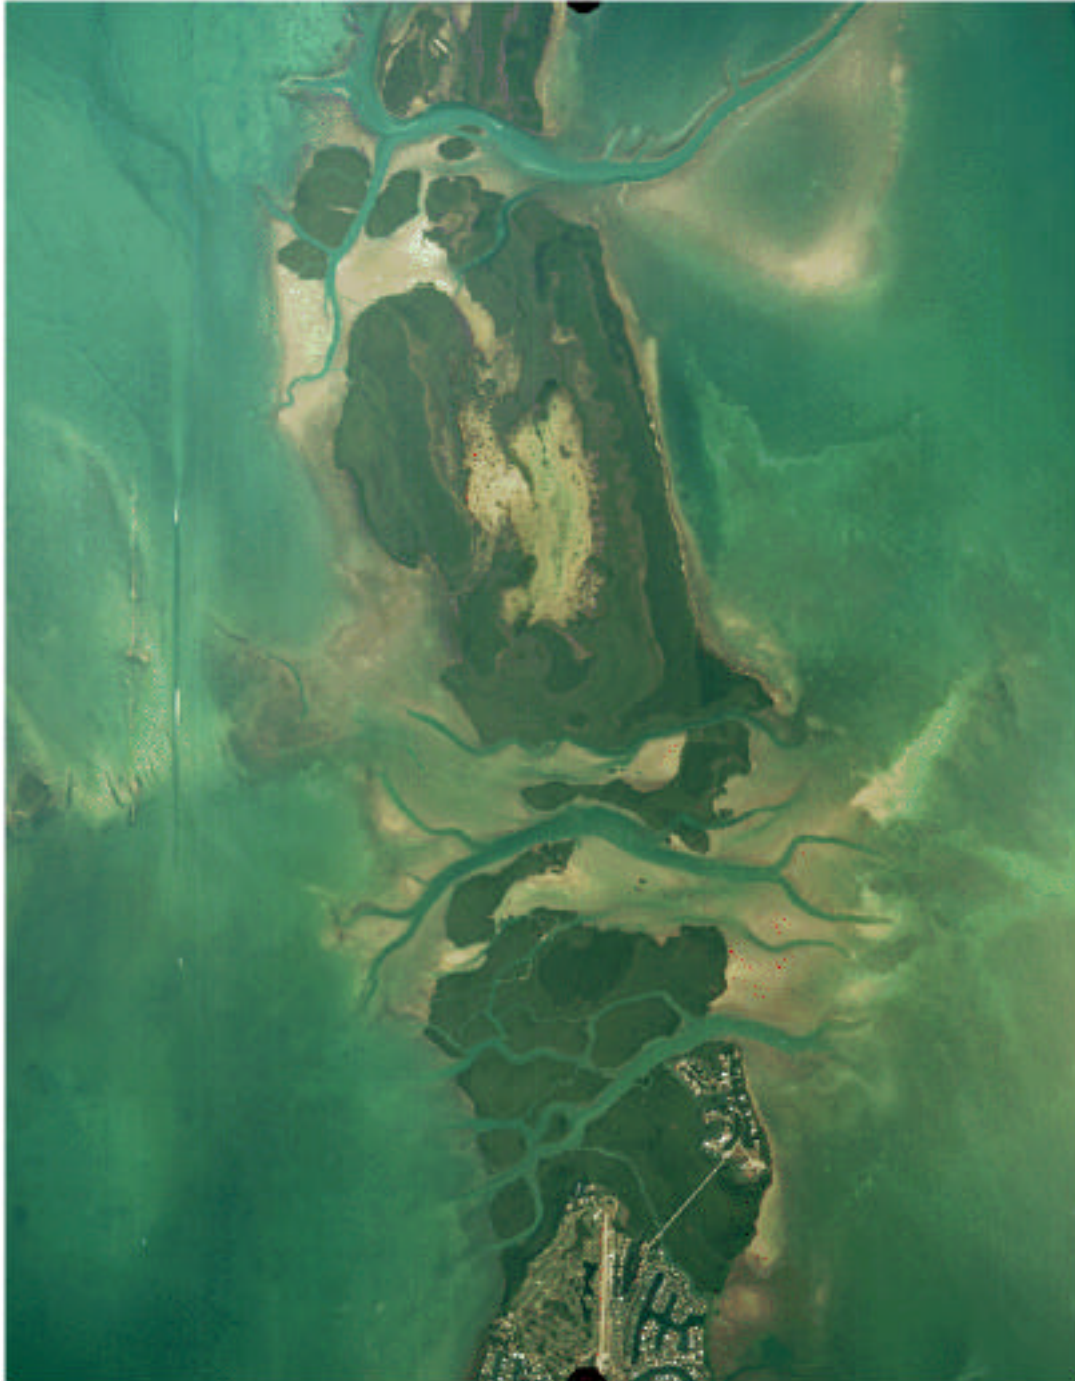
Figure 43. Broad Creek and Angelfish Creek. (Biscayne Bay and Card Sound are to the right of the image.) [Aerial photograph 5WGN2889, 1992. Scale 1:48000, azimuth 209.2, 25.34333° N, 80.25306° W. (Coastal Aerial Photography, NOAA/National Ocean Service, <<http://mapfinder.nos.noaa.gov:80/mapfinderhtml3/surround/photos/photos.html>>, <<http://mfproducts.nos.noaa.gov/images/Photos/5WGN2889.gif>>. See Figure 2 for identification details.] See color version on p. 126.

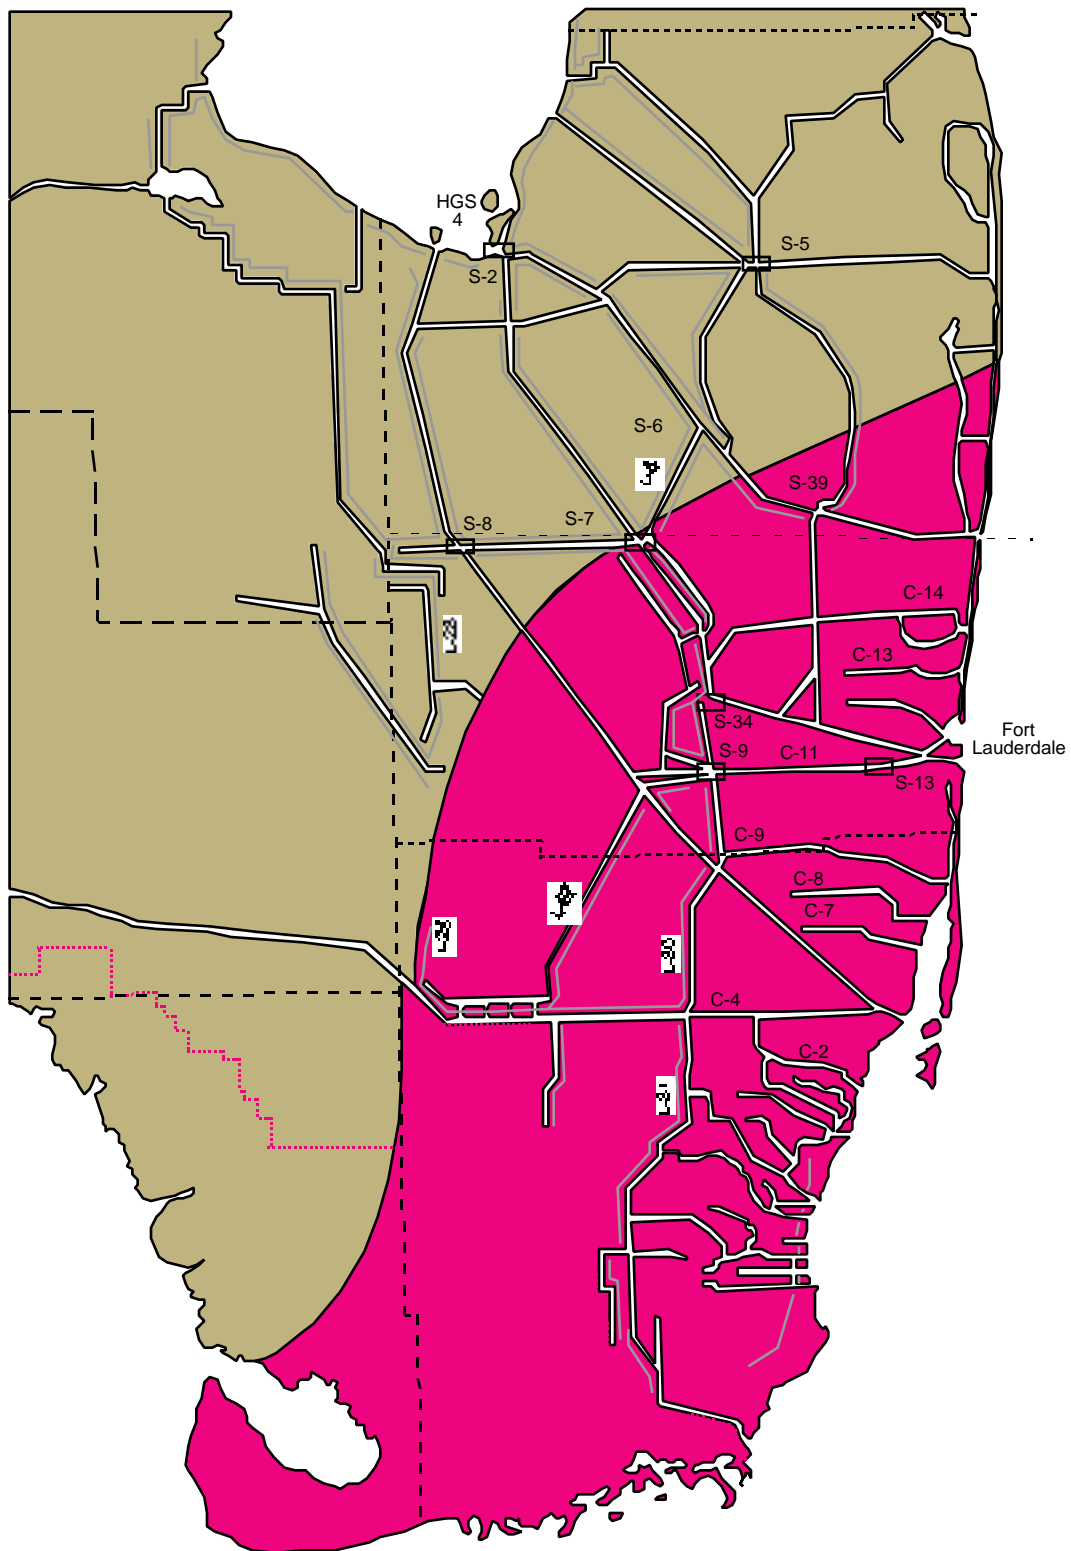
Figure 44. Hydrologic structures and hydrologic features of the South Florida Water Management District.
[Redrawn from Klein and Hull (1978).]

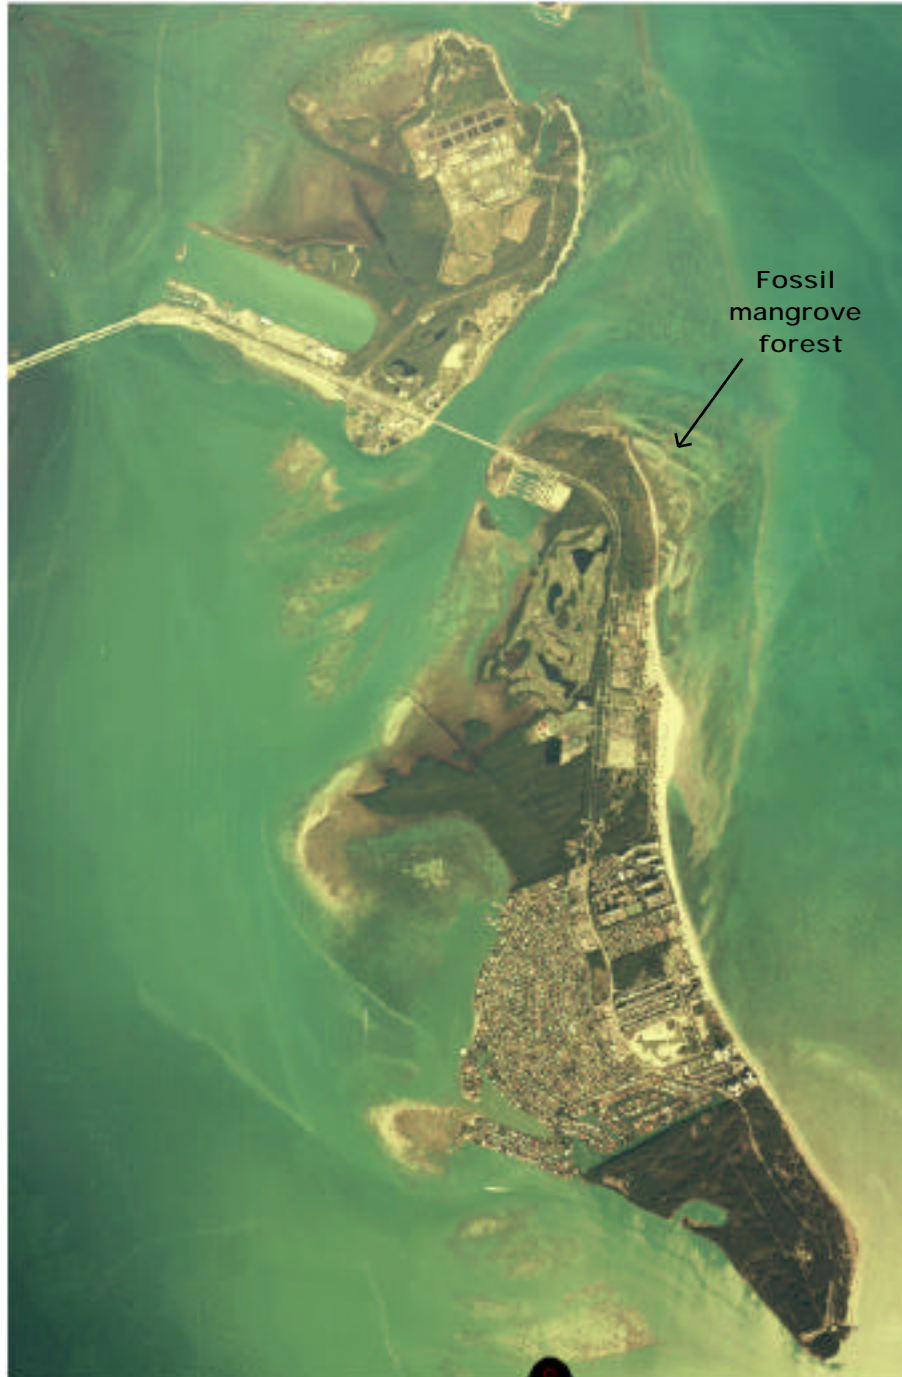
Figure 45. Virginia Key and Key Biscayne prior to Hurricane Andrew. (Note extensive Australian pine cover at the southern end of Key Biscayne.) [Aerial photograph 5WGQ2991, Jan. 17, 1992. Scale 1:48000, azimuth 191.1, 25.70722° N, 80.15889° W. (Coastal Aerial Photography, NOAA/National Ocean Service, <<http://mapfinder.nos.noaa.gov:80/mapfinderhtml3/surround/photos/photos.html>>, <<http://mfproducts.nos.noaa.gov/images/Photos/5WGQ2991.gif>>. Black area at the bottom of the image is an artifact in original photograph. See Figure 3 for identification details.] See color version on p. 127.

Hurricane Andrew destroyed the forest of Australian pines (*Casuarina*) that covered Cape Florida and the northeast end of the island. These areas have been revegetated with native plants (Figures 45 and 46). The restoration effort in the Cape Florida area is described in Section 6.3.2. The Bear Cut Preserve Wetlands Restoration, completed in 1996, was funded by

Along the southern shore and northeastern shore of Key Biscayne there is a small rock reef approximately 400 yds long and extending out for 115 yds seaward (Hoffmeister and Multer, 1965) (Figure 45). This reef is composed of a framework of fossilized black mangrove (*Avicennia nitida*) roots. The mangrove swamp probably extended seaward beyond the present edge of the reef and landward over at least the northern part of what is now Key Biscayne. The reef is barely awash at high tide and it is exposed at low tide. The roots turned into calcareous rods and are embedded in a friable calcareous-quartzitic sand which can be washed away by wave action thus exposing the lattice work of the root systems. Part of the reef has been hardened and protected by coatings of barnacles. Marine algae also cover part of the reef but it is not as effective as the barnacle coating in protecting the area from erosion. Radiocarbon dating indicates the age of the rods to be between 1000 and 2000 yrs old. This is believed to be the first reported occurrence of fossilization of mangrove roots.

Hurricane Andrew destroyed the Australian pines that once covered the area thus providing an opportunity to restore the natural plant communities and systems historically associated with the island (Figures 45 and 46)) (Colon, 1998; Florida Department of Environmental Protection, 2000c). Seventy five acres of mangroves, beach dunes, the maritime hammock and the freshwater wetland are also being restored. The Bill Baggs Cape Florida State Recreation Area

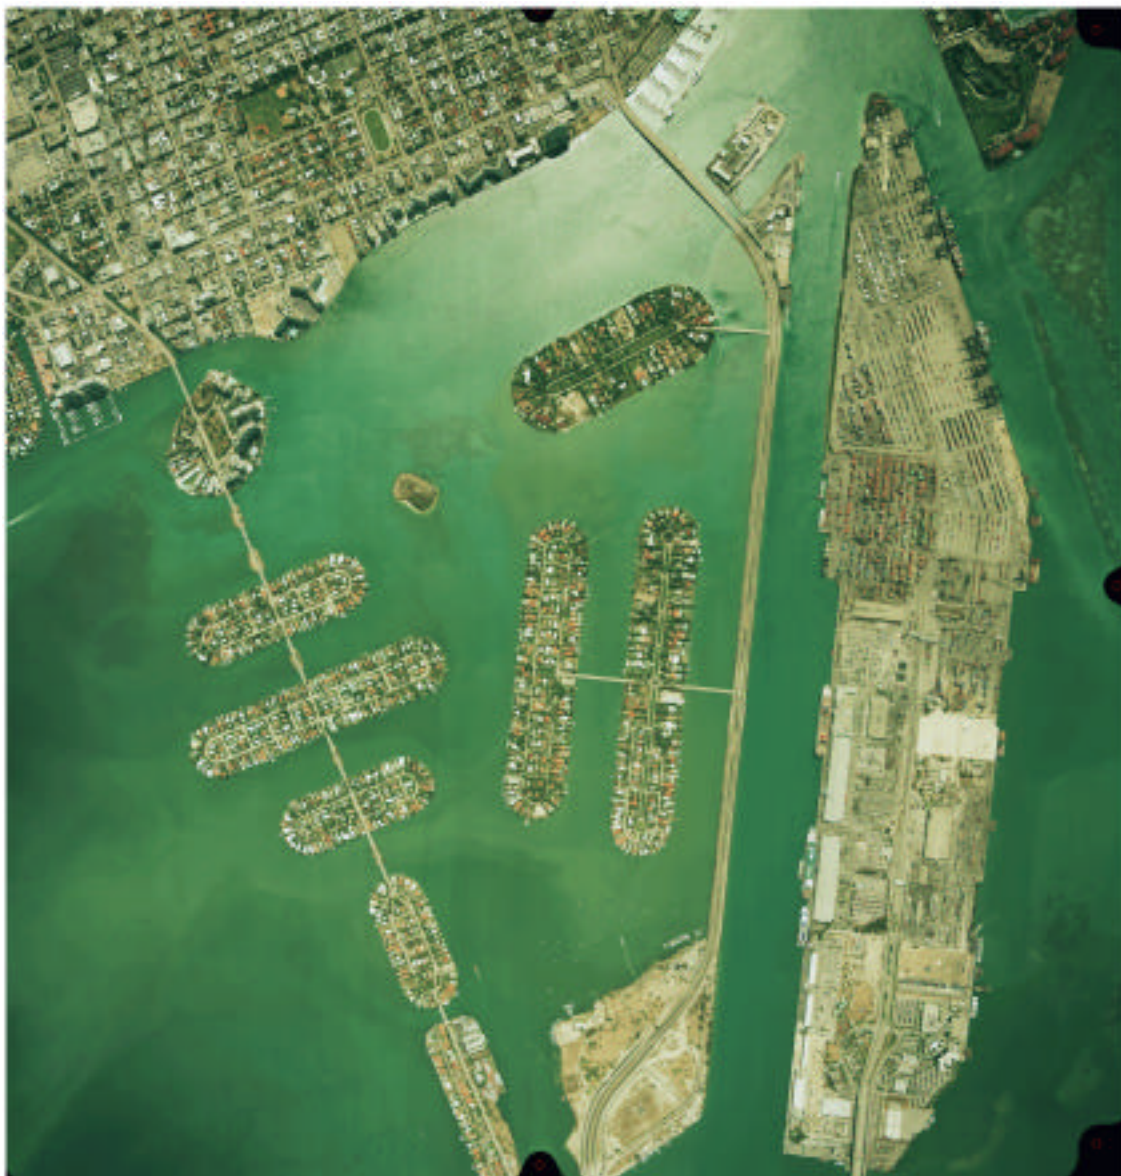
Figure 48. Belle Isle, the Venetian Islands, Watson Island, and the Port of Miami. [Miami Beach is at the top left of the image, and Fisher Island is at the top right. Note that the rectangular ship berthing basins have been filled in (see Figure 38).] [Aerial photograph 5WPB1537, 1999. Scale 1:20000, azimuth 290.2, 25.78139° N, 80.15513° W. (Coastal Aerial Photography, NOAA/National Ocean Service, <<http://mapfinder.nos.noaa.gov:80/mapfinderhtml3/surround/photos/photos.html>>, <<http://mfproducts.nos.noaa.gov/images/Photos/5WPB1537.gif>>. Black areas are artifacts in original photograph. See Figure 2 for identification details.] See color version on p. 129.

Burlingame Island was built with dredge material from deepening of the Miami River port site in 1923. In 1925 the western edge of the Bay was dredged to provide fill for Bayfront Park, the area on the east side of the City of Miami (Figure 47). In this same year, Government Cut was deepened and broadened. Port facilities moved to a site north of Bayfront Park. The Port remained at that location until the construction of the Dodge Island Seaport in the 1960s. Shipping activities declined after the Land Boom, Stock Market Crash and Hurricane of 1926. Cruise service to Havana began during the 1930s (Miami-Dade County, 2000). During World War II, the US Navy assumed control of the Port (see Section 4.4 for wartime activities in Biscayne Bay). In 1956, the Port selected Dodge Island for future expansion. The City of Miami transferred port administration to Dade County in 1960 and work began on the Dodge Island Seaport in 1962. Port operations at the new site began in 1963. By 1968, a cruise port record was set with four maiden voyages in one month (Miami-Dade County, 2000). The Port of Miami was the first in history to record more than one million passengers in a year. Oceanographic research vessels of NOAA and the University of Miami Rosenstiel Institute of Marine Sciences used the Port of Miami as home. The Seaport was expanded in the 1980s by joining Dodge and Lummus Islands (Miami-Dade County, 2000). Passenger and cargo records continued to be set. In 1991, a record 3.9 million tons of cargo were handled in one year. One of the last modifications to the Port was the infilling of small ship basins on the perimeter of Dodge-Lummus Islands (Figure 48).

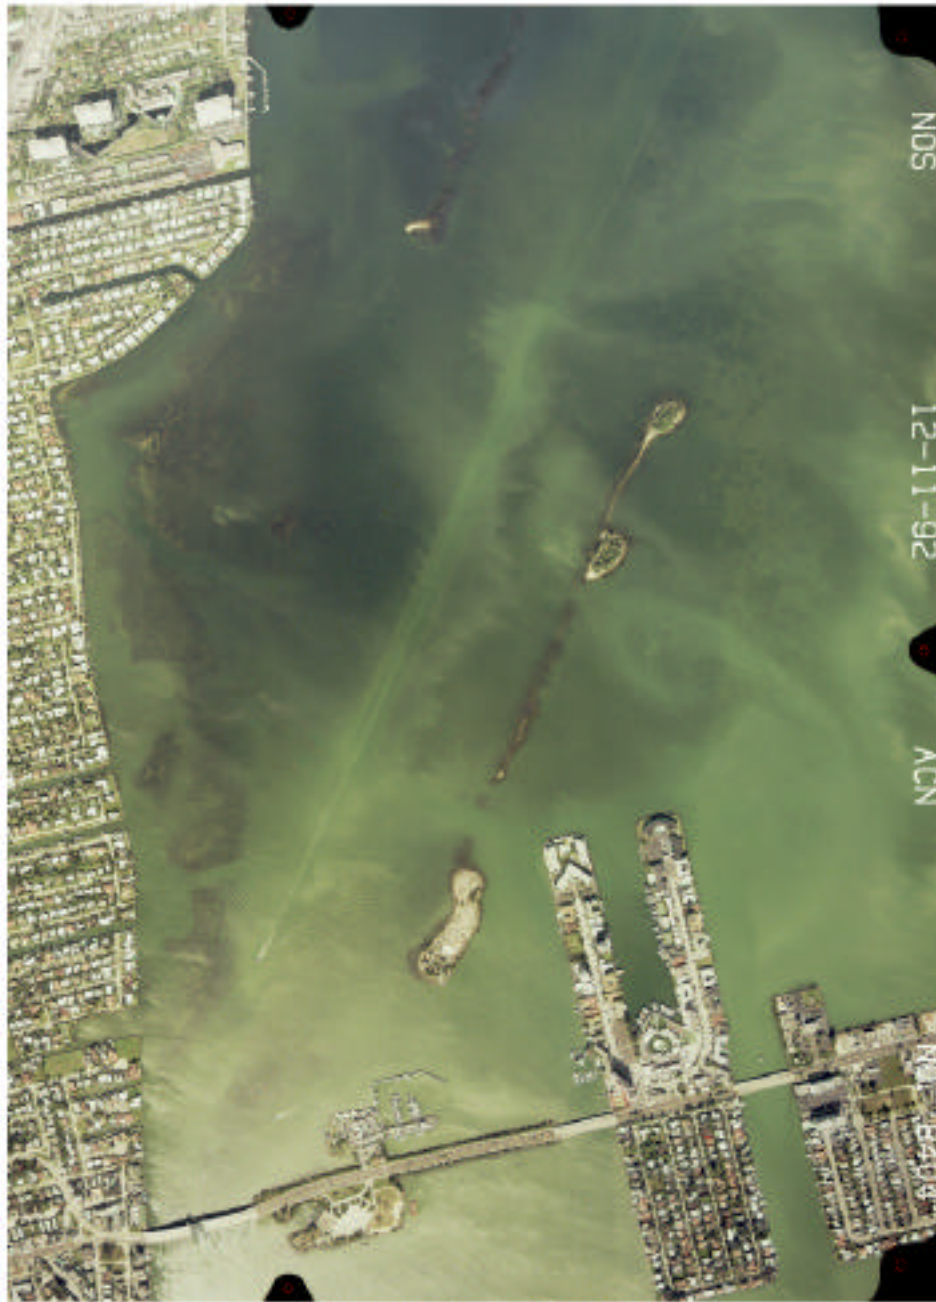
Figure 51. North Bay, Harbor and Treasure Islands. [Note spoil islands and Intercoastal Waterway.] [Aerial photograph 5WJ68404, 1992. Scale 1:15000, azimuth 189.7, 25.87195° N, 80.16028° W. (Coastal Aerial Photography, NOAA/National Ocean Service, <<http://mapfinder.nos.noaa.gov:80/mapfinderhtml3/surround/photos/photos.html>>, <<http://mfproducts.nos.noaa.gov/images/Photos/5WJ68404.gif>>. Black areas are artifacts in original photograph. Figures 38 and newb through newe were reduced to the same scale. See Figure 2 for identification details.] See color version on p. 130.

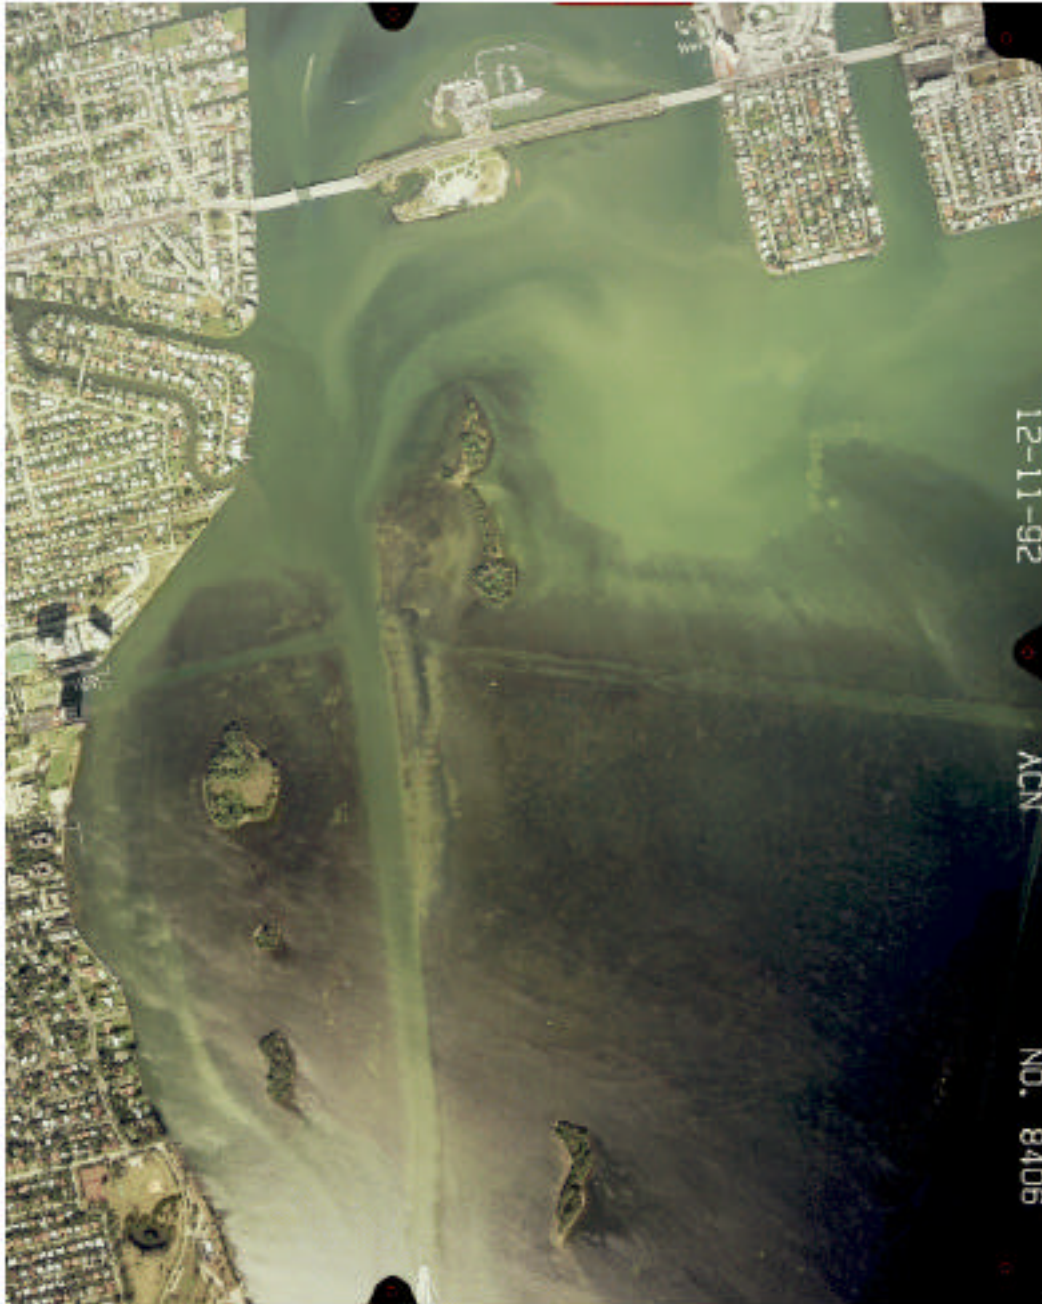
Figure 52. Bird, Legion, Mangrove and Morningside Keys. [North Bay, Harbor and Treasure Islands are at the top of the image. Note channels cutting across seagrass bed.] [Aerial photograph 5WJ68406, 1992. Scale 1:15000, azimuth 189.7, 25.84833° N, 80.165° W. (Coastal Aerial Photography, NOAA/National Ocean Service, <<http://mapfinder.nos.noaa.gov:80/mapfinderhtml3/surround/photos/photos.html>>, <<http://mfproducts.nos.noaa.gov/images/Photos/5WJ68406.gif>>. Black areas are artifacts in original photograph. Figures 38 and newb through newe were reduced to the same scale. See Figure 2 for identification details.] See color version on p. 131.

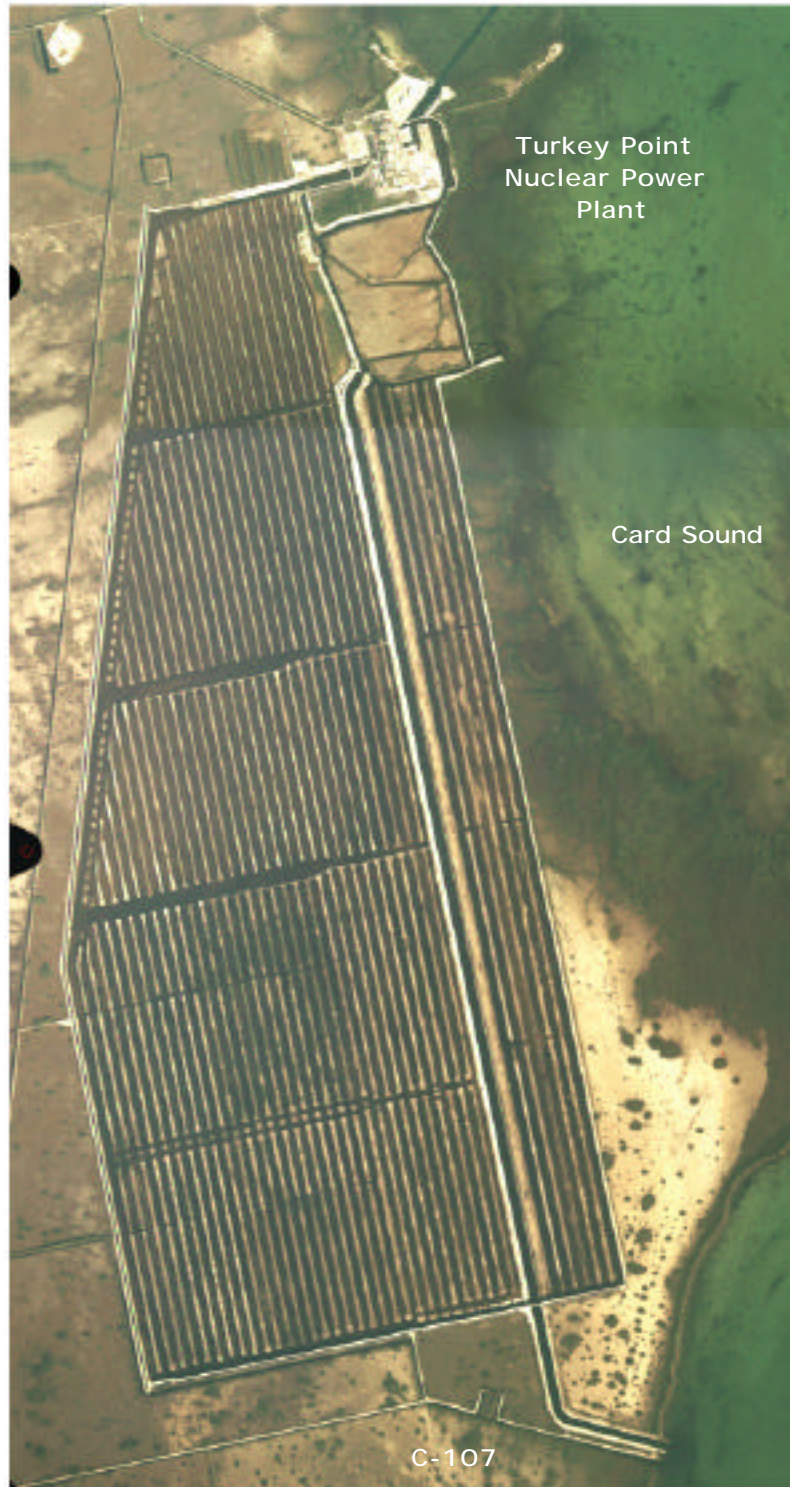
Figure 57. Turkey Point cooling canals. [Composite image prepared from aerial photographs 5WGS3233 and 5WGS3235, Jan. 2, 1992. Scale 1:48000; azimuth 191 and 192.1; 25.40778° N, 80.31194° W and 25.37195° N, 80.31972° W. (Coastal Aerial Photography, NOAA/National Ocean Service, <<http://mapfinder.nos.noaa.gov:80/mapfinderhtml3/surround/photos/photos.html>>, <<http://mfproducts.nos.noaa.gov/images/Photos/5WGS3235.gif>> and <<http://mfproducts.nos.noaa.gov/images/Photos/5WGS3233.gif>>. Black areas on the left of the image are artifacts in original photographs. See Figure 3 for identification details.] See color version on p. 136.

The effect of thermal pollution on the fauna and flora of southern Biscayne Bay and Card Sound were extensively studied during the 1970s before and after cooling canals were installed. In 1972, a 2700 ft³/min thermal effluent flowed directly into Card Sound at a point 6 miles south of the Florida Power and Light Company's Turkey Point site (Thorhaug and Bach, 1973). In March 1973, a self-circulating canal system was opened and effluent stopped entering Card Sound (Figure 57).

The self-circulating cooling canal system has affected the fauna and flora of the area. About 64% of the system is water and about 36% is spoil berm (Gaby *et al.*, 1985). The berms were created from material dredged during the construction of the canals and support a variety of vegetation. While vegetation of the surroundings is dominated by mangrove swamp, the dominant vegetation of the cooling canals is Widgeon grass (*Ruppia maritima*).

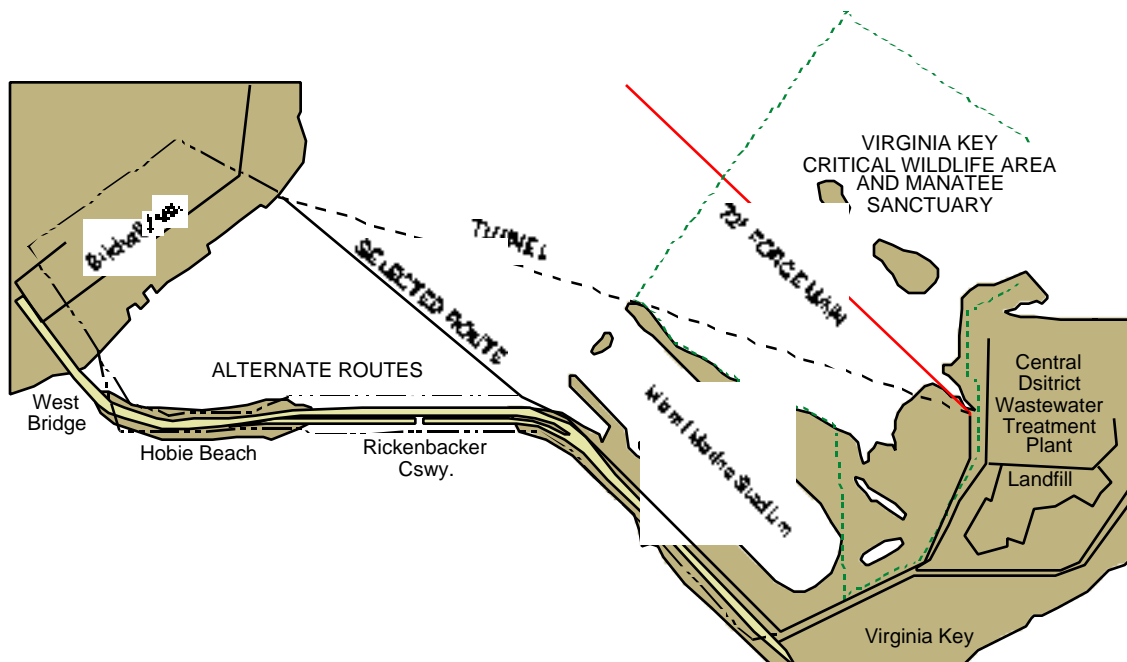
Figure 58. Alternate and final routes for the Cross Bay sewer line. [Redrawn from Swakon *et al.* (1995).]

The Cross Bay Line, in operation since 1956, is a 72-in diameter reinforced concrete cylinder pipe (Figure 58) (Wilson, 1993; Miami-Dade Water and Sewer Department, 1994; Stone and Suman, 1995). The line crosses under Biscayne Bay from Bayside to the shore of Virginia Key, a distance of approximately 14,400 ft. Building specifications required the pipe to be buried below the bottom to a minimum cover of 5 ft. The invert elevation at Bayside is 28 ft below mean sea level and rises to a depth of 15.5 ft at Virginia Key. There are nine manhole covers along the crossing. The manholes rise from the pipe to the top of the sediment. Additionally, there is a 16-in sludge force main from the North District Plant paralleling the Cross Bay Line.

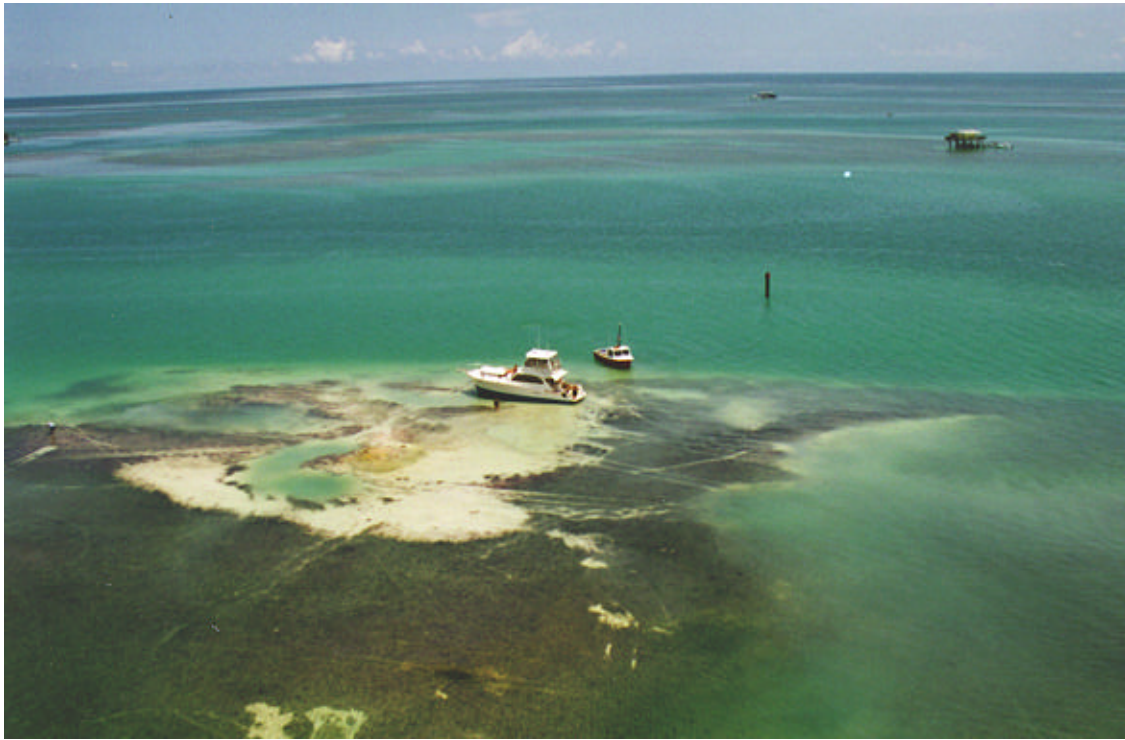
Figure 60. Vessel aground, Biscayne Channel, Biscayne National Park (1998). [Note prop scarring in the seagrass bed. One of the houses of Stiltsville is seen at the upper left of the image.] (Photo by Karen Battle, Biscayne National Park.) *See color version on p. 137.*

Stiltsville has served as an unofficial navigation aid to the inexperienced boater: "No body of water in North America attracts more certifiable morons in high powered yachts and speedboats than Biscayne Bay. Most of them don't know the difference between a channel marker and a lobster pot, but they do know a double-decker house when they see one looming off their bow" (Hiaasen, 1999) (Figure 60).

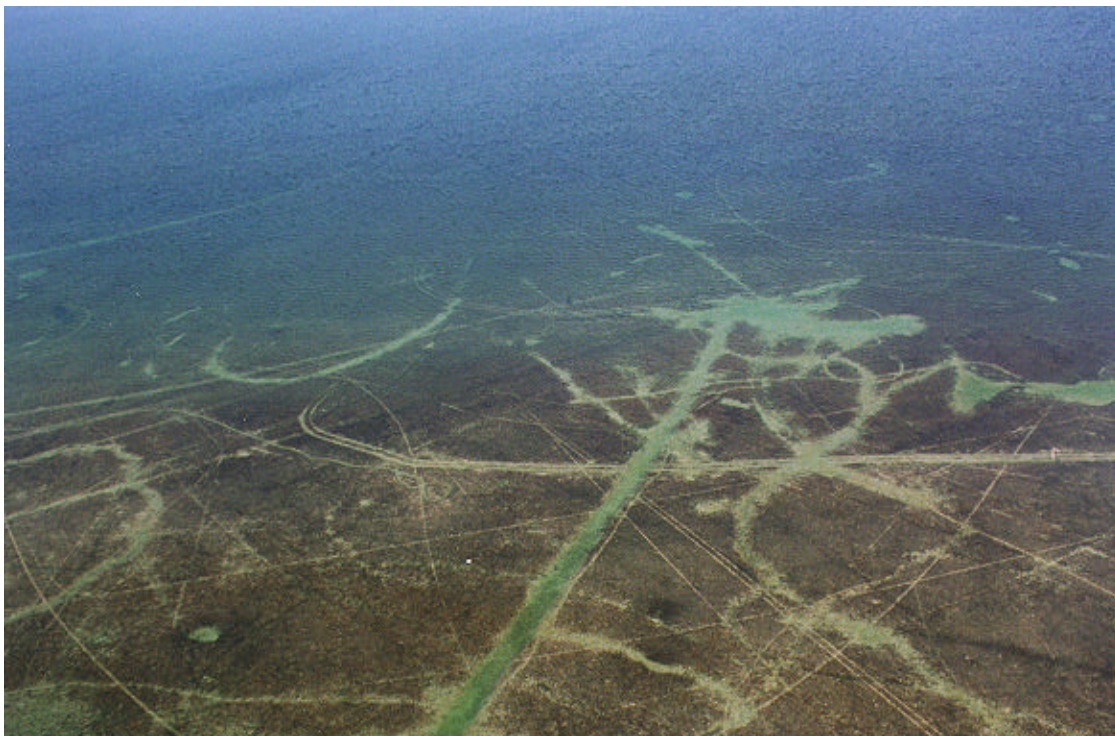
Figure 61. Grounding and prop scars, Featherbed Shoal, Biscayne National Park (1996). (Photo by Karen Battle, Biscayne National Park.) *See color version on p. 137.*

An increasing problem in Biscayne Bay is the scarring of seagrass beds, commonly made when a boat's propeller tears and cuts up roots, stems and leaves (Sargent *et al.*, 1995; Zaneski, 1998). The greatest acreage of moderate to severe scarring occurred in areas of dense human population and a large number of registered boats. An assessment of the degree of seagrass bed scarring statewide indicated that approximately 8% of the seagrass beds in Dade County were scarred, and approximately 6% were rated with moderate/severe scarring (Figures 61 and 62).

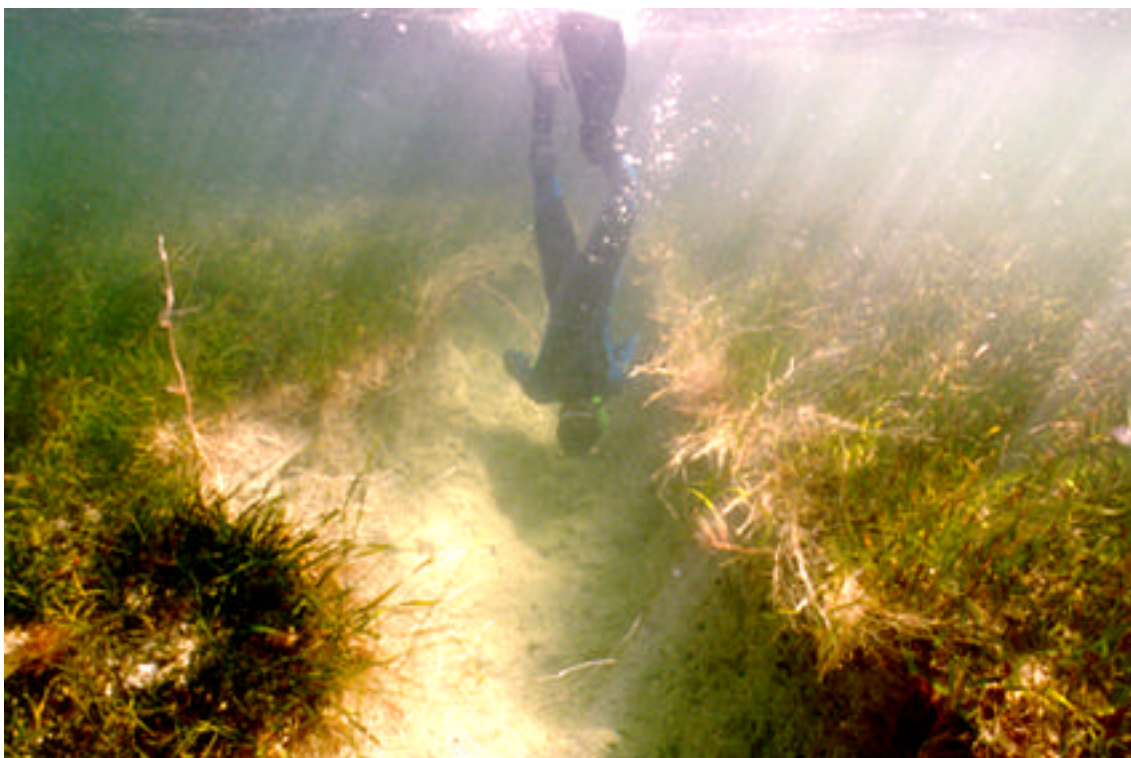
Figure 62. Grounding trench, Pelican Bank (1994). (Photo by Mark Nicholas, Gulf Islands National Seashore.) *See color version on p. 138.*
