NISTIR 6923

Simulation of the Dynamics of a Fire in a One-Story Restaurant --
Texas, February 14, 2000

Robert L. Vettori
Daniel Madrzykowski
William D. Walton

October 2002

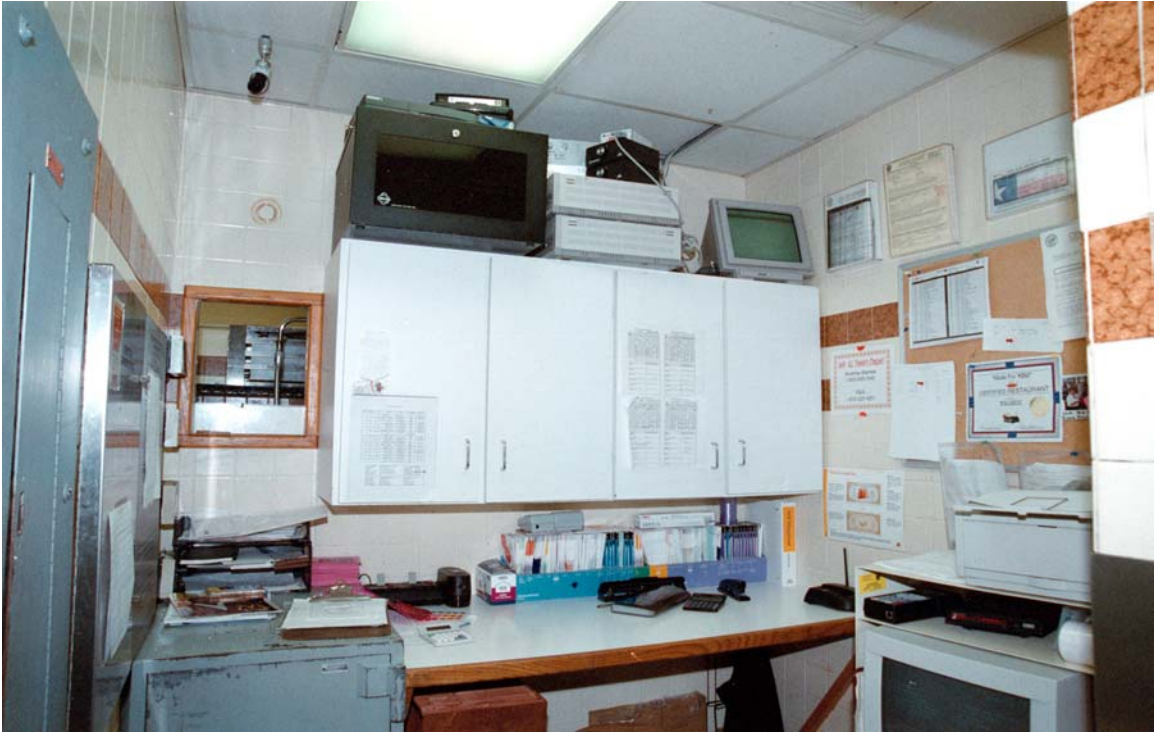
Figure 1. Office area in a similar restaurant.

On the morning of February 14, 2000, a fire started in the office area of a fast food restaurant. Figure 1 and Figure 2 show the office area of a similar restaurant. At 4:30 AM the fire department received a call from a civilian who reported that fire was emanating from the roof of the restaurant. At 4:37 AM the first fire department apparatus arrived on the scene and confirmed that fire was visible from the roof, Figure 3. Shortly after arrival, two fire fighters from the first arriving fire apparatus, entered the structure using a door located on the west side in an effort to locate and extinguish the fire. Other firefighters

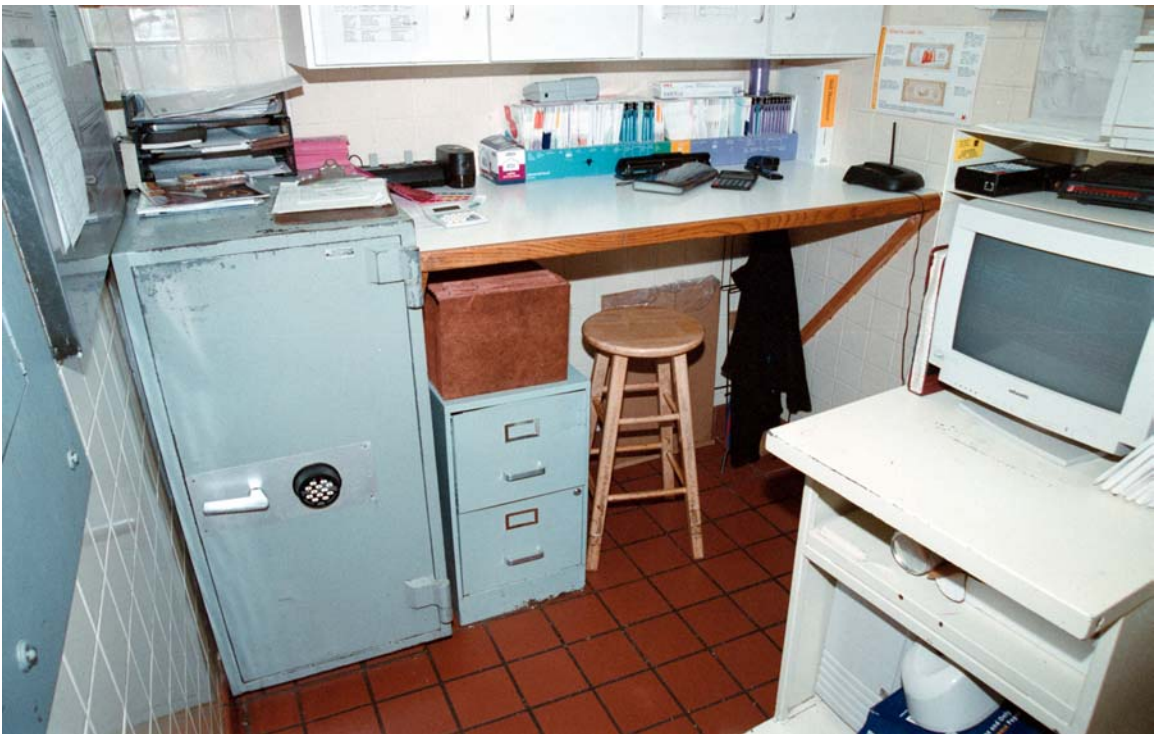
Figure 2. Office area in a similar restaurant.

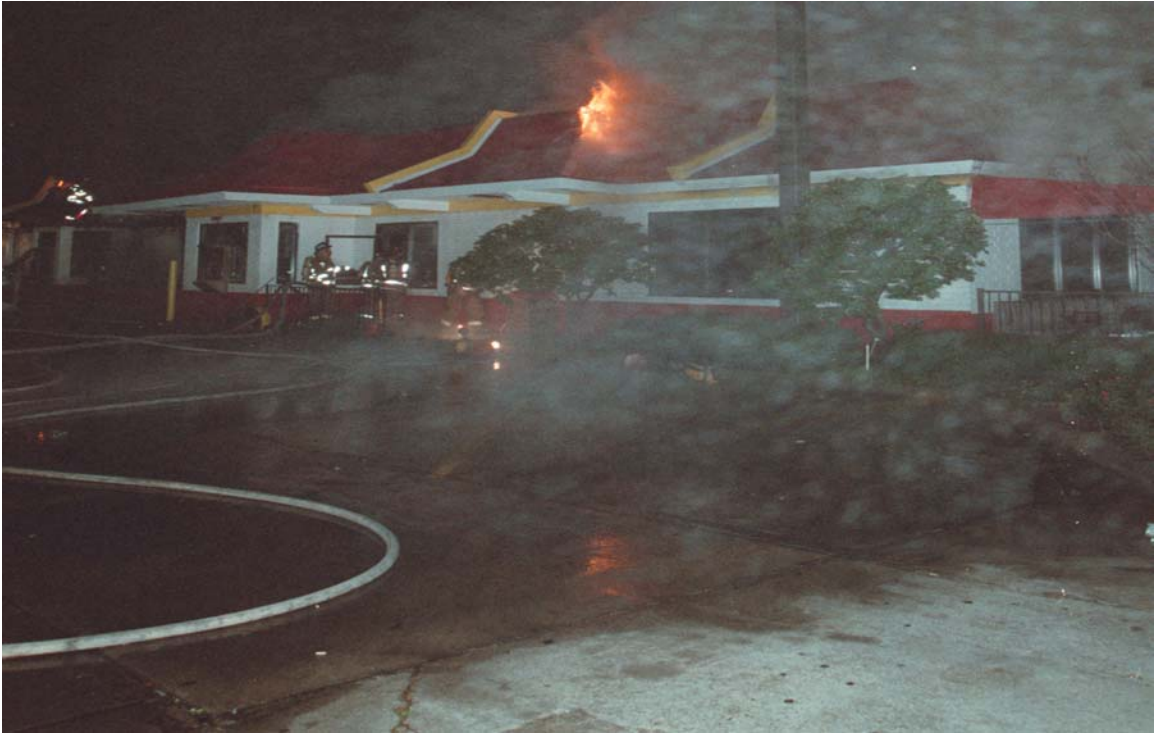
Figure 3. Early stages of the fire.

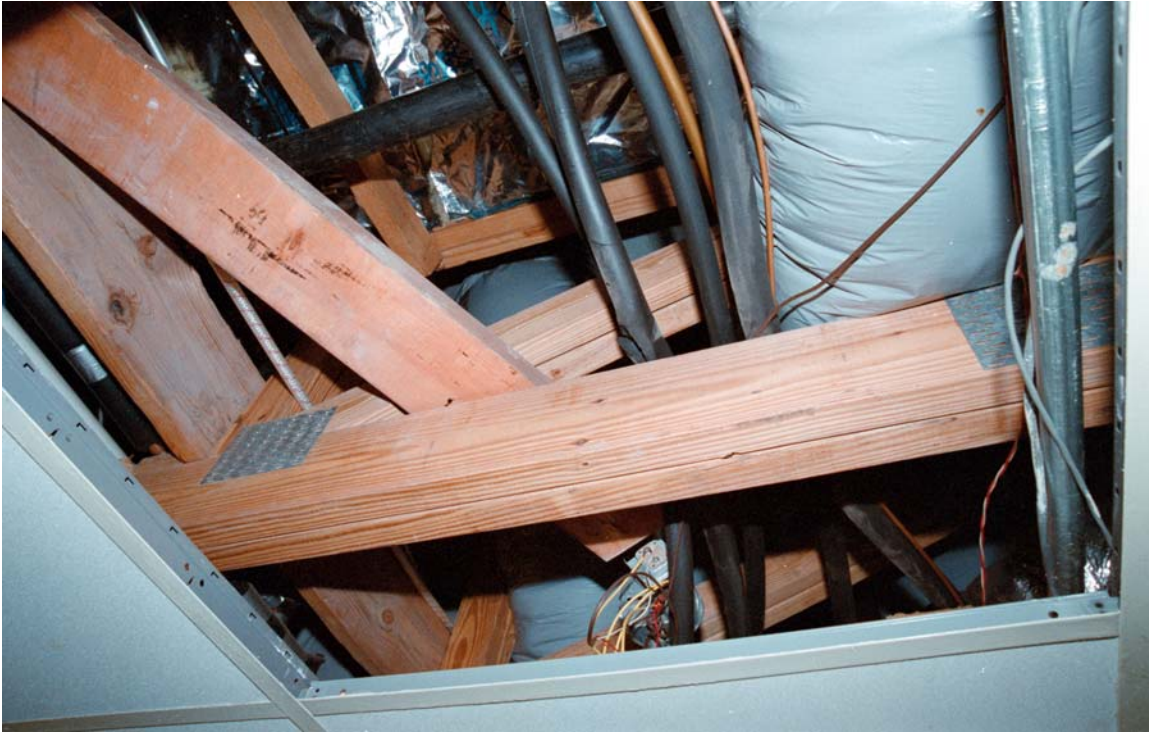
Figure 5. Attic area in a similar restaurant showing the trusses.

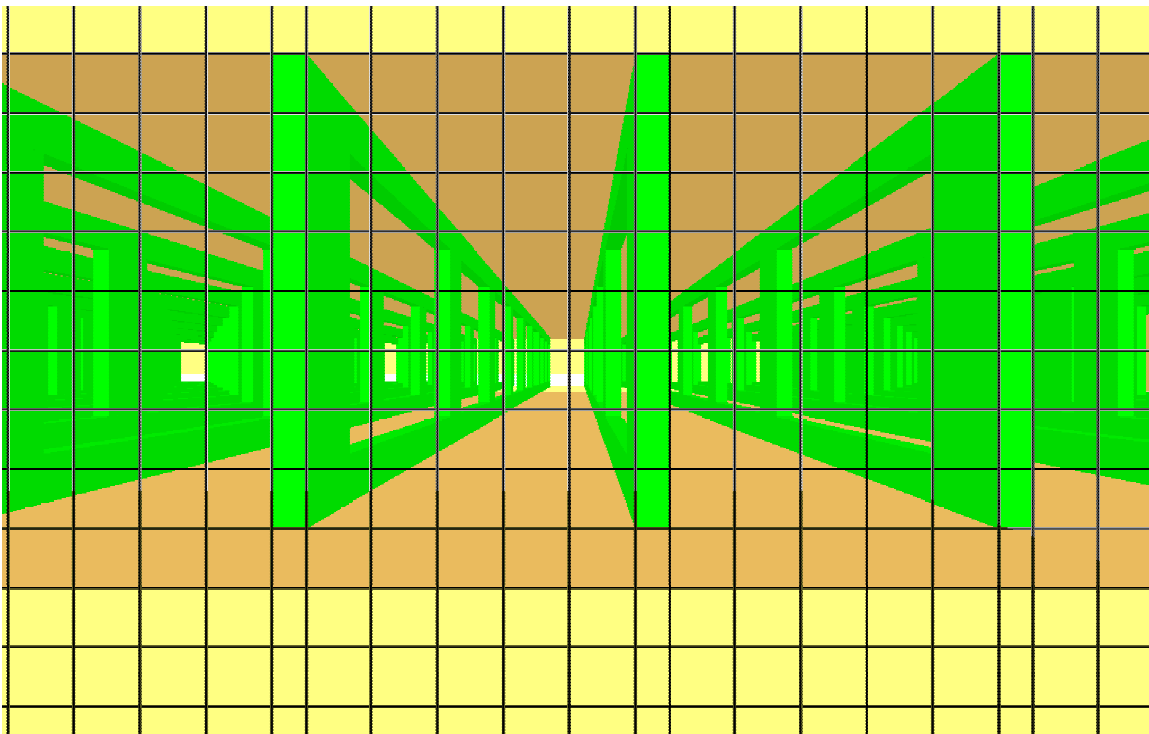
Figure 6. Attic computational cells in the north-south direction.

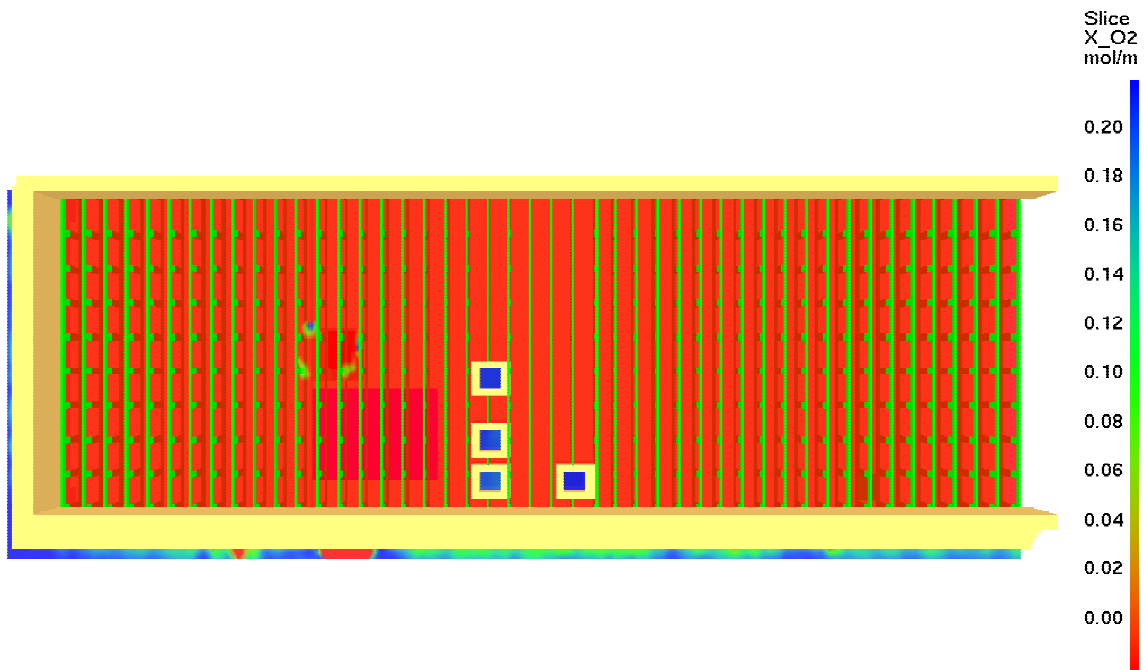
Figure 14. Oxygen concentrations in the attic area at 1500 s into simulation, the approximate time of arrival of the first fire department apparatus.

Figure 13 and 14 show the oxygen concentration within the attic at the same simulation times as Figures 11 and 12. Figure 13 and Figure 14 depict high temperature and low oxygen concentration within the attic area of the restaurant at approximately the time the fire department arrived. This would indicate there is little actual burning within the attic, except where the flames from the office area enter the attic and along the edges of the structure where the hot gases mix with fresh air and ignite. Even though there may not have been flames within a large part of the attic area, the gases themselves were hot enough to allow the wood trusses to pyrolyze.

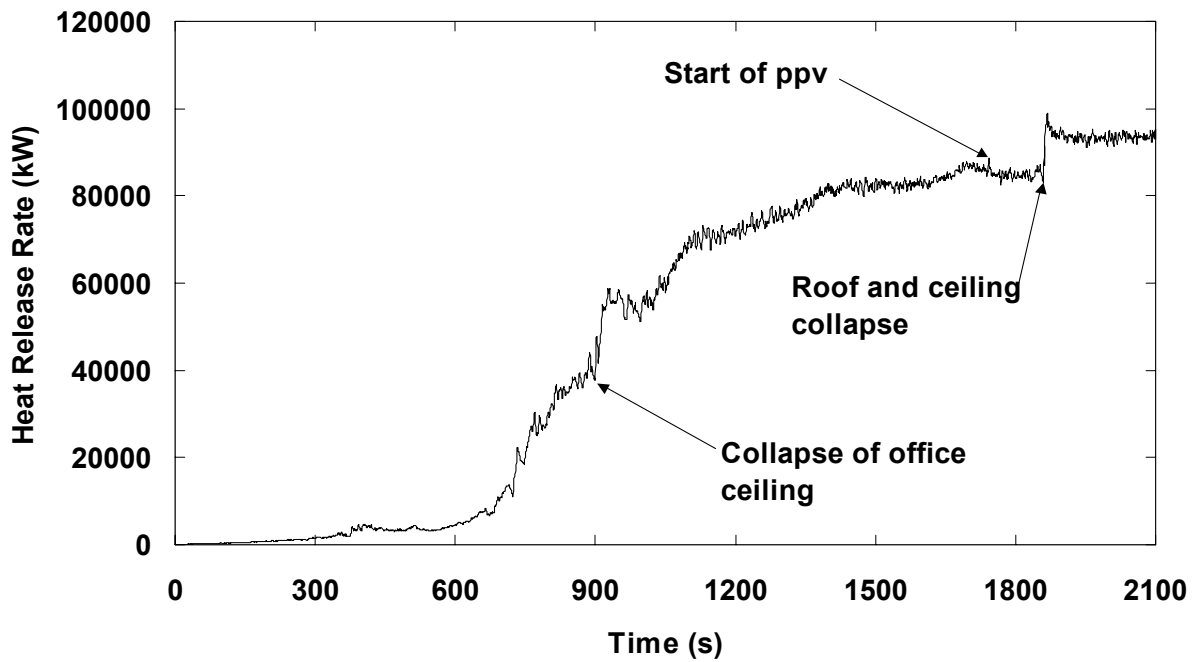
Figure 20. Heat release rate for simulation.

A measure of the intensity of a fire is the amount of heat that is being generated or released by the fire. Figure 20 is a graph of the heat release rate of the fire. From this graph it appears that the ceiling collapse in the office at 900 s and the roof/ceiling collapse at 1860 s into the simulation had a much greater and sustained impact on the heat release rate than the use of positive pressure ventilation.
