**Second Five-Year Review Report
Peterson/Puritan, Inc. Superfund Site
Towns of Cumberland and Lincoln
Providence County, Rhode Island
September 2007**

Prepared by
Engineering/Planning Division
New England District
Concord, MA

Prepared for
United States Environmental Protection Agency
Region 1-New England
Boston, Massachusetts

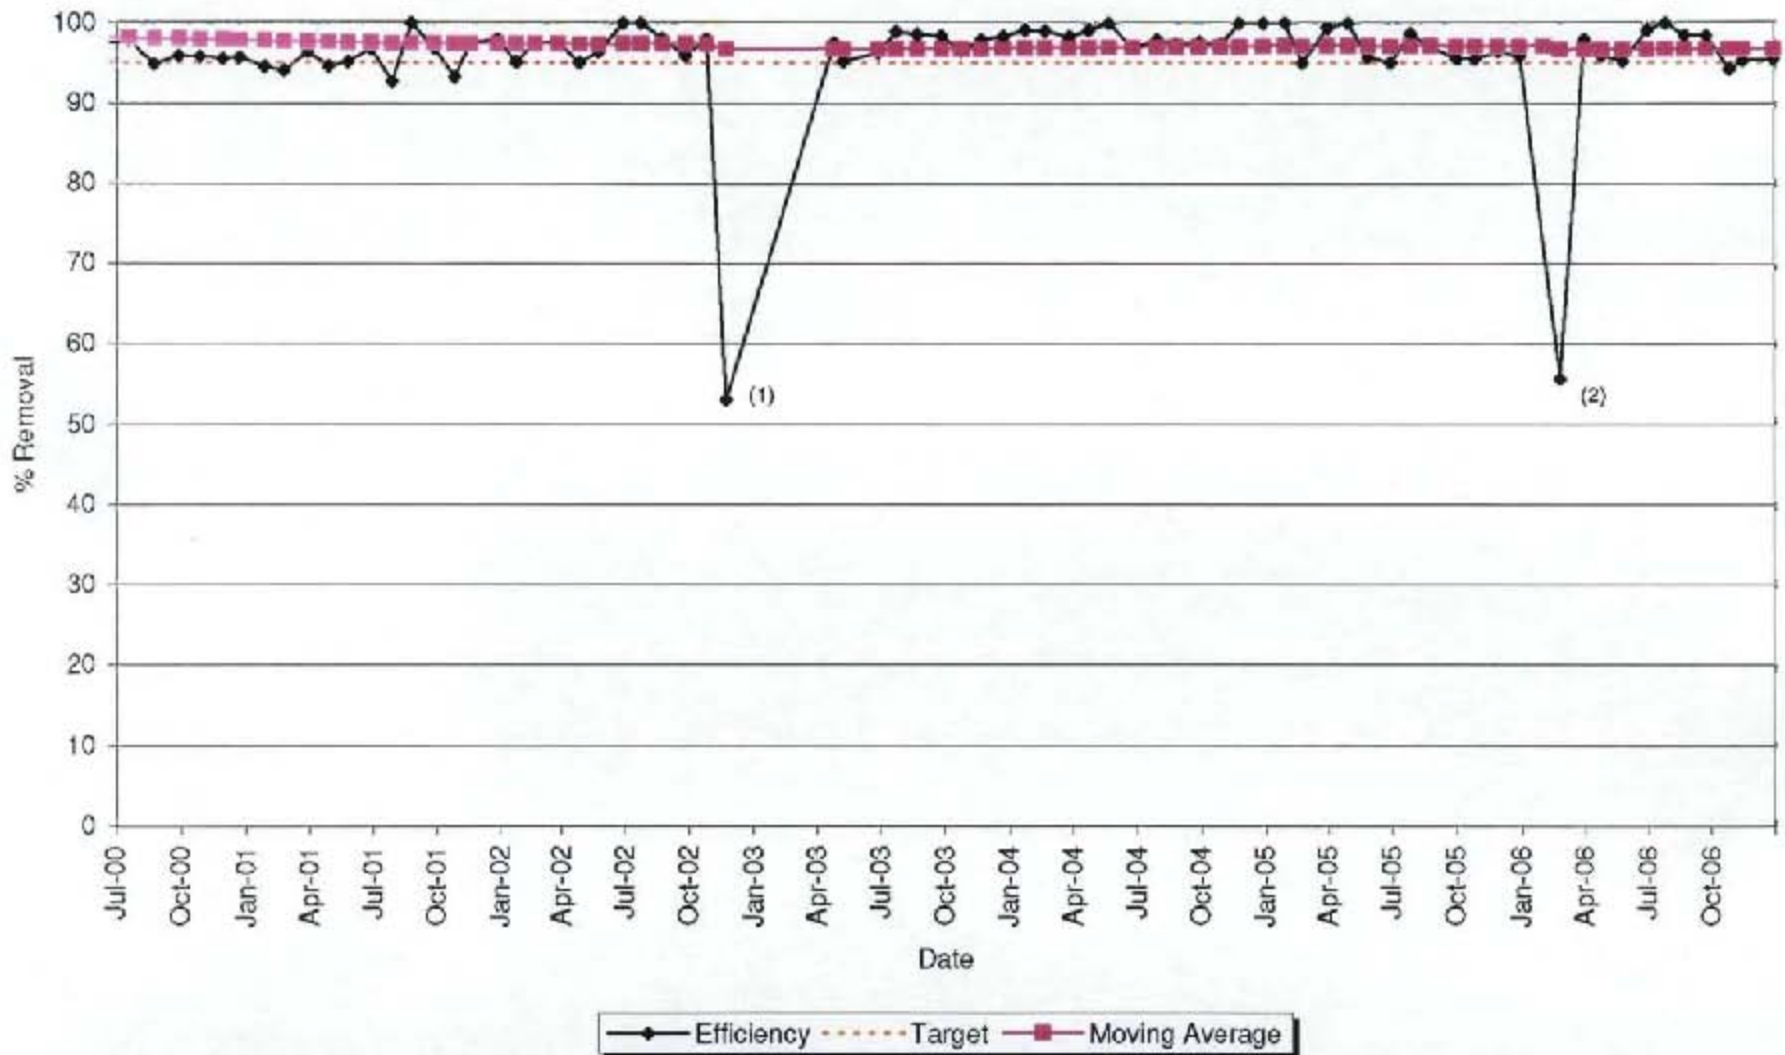
**Figure 8. GAC Removal Efficiency at CCL Remediation Area
Peterson/Puritan Superfund Site, OU-1, Cumberland, RI (ENSR, 2007)**

- (1) - SVE down during carbon vessel replacement
- (2) - Carbon changed after testing result
