Final Report

Kuck Bioengineered Bank Protection

2000-HR-04
14-48-11333-00-J003

July 10, 2002

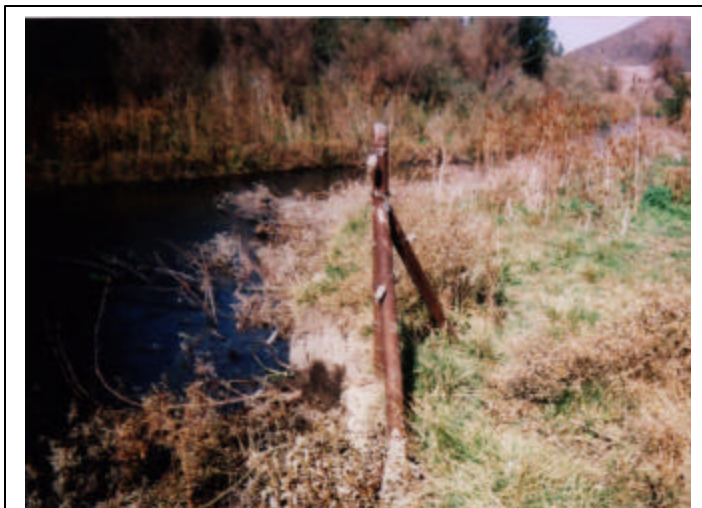
The currently excessive lateral migration of the stream on the Kuck property is a result of a combination of events including fairly recent river avulsion, intensive grazing, longstanding loss of woody riparian plants and sandy erodible soil.

This fence post was 20 feet back from the edge of the stream when installed in 1996.

Livestock exclusion fencing proved insufficient to allow the stream to re-stabilize itself, and over the approximately 5 years since it was installed, parts of the river have moved over 20 feet, undermining sections of the exclusion fence and sending tons of fine sediment down the river. When it became apparent that natural forces would be inadequate to reverse the erosion problem anytime soon, we chose to utilize willow mattresses as a way to provide temporary “rip-rap” to the bank to allow time for riparian and emergent plants and trees to stabilize the site. The willow mattresses are expected to last about 10 years, during which time the site will be

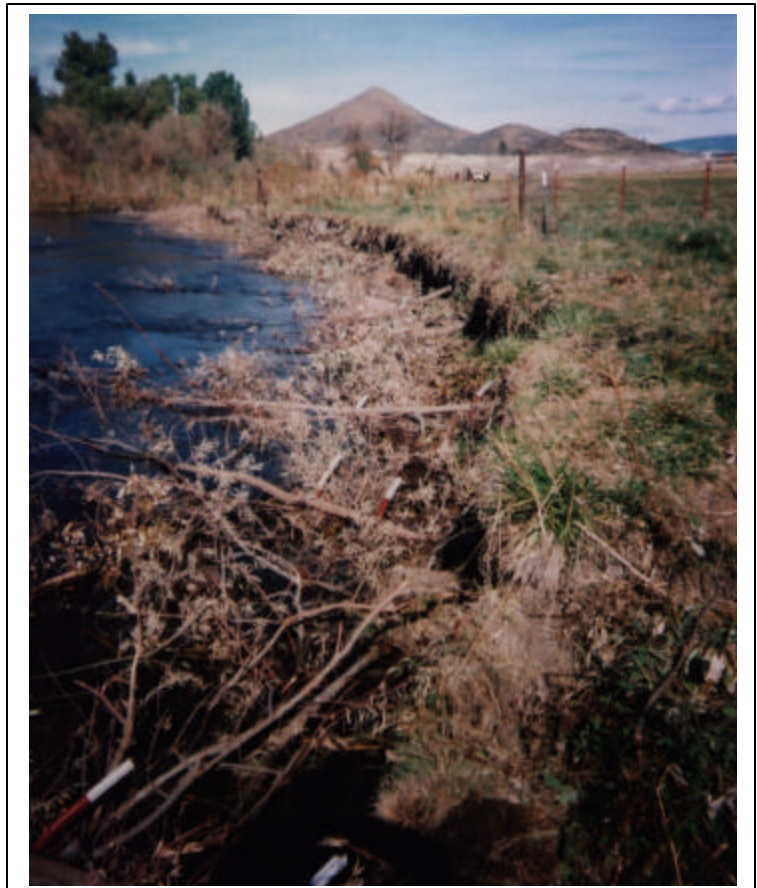
Long vertical bank with matting newly completed.

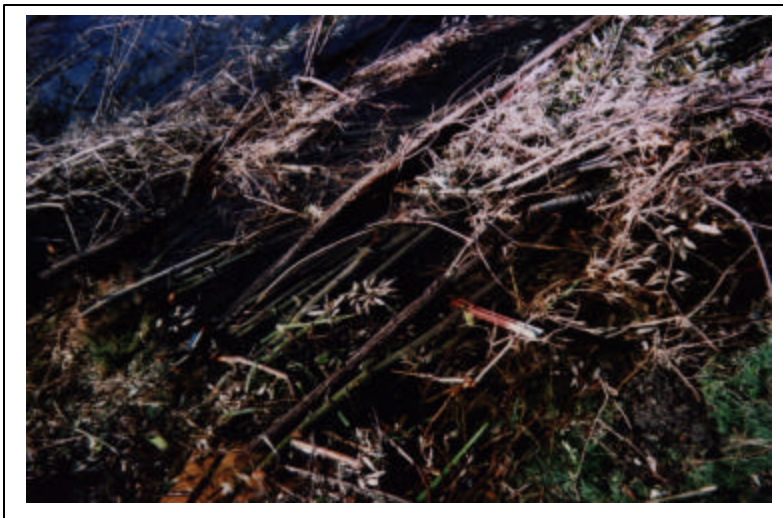
Close-up showing closely spaced willow bundles and bent T posts.

Once all that is done, all the "T" posts are then progressively driven further into the bank, pulling the entire assembly tightly into the substrate. Finally, the T posts are bent over pointing downstream to minimize potential hazards to boaters.
