ACCIDENT/INCIDENT ALERT

Fatal Grinder Accident at Quarry

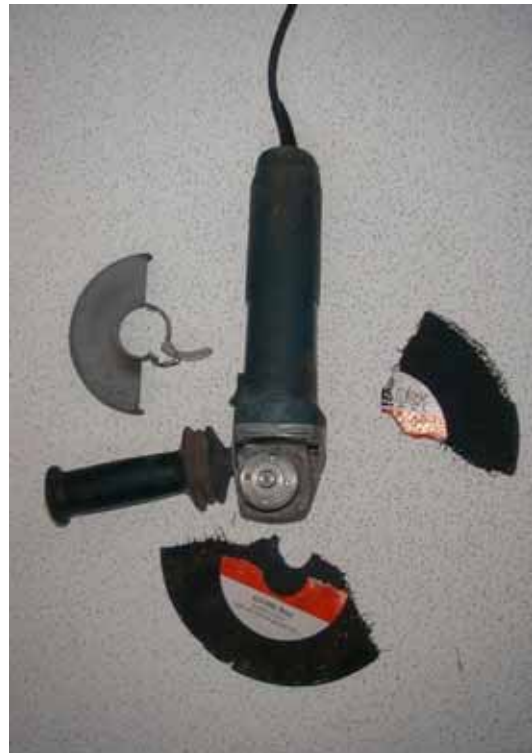
The hand-held angle grinder was fitted with a 230 mm diameter cutting-off wheel and when it disintegrated, fragments penetrated the victim's chest and abdomen. He was rushed to hospital by rescue helicopter but died the same day.

This is continuing but initial inspections show that the grinding machine and cutting disk were not compatible - and the grinder was not fitted with a guard.

Angle grinder and disintegrated disk

Grinding machines and abrasive wheels should always be used in accordance with the manufacturer's instructions.

- Always ensure the maximum speed (the no load rpm) marked on the abrasive wheel is greater than the rated speed of the grinder.
- Do not use grinding wheels that are larger than the maximum recommended size, or worn down wheels from other grinders.

- Never use grinding wheel power tools without the wheel guard attached to the tool and positioned for maximum safety.
- Store and handle abrasive wheels with care and inspect them for chips or cracks before installing. Do not use any wheel that may be damaged.
- Refer to Australian Standard 1788 - *Abrasive Wheels* for more detail.
