Geochemical and Mineralogical Characterization of the Abandoned Valzinco (Lead-Zinc) and Mitchell (Gold) Mine Sites Prior to Reclamation, Spotsylvania County, Virginia

Scientific Investigations Report 2006–5085

Prepared in cooperation with the Virginia Department of Mines, Minerals, and
Energy

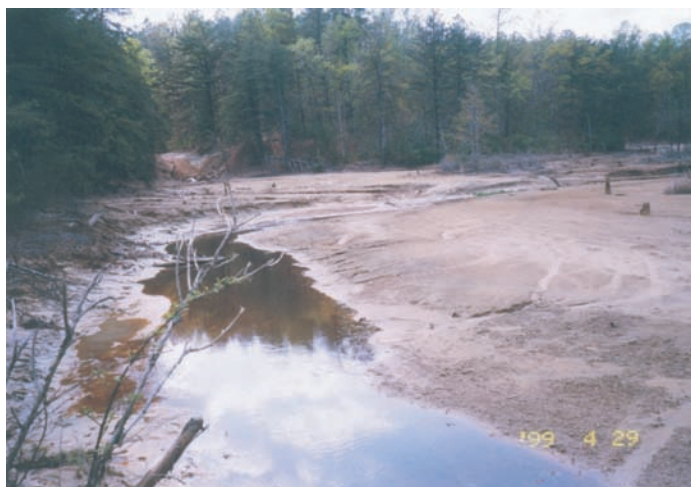
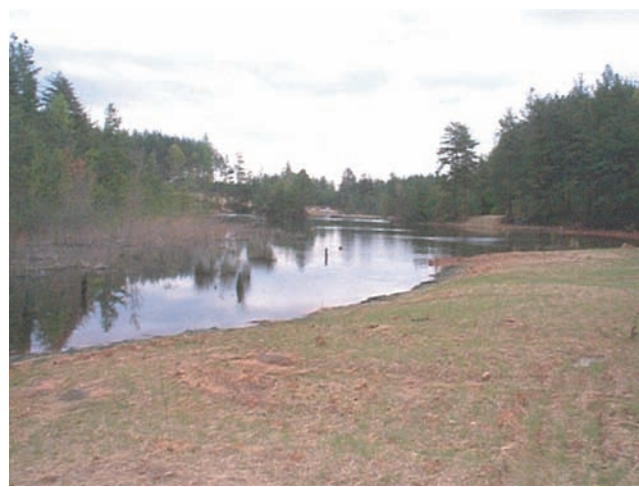
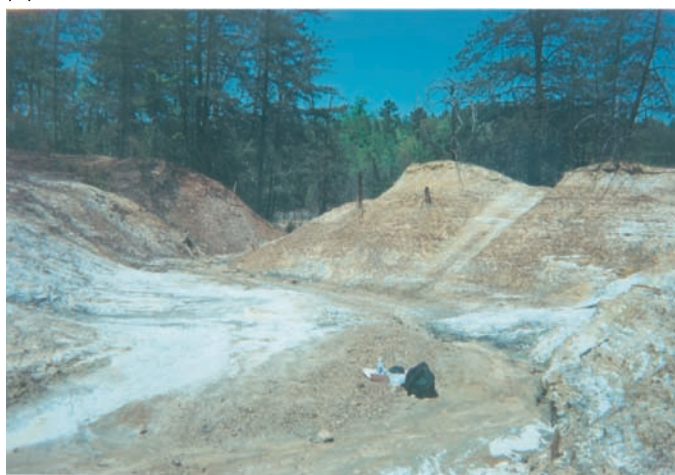
Figure 4. Photographs of the Valzinco mine area. *A*, Knights Branch flowing through the Valzinco flotation tailings (April 1999). View west towards headwaters (upper right) and gulch (upper left). *B*, Same area after reclamation (2002). The gulch was filled with tailings and capped. Limestone drains were installed along with rerouting of the main stream channel. *C*, Pre-reclamation view from the flotation plant foundation looking northeast along the tailings-lined gulch. *D*, Efflorescent sulfate salts coating tailings along the gulch.

failure (date unknown) caused fluvial transport of tailings downstream from the site. The mill foundation and a concrete silo remained on the site after mining ceased, at the head of a tailings-lined gulch (fig. 4C) that formerly served as the discharge pond area for flotation mill slimes. The gulch below the mill was probably a pond area at one time but was dry (except for surface runoff) during the course of this study. The gulch walls were composed of very-fine grained oxidized tailings. A variety of highly soluble sulfate minerals effloresced on the tailings intermittently during the course of this study, depending on the prevailing weather conditions (fig. 4D).

accounting to determine treatment dosages for acid abatement) was conducted by MVTechnologies, Inc. (1998) under contract with the VDMME. That study and grab water samples analyzed by the Commonwealth showed acidic soils (paste pH 3.2) and elevated concentrations of iron, lead, manganese, and zinc in Knights Branch as it flowed through the Valzinco mine site. The project goals included restoration of Knights Branch and reclamation and revegetation of more than 4.0 hectares (10 acres) of disturbed lands. Reclamation included (1) the land-filling of mine wastes, (2) the construction of water diversion channels, (3) the construction of anoxic limestone drainages, (4) the application of bacteriocides, (5) the construction of wetlands, (6) revegetation, and (7) plugging of shafts (Sobeck, 2000). The dry gulch area below the flotation mill site was used as a repository for tailings. Water diversion and recontouring have resulted in a wetland/pond system that occupies the former stream channel through the tailings (fig. 4B).

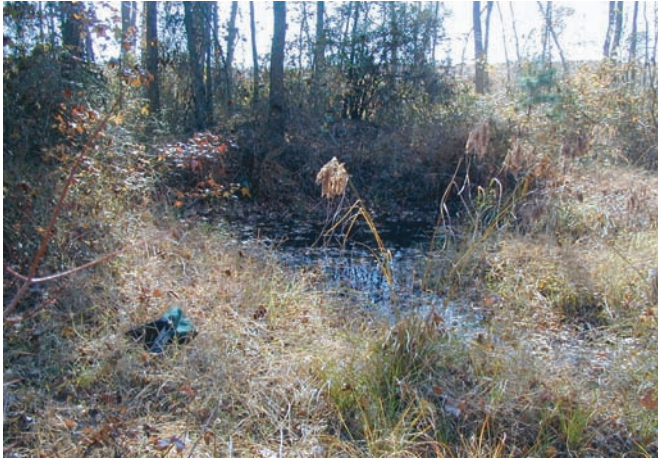
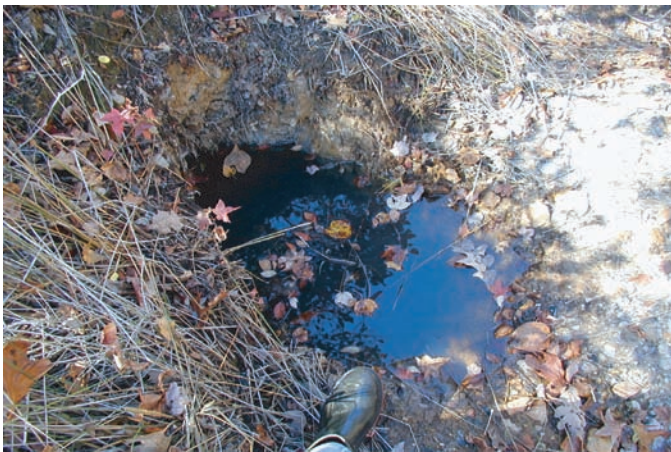
Figure 5. Photographs of the Mitchell mine area. A, Large pond. B, Small pond.

than those observed for the small pond. If tailings are present in the small pond, it seems likely that tailings are also present in the other ponds at the Mitchell mine site.

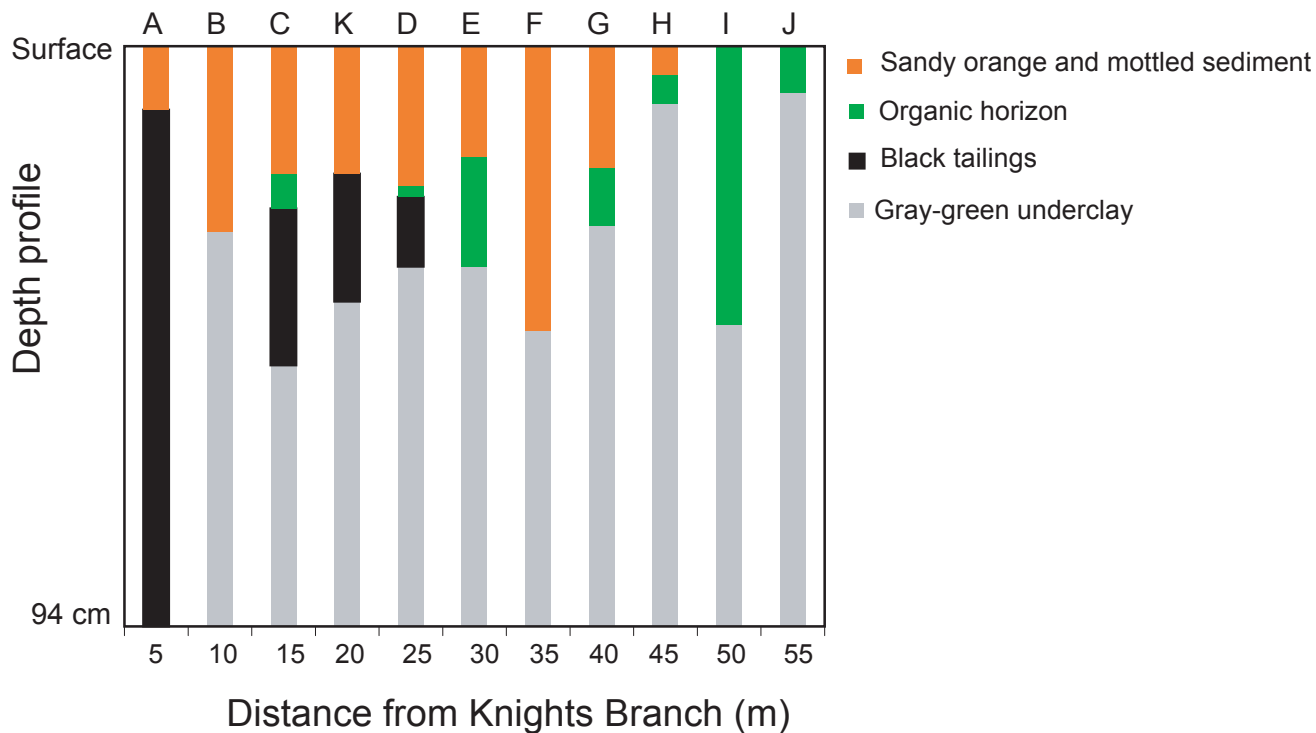
Figure 9. Schematic cross-section of fluvial tailings deposit 3 (downstream of the Mitchell mine) showing the stratigraphy of the deposit from streamside (A) to a boggy area (J) at the edge of the clearing (see fig. 3). Classification is based on visual inspection of auger cores samples at 5-m intervals across the width of the deposit.

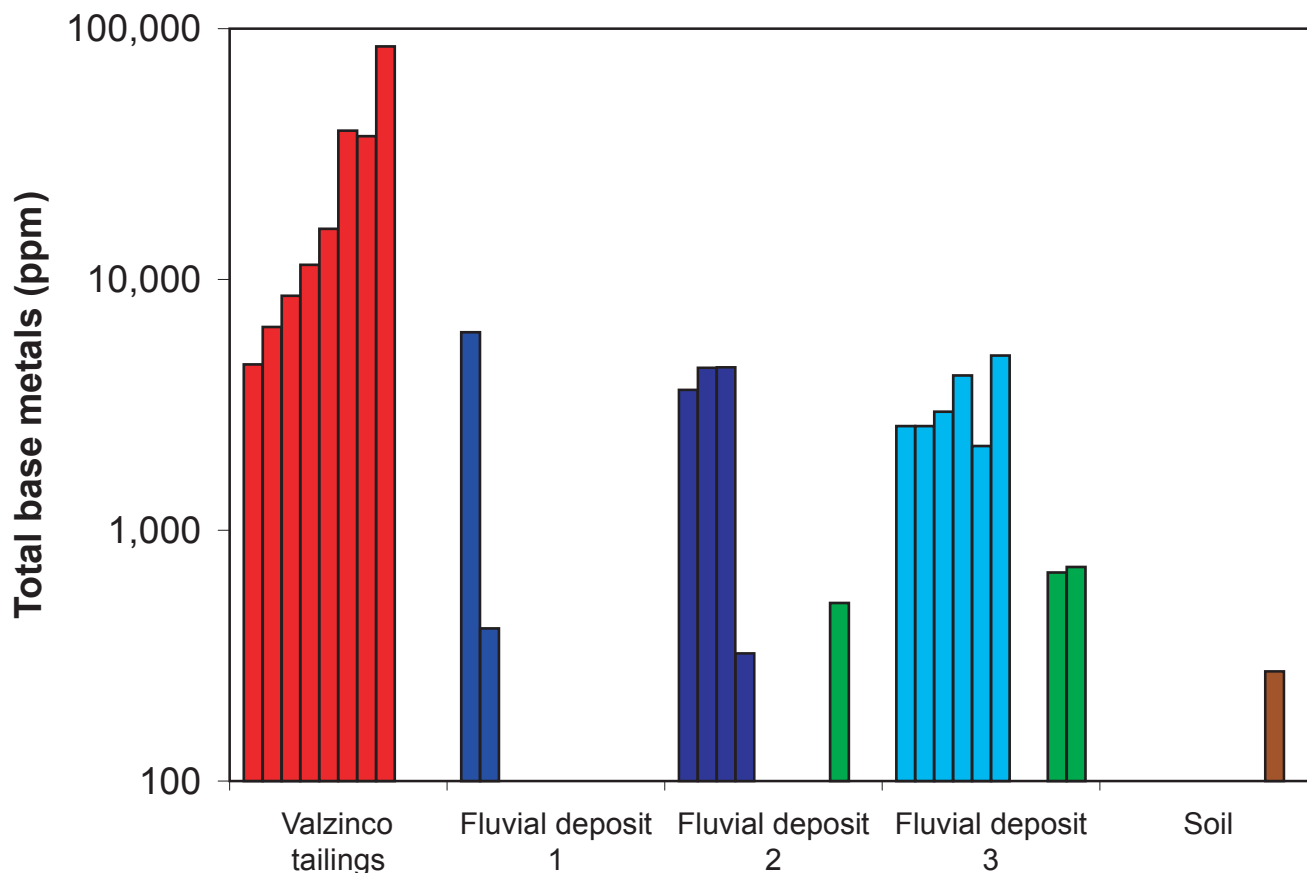
Figure 10. Bar chart comparing total base-metal concentrations (Cu+Co+Cd+Ni+Pb+Zn) in Valzinco mine tailings, downstream fluvial deposits, and background soil. Each bar represents a separate sample. Gray-green underclay at fluvial deposits 2 and 3 is shown as green bars. Samples include surface composites as well as subsurface samples.

Mercury was not known to be a concern at the start of this study, so it was not included in analyses of the Valzinco tailings or fluvial deposit 1. Comparison of mercury data for fluvial deposits 2 and 3, however, provides an indication of the influence of the Mitchell mine on downstream deposits. The abundant quartz litter on fluvial deposit 3 suggests that the site was used for working Mitchell ores or, alternatively, that quartz was carried downstream from the Mitchell site and deposited there during storm events. Mercury concentrations in fluvial tailings from deposit 2 (upstream of Mitchell) range from 0.02 to 0.1 ppm (table 5). Mercury concentrations in deposit 3 are consistently higher (0.1-0.3 ppm). Thus, fluvial deposit 3 apparently contains material contributed by both mines.

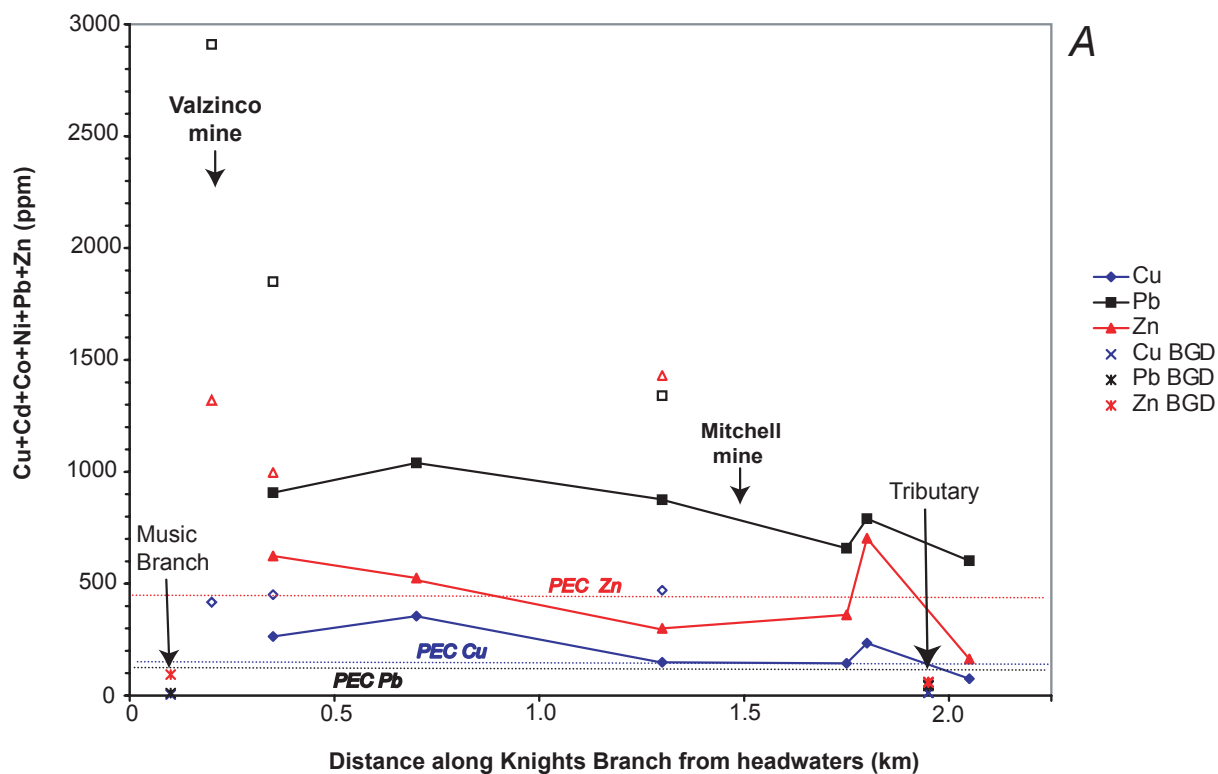
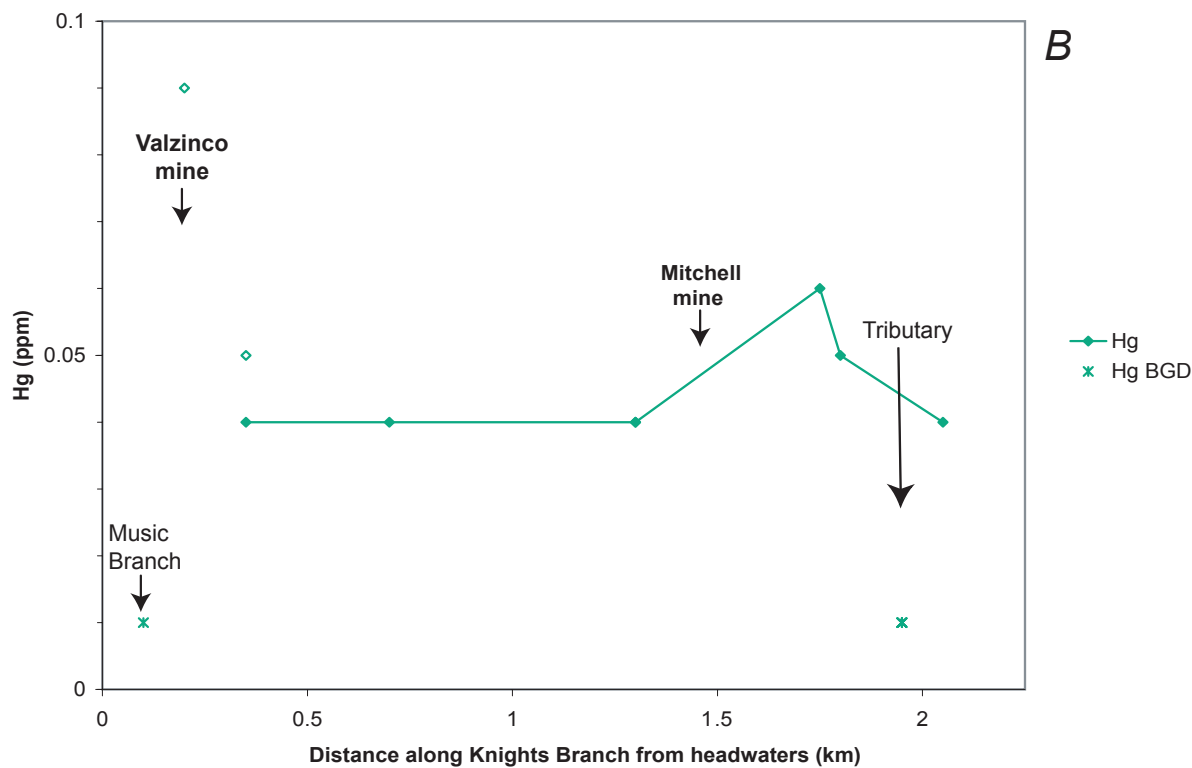
Figure 11. Stream sediment geochemistry along Knights Branch as a function of distance downstream from the headwaters. Background samples include Music Branch (in another watershed but plotted at 0.1 km for illustration) and an unnamed tributary that enters Knights Branch at fluvial deposit 3. Open symbols, samples collected in 1999 before reclamation. Solid symbols, samples collected in 2002 post-reclamation. *A*, Base metals. *B*, Mercury. Dotted lines show the probable effects concentrations (PEC) for zinc, copper, and lead.

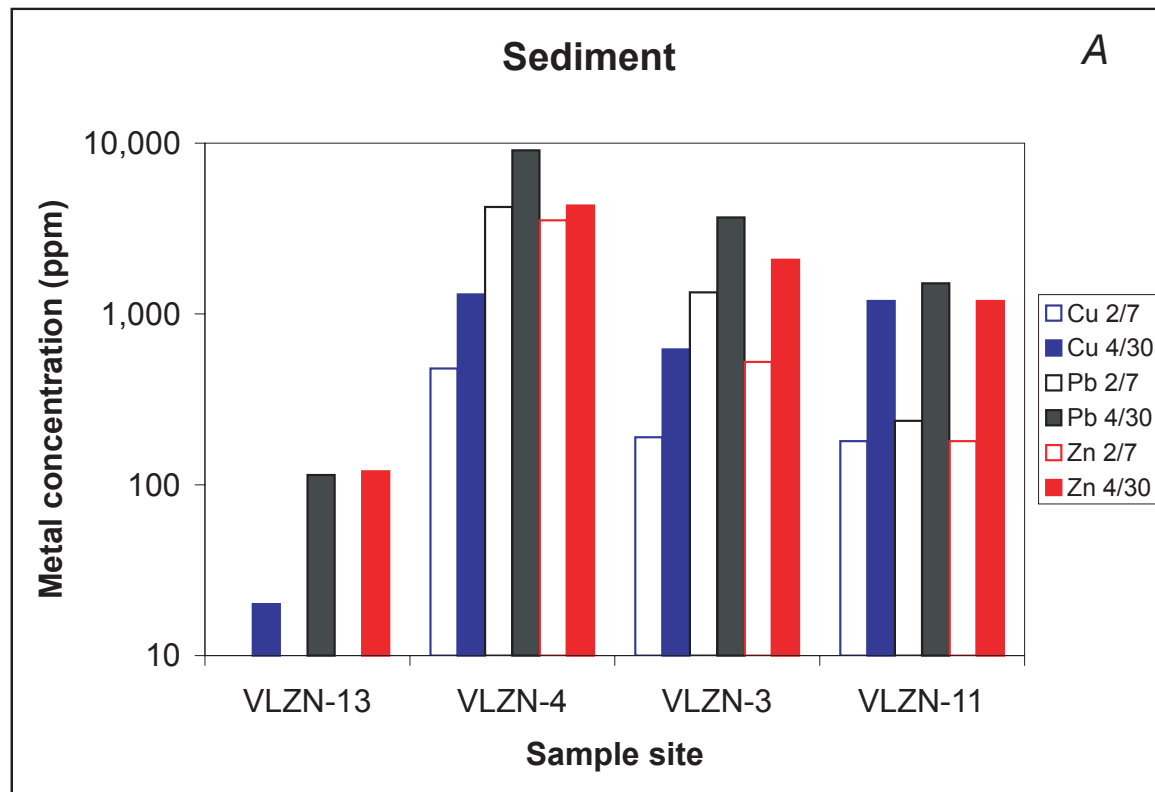
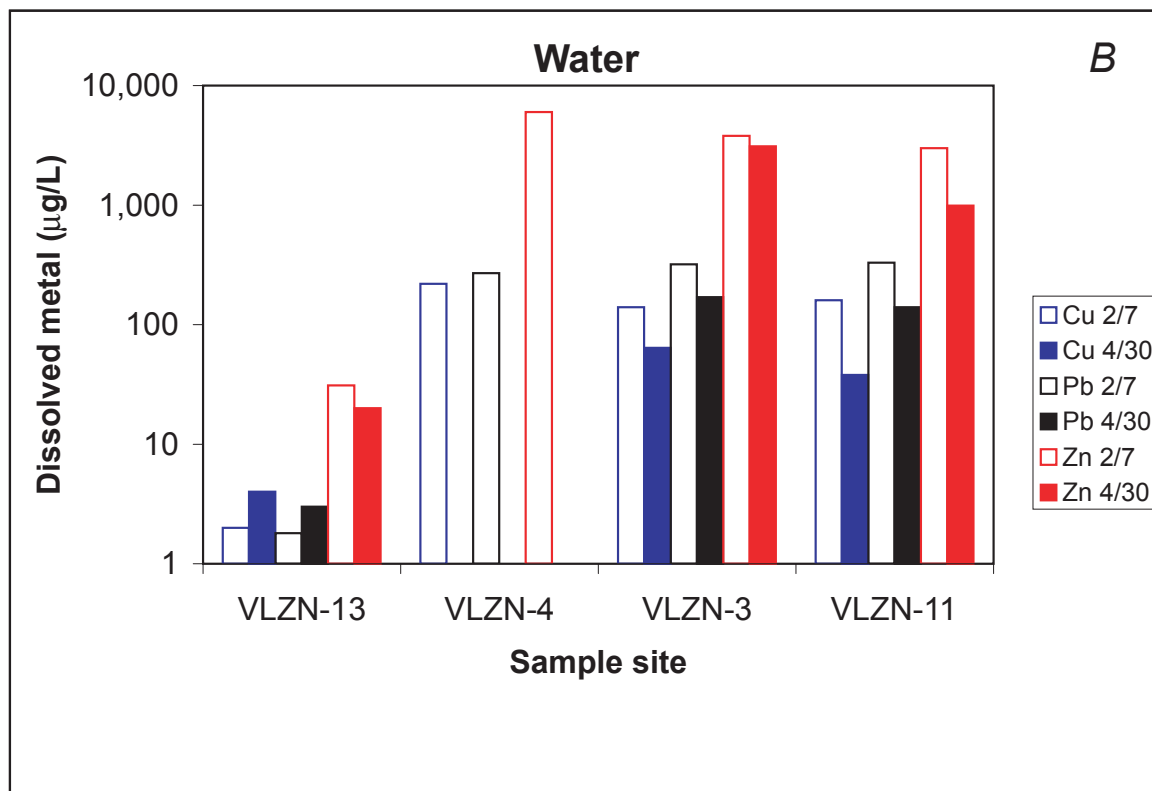
Figure 13. Bar charts showing the relative increase in base-metal concentrations in sediment and concomitant decreases in dissolved base-metal concentrations in stream water between February 7 and April 30, 2001. Same sample sites are as shown in figure 12. Water data from Seal and others (2002).
