**Improved Natural Gas Storage Well Remediation  
FINAL REPORT BUDGET PERIOD TWO  
FOR THE  
NATIONAL ENERGY TECHNOLOGY LABORATORY**

**Report Issue Date:** January 2005

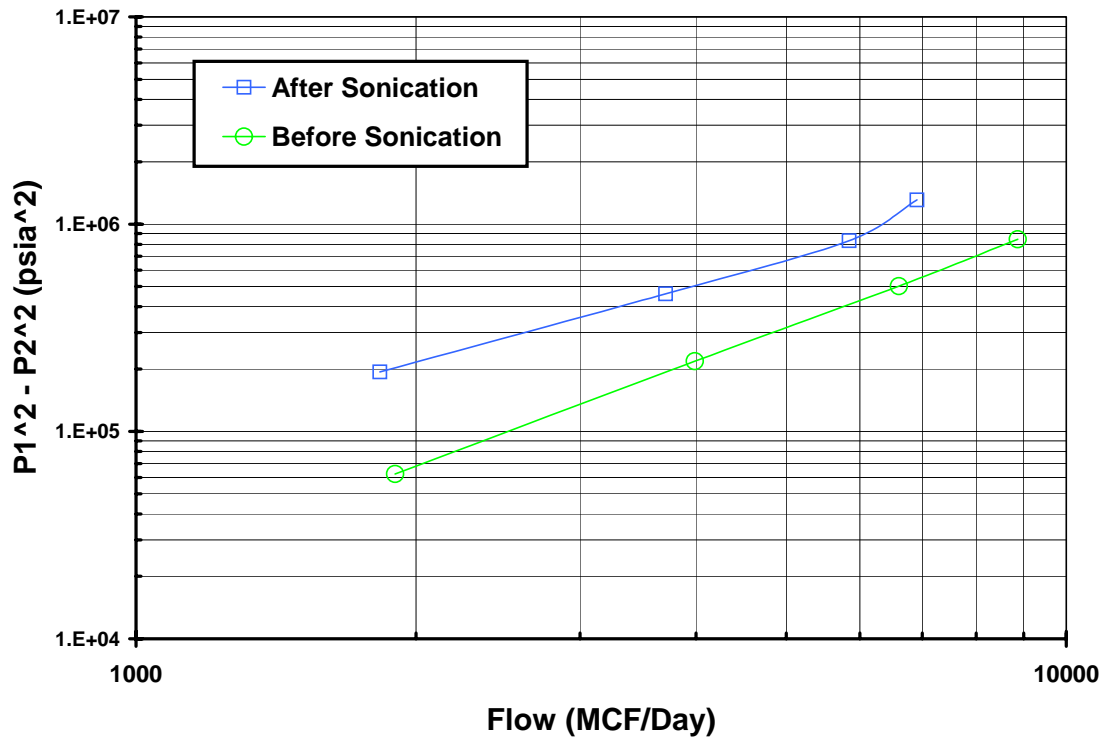
**Figure 2:** Pressure-Flow Calculation Data for Fienhold #18 Well Pre- and Post-Sonication

The complete set of flow prover data including the information in Charts 1 & 2 is tabulated in Appendix B of this document. Charts 1 & 2 clearly illustrate a productivity decrease in the Fienhold #18 well. This productivity drop could have been due to the sonication, the extended removal from service of the well for testing, and/or from overfilling the well with water.

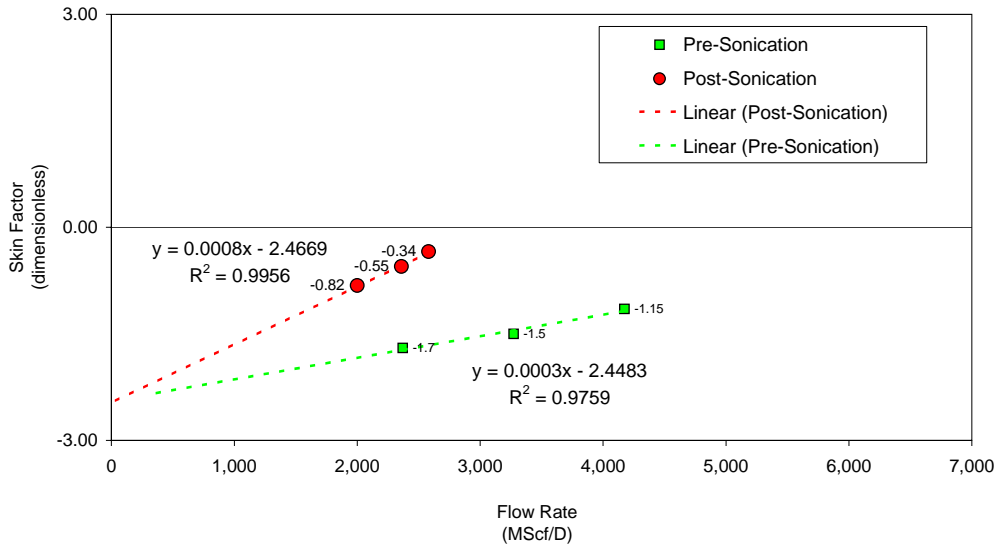
**Figure 6: Rate vs Total Skin from MRPTT in Fienhold #18**

As evidenced in Table 4 and in Figures 4-6, post-sonication analysis of the Fienhold #18 revealed a slight increase in permeability (30.5→35.3 md), an increase in the Non-Darcy Damage Coefficient (0.305 → 0.820) and no appreciable change in the mechanical skin. The increase in the Non-Darcy Damage Coefficient is consistent with the slight decline in the slope (coefficient n) obtained from the backpressure testing. The expectation of the project team was that the sonic treatment would have its greatest impact through reducing the skin by unblocking pores, perforations and casing. Since the mechanical skin was already negative for the Fienhold #18 well (-2.45), in hindsight this well was probably a poor candidate for sonication. The data demonstrated little or no overall improvement for this well from the treatment. Put in the overall context of the backpressure test and pressure transient test data, the project team did not consider the increase in permeability to be significant.

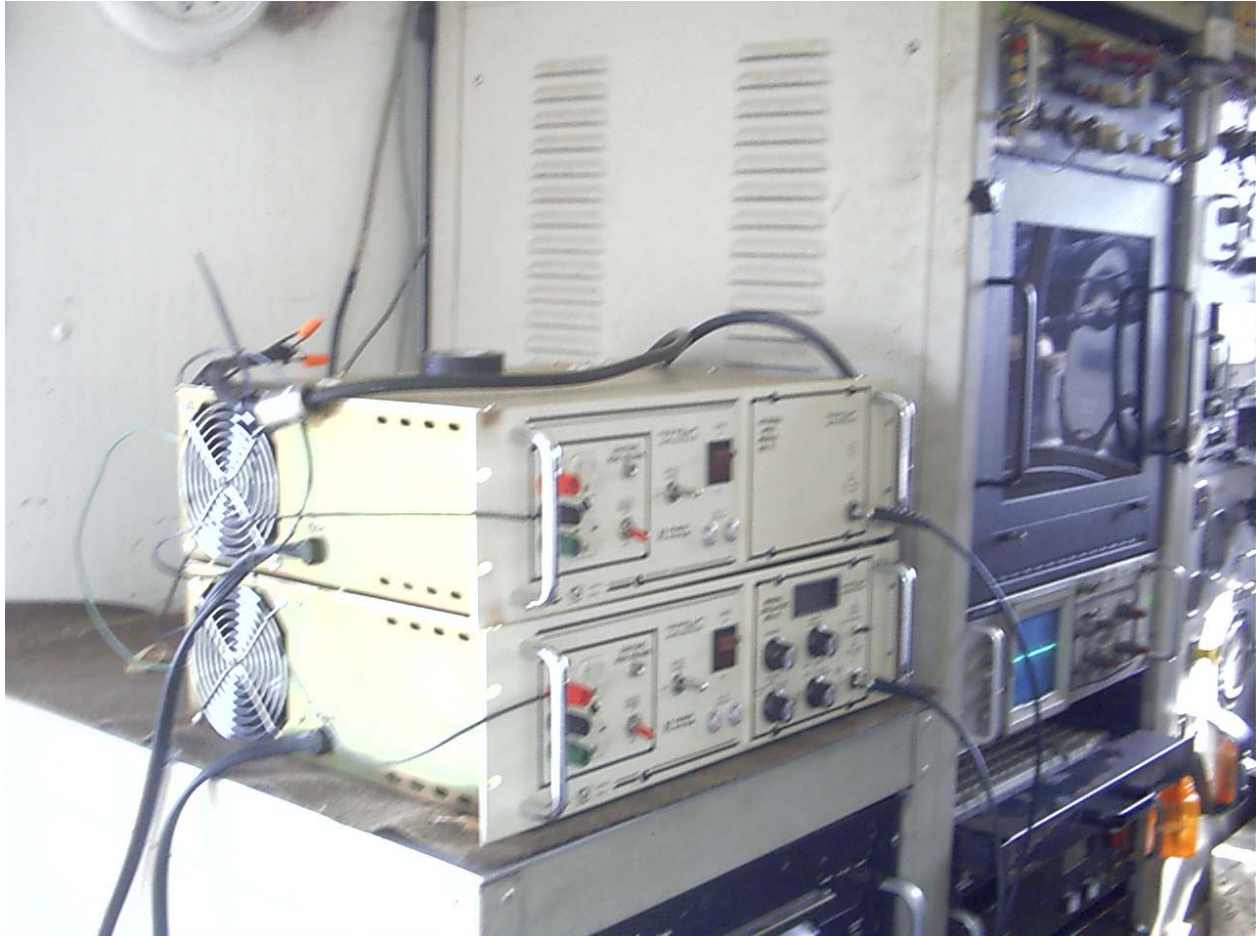
**Figure 8:** Acoustic power supplies

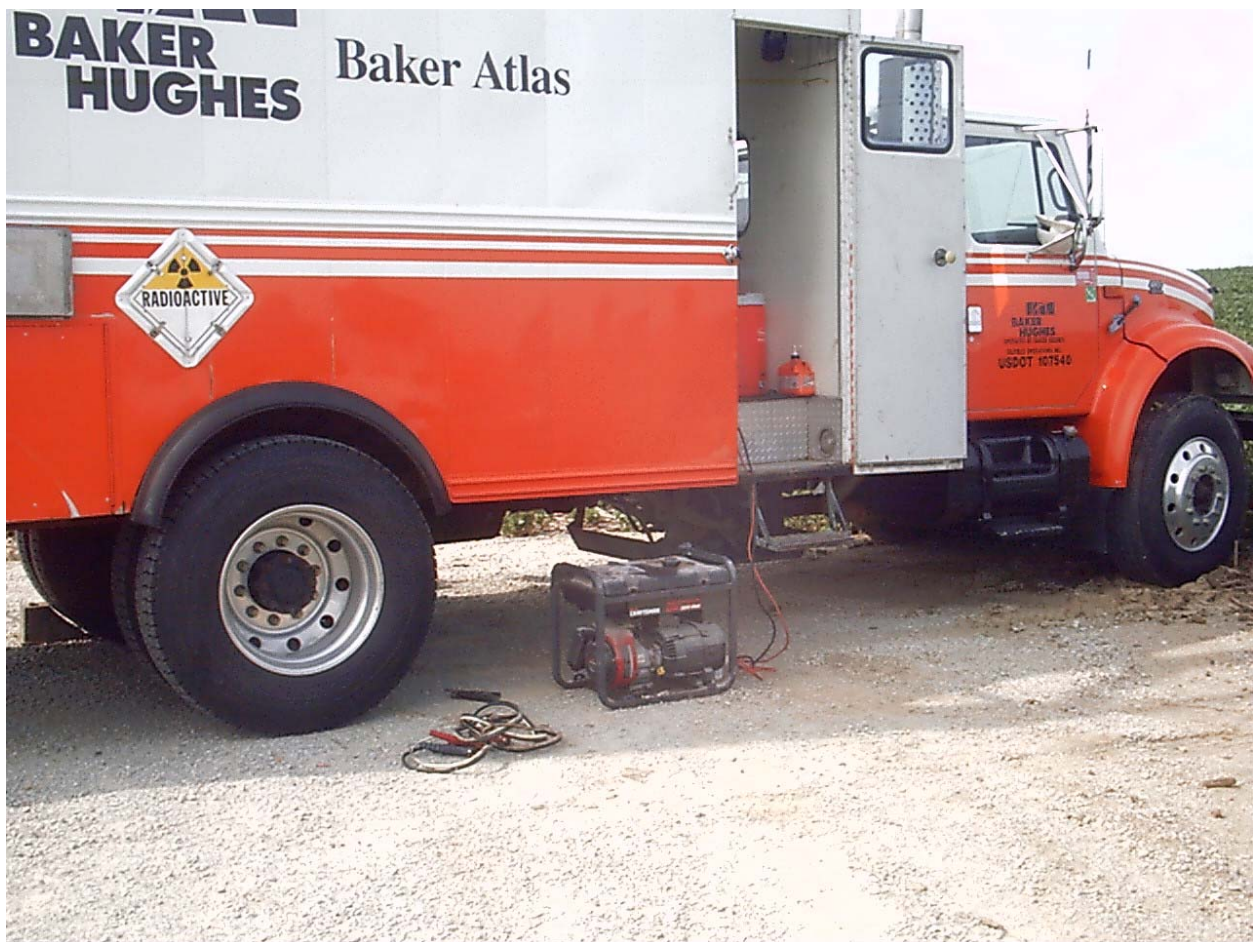
**Figure 9:** Wire line truck and separate external power generator

The separate electric generator doubled the power delivered to the wire line that supplied the tool to 1450-1600 watts. The estimated wire line losses for Field Test B were approximately 300 watts.

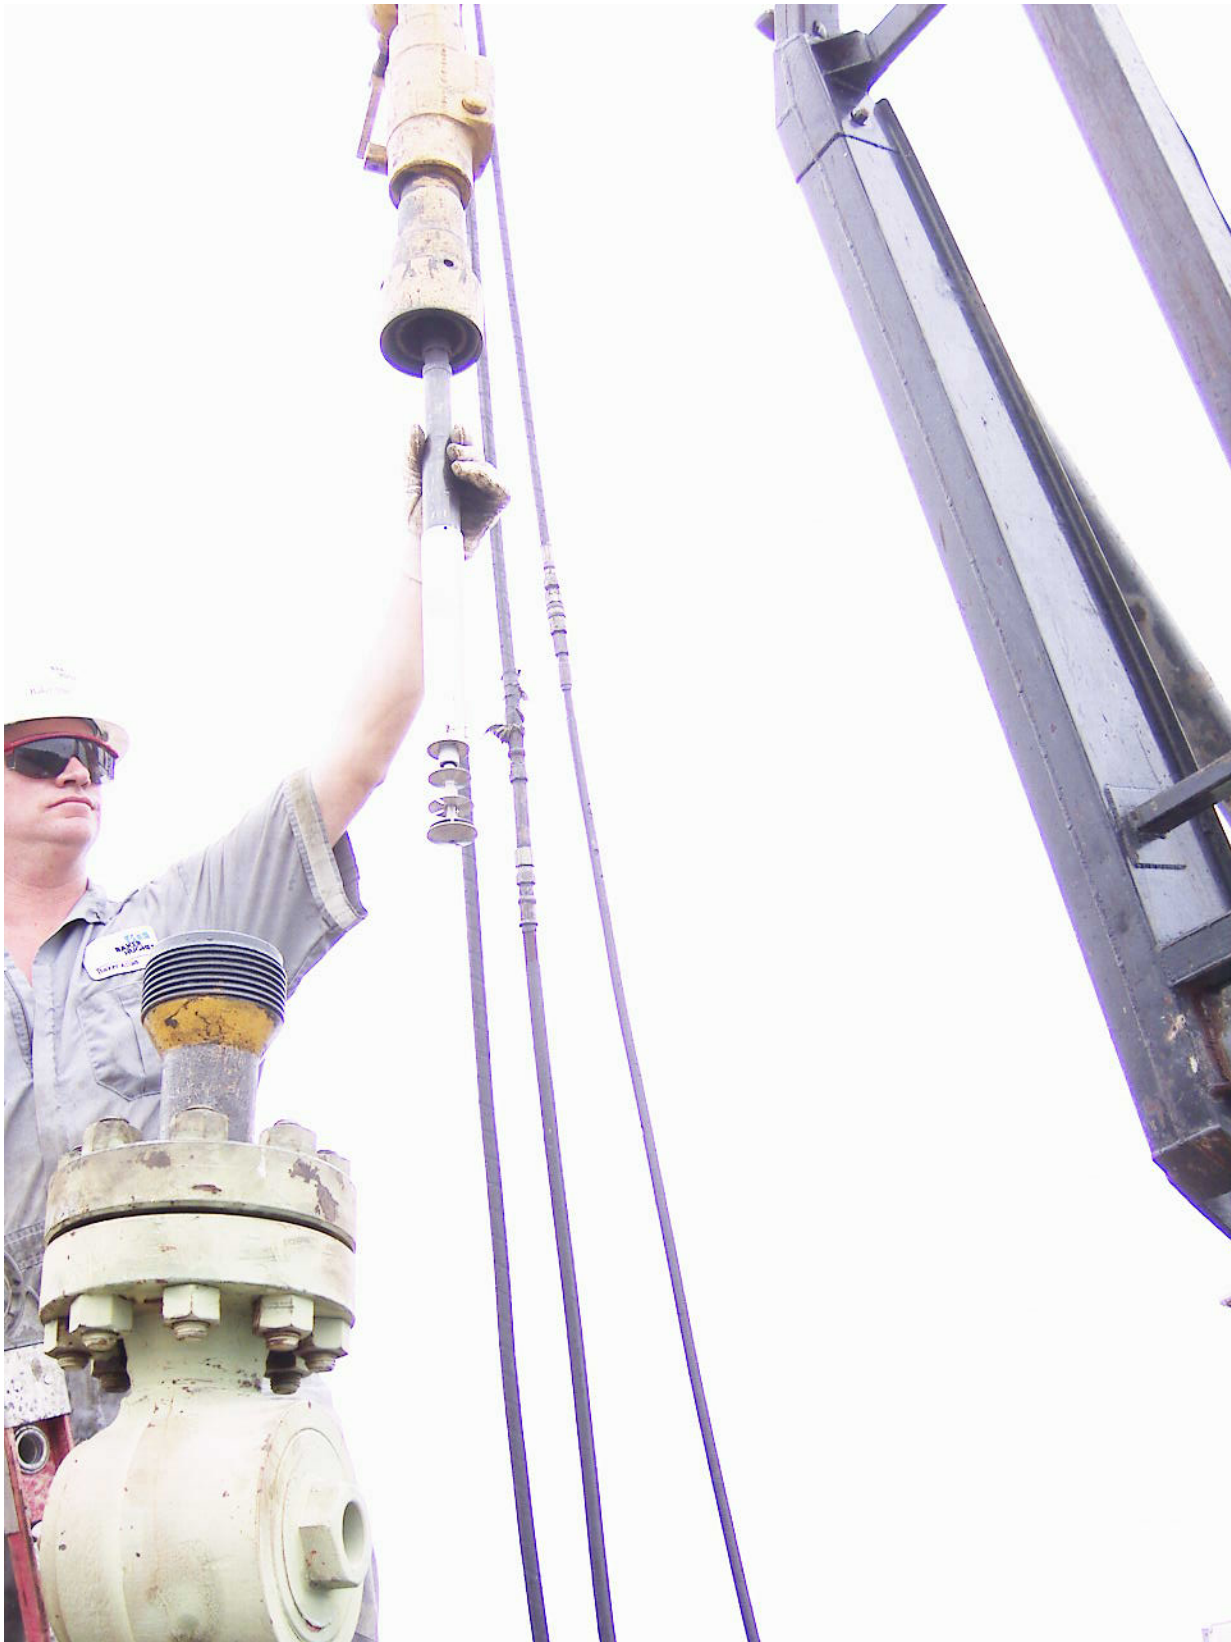
**Figure 11:** Insertion of acoustic tool into well

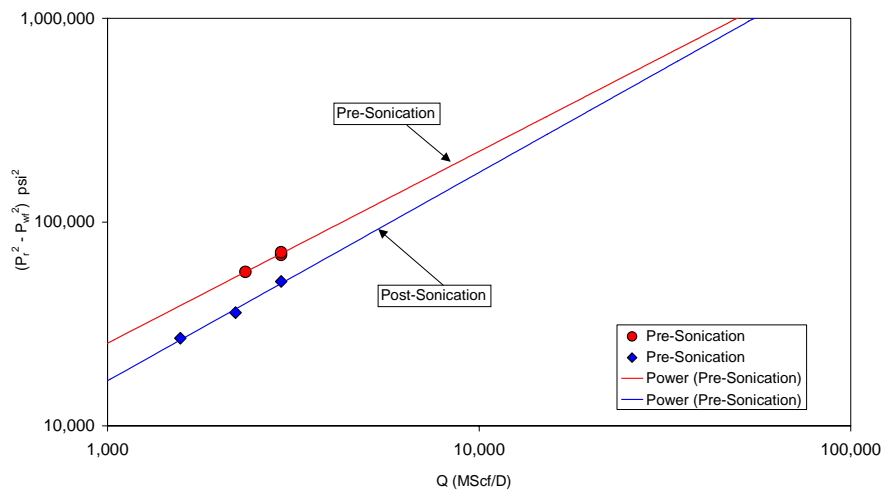
**Figure 14:** L. Wilson #9 backpressure plots for Pre- and Post-sonication

When backpressure data were fitted into the backpressure equation (Table 8), the result of sonication was to increase the intercept coefficient by 77% while decreasing the slope by 2%. Using this backpressure data, the absolute open flow potential (AOF) increased by 28%.

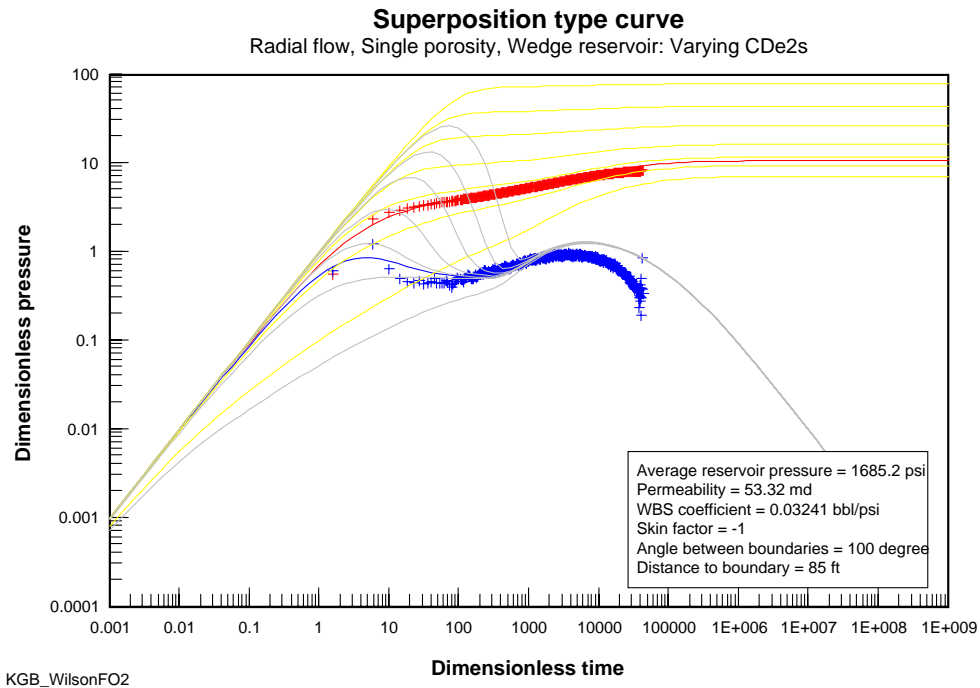
**Figure 15:** Type curve analysis plot of falloff period #2 in L. Wilson #9 Well (Post-Sonication)

Figures 15-17 show the data and model for one of the three pressure transient tests. Nearby offset wells were shut-in during testing of the well, but distant offset injection still occurred. Consequently, there is deviation between the actual and modeled pressures late in the test periods. MRPTT results are plotted in Figure 18 for both pre- and post-sonication testing. Damage coefficients are given in Table 8. The negligible values determined for the non-Darcy damage coefficients in both pre- and post-sonication MRPTT analyses are consistent with the slopes of 0.98 and 1.00 obtained from the BPT analyses.

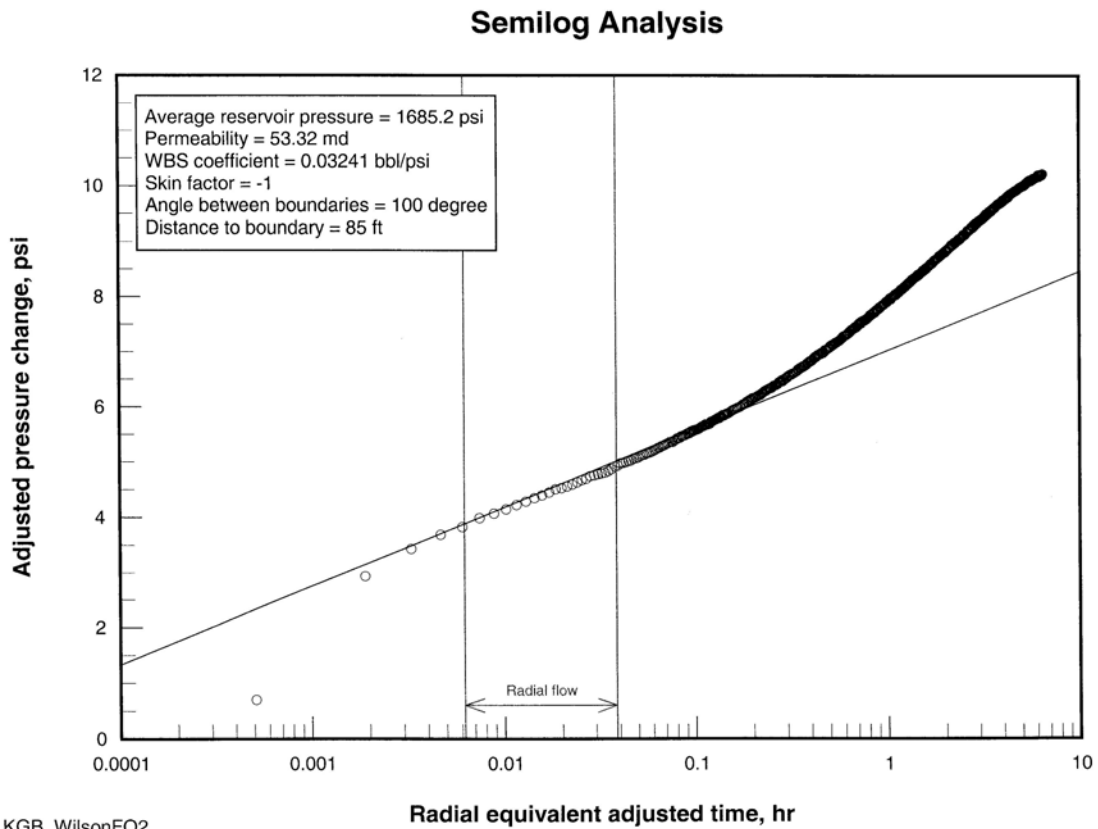
**Figure 16:** Semi-Log PTT analysis (Post-Sonication) for L. Wilson #9

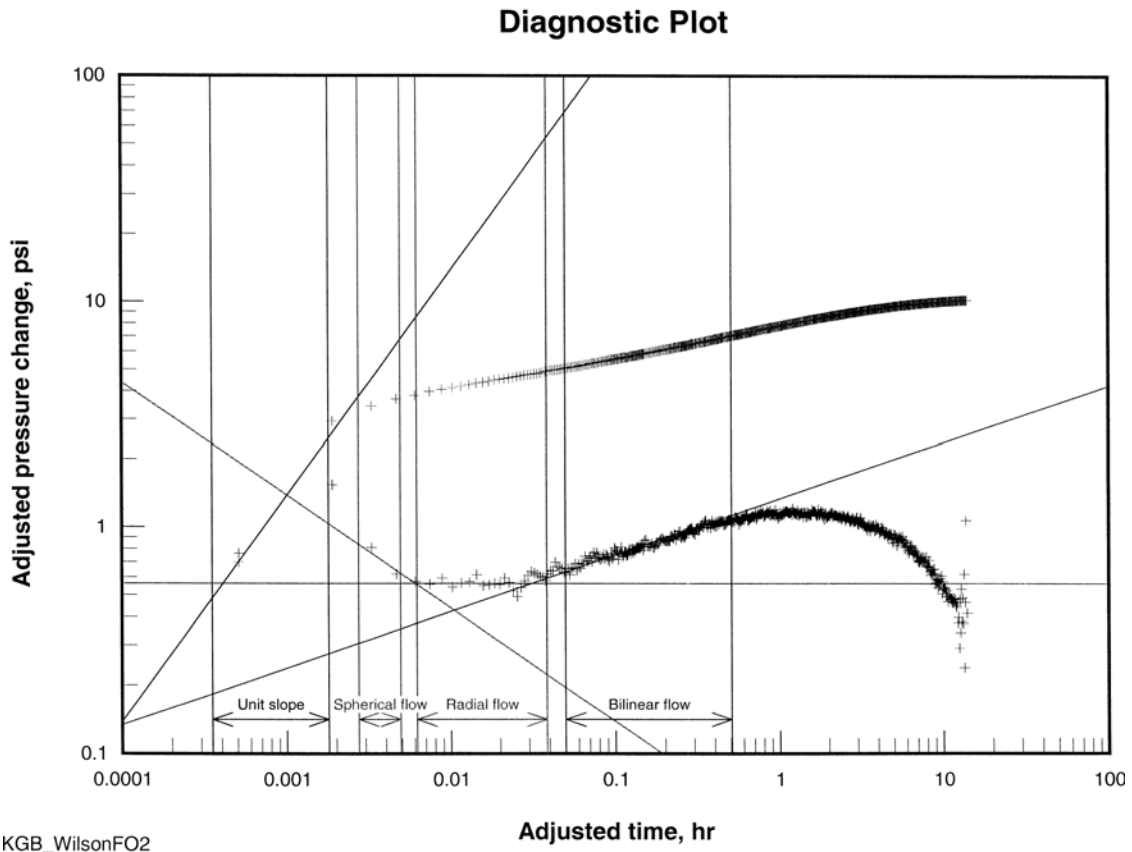
**Figure 17:** Diagnostic plot PTT analysis (Post-Sonication) for L. Wilson #9

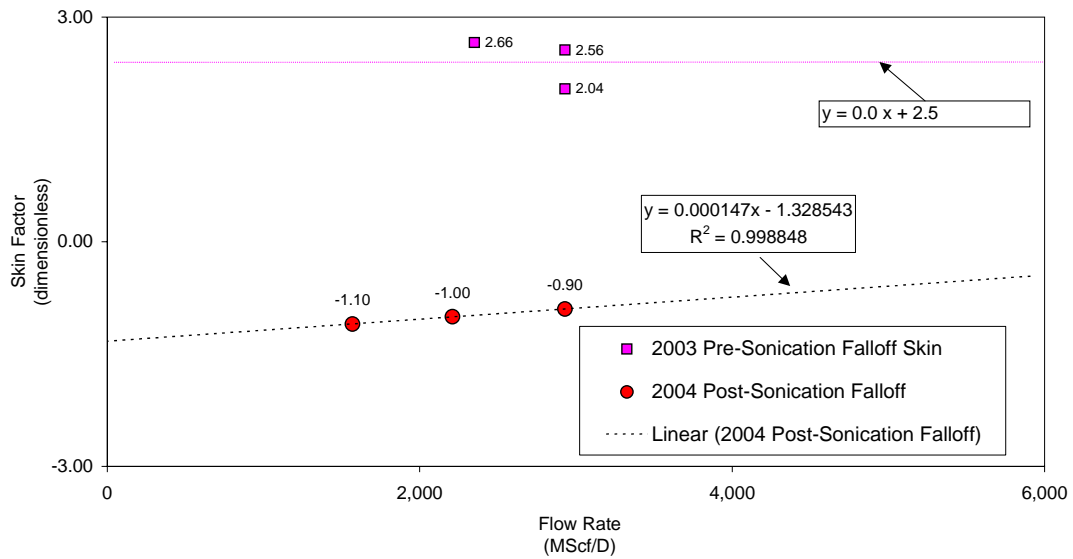
**Figure 18:** Rate vs Total Skin from MRPTT in L. Wilson #9

The MRPTT results also indicate an improvement from sonication in the L. Wilson #9 well. This improvement exhibited itself as a drop in the mechanical skin coefficient from +2.5 to -1.3. Using Schlumberger's model, little or no change occurred in the permeability or non-Darcy damage coefficient as was expected.

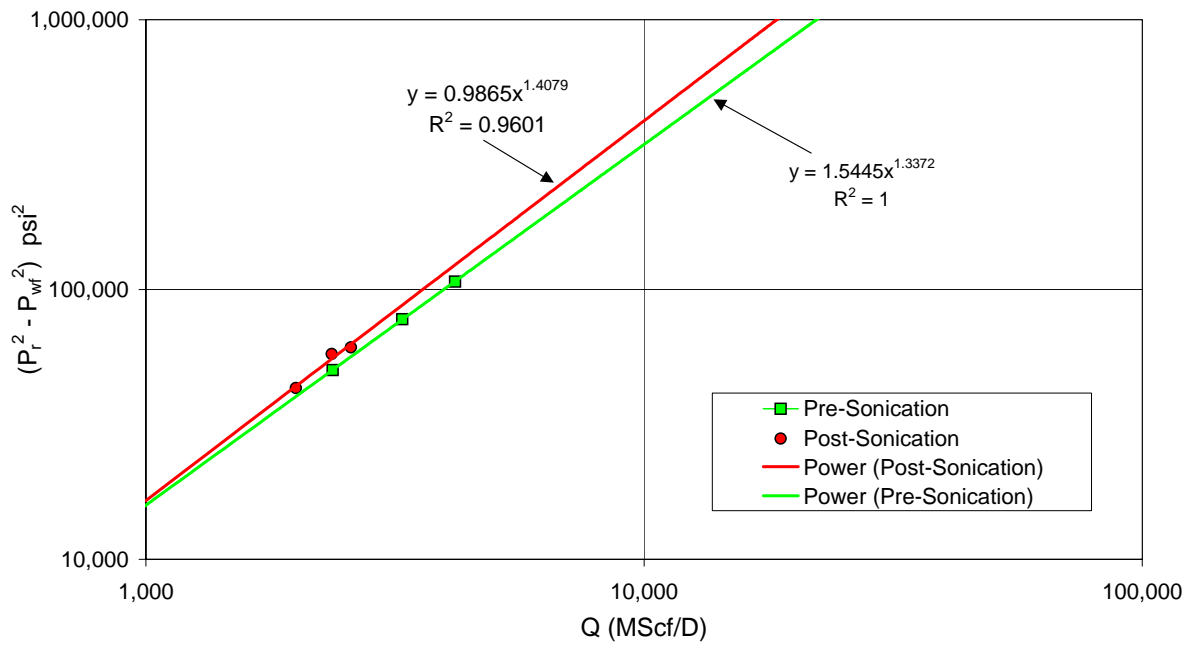
Figure 24: Fienhold #18 Backpressure Plots – Before and After Sonication

Backpressure analyses were performed for all four wells, and the backpressure plots are shown in **Figure 23** through **Figure 26** below. Only the Fienhold #18 well had tests before and after stimulation (i.e., the sonication treatment). Therefore, this is the only plot where before and after curves are plotted and compared. As evidenced from the Fienhold #18 backpressure plot, there is very little difference in performance before and after the treatment. In fact, a slight decline in performance is evidenced after the treatment. However, the well may not be completely cleaned up yet, so the well's performance may improve over time.

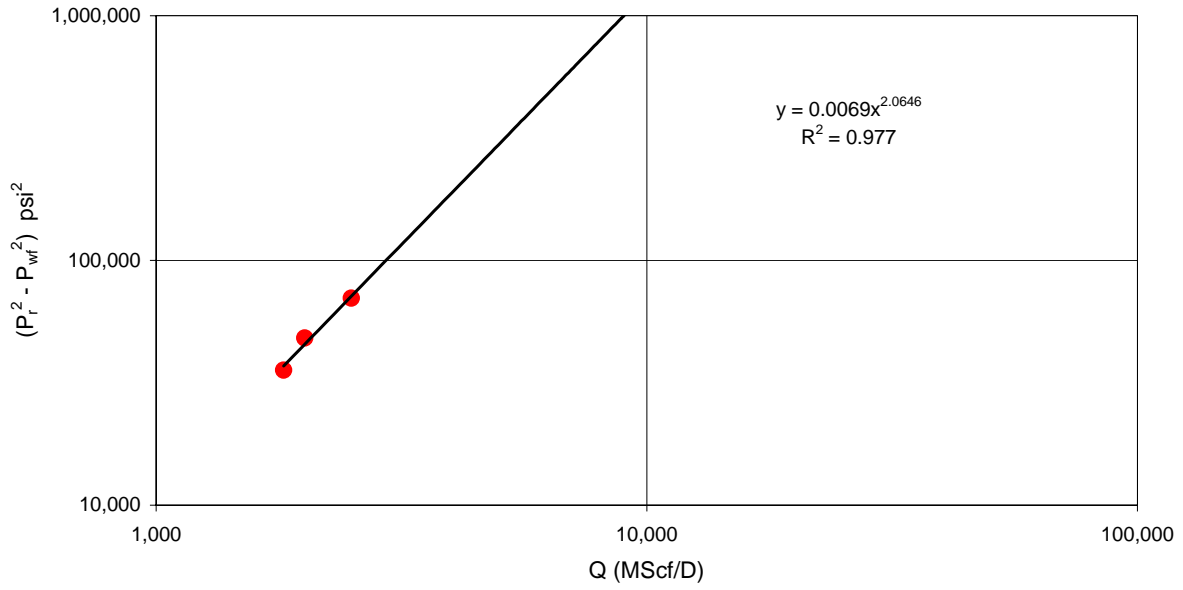
**Figure 25: Grimes #9 Backpressure Plot**

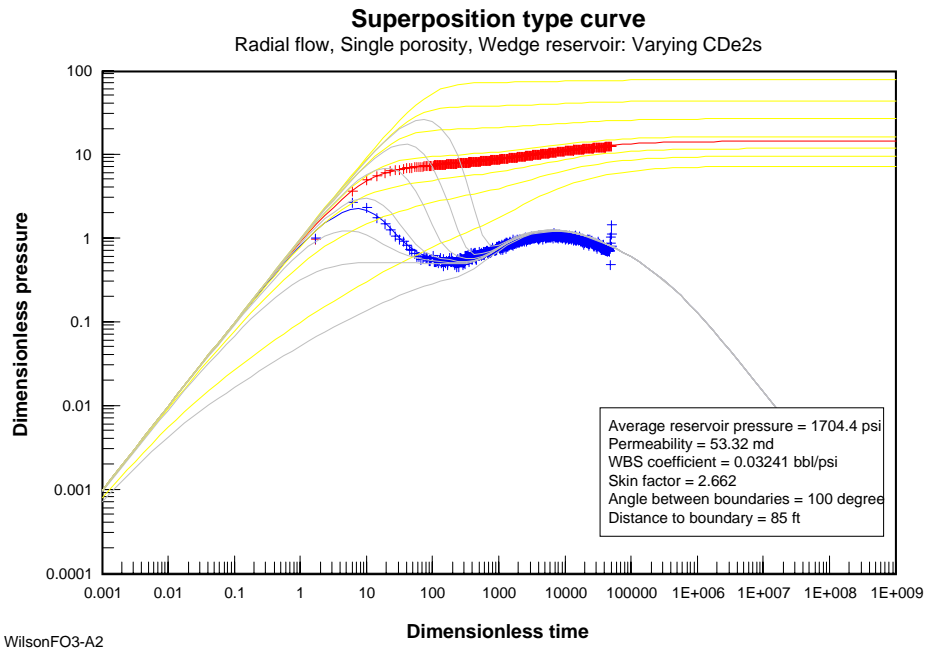
**Figure 30: Type Curve Analysis of Falloff Period #3 From PTTA in L. Wilson #9 Well**

Type curve analysis results of post-stimulation falloff test data are shown in **Figure 27** through **Figure 30**. Analysis results are shown for the third falloff period in each well, and all test periods yielded the same calculated permeability values for a given well. Analysis results from all the test periods are included in Appendix I.

Nearby offset wells were shut-in during testing of individual wells, but distant offset injection still occurred. A constant pressure outer boundary condition was used in type-curve analyses, which approximates this condition. An increasing pressure outer boundary is more representative of reality, but not an available option in WELLTEST™. Consequently, there is some deviation between modeled and actual pressures for some test periods, and indicated boundaries are probably questionable.

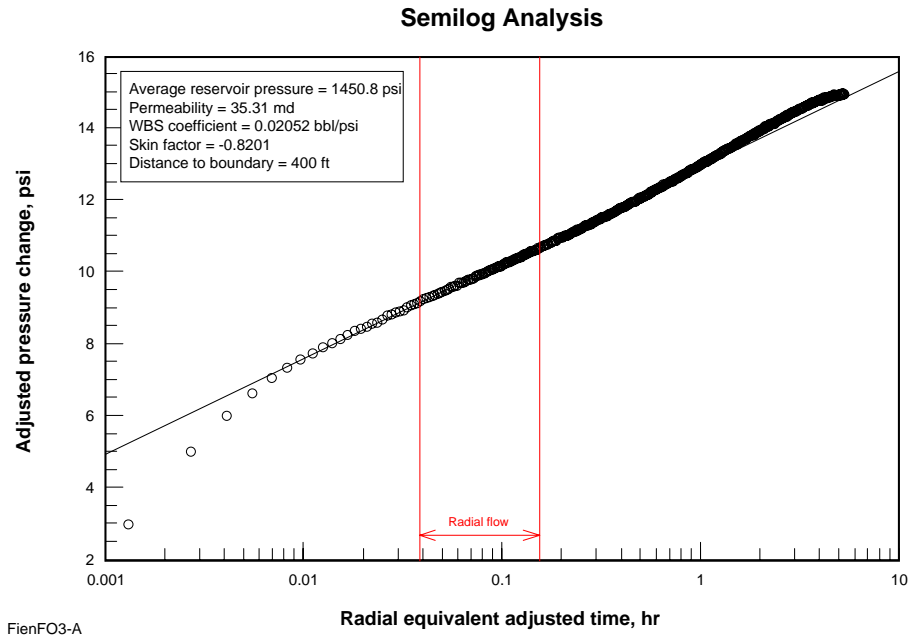
**Figure 32: Semi-Log PTT analysis (post-sonication) - Fienhold #18**

Semi-Log analysis results of post-stimulation falloff test data are shown in **Figure 31** through **Figure 34**. Analysis results are shown for the third falloff period in each well, and all test periods yielded the same calculated permeability values for a given well.

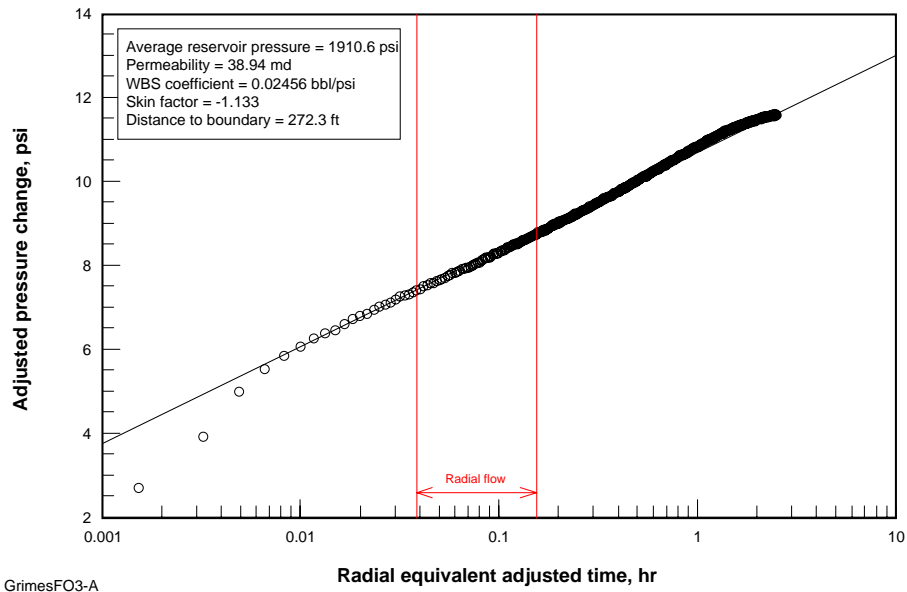
GrimesFO3-A

Figure 33: Semi-Log PTT analysis - Grimes #9

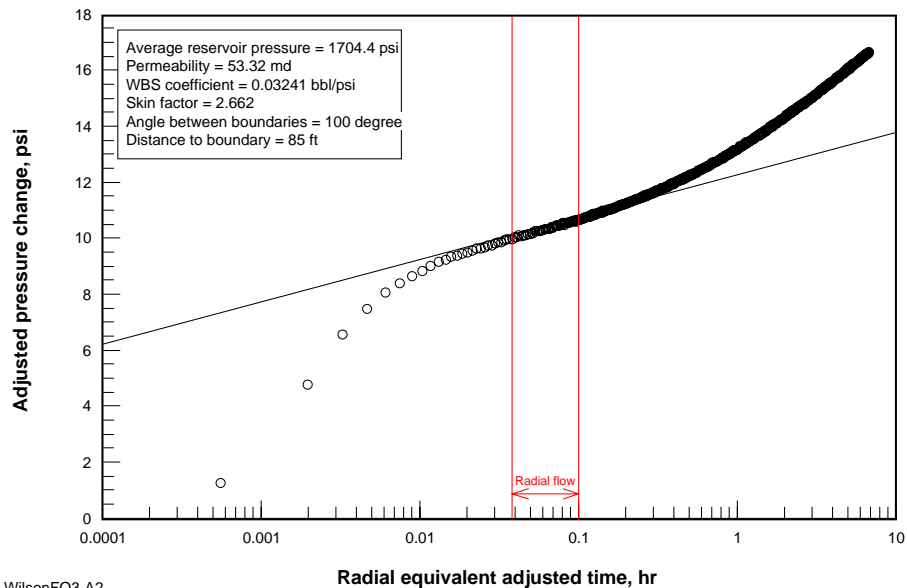
WilsonFO3-A2

Figure 34: Semi-Log PTT analysis - L. Wilson #9

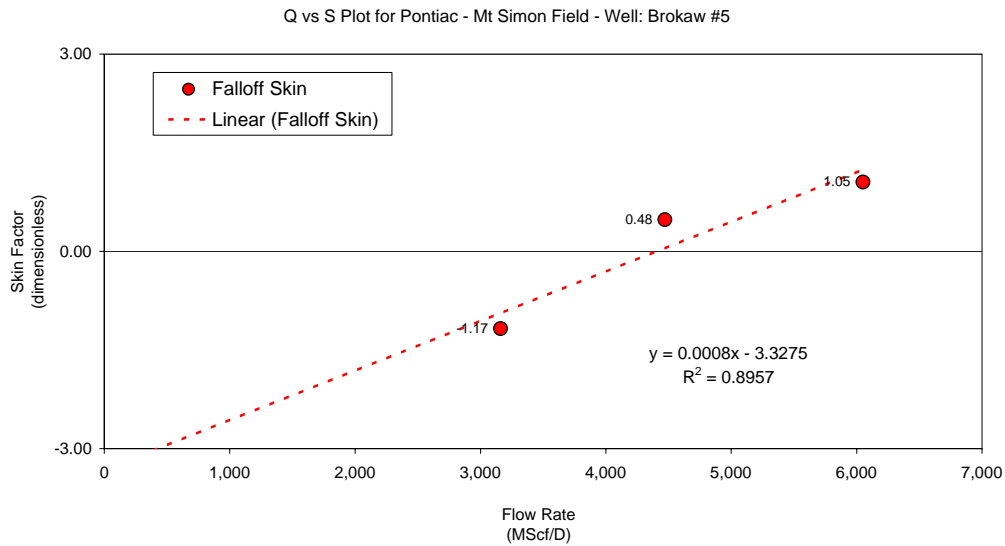
Figure 35: Rate vs Total Skin from MRPTT in Brokaw #5

Figure 35 through Figure 38 show plots of total skin versus flow rate for each test period in the four wells tested. From this analysis, we estimate a mechanical skin value (y-intercept) and non-darcy D-value (slope). The plots are scaled similarly to allow easy comparison. The Fienhold #18 Well is the only one showing both pre-sonication and post-sonication test results, as it was the only well treated.

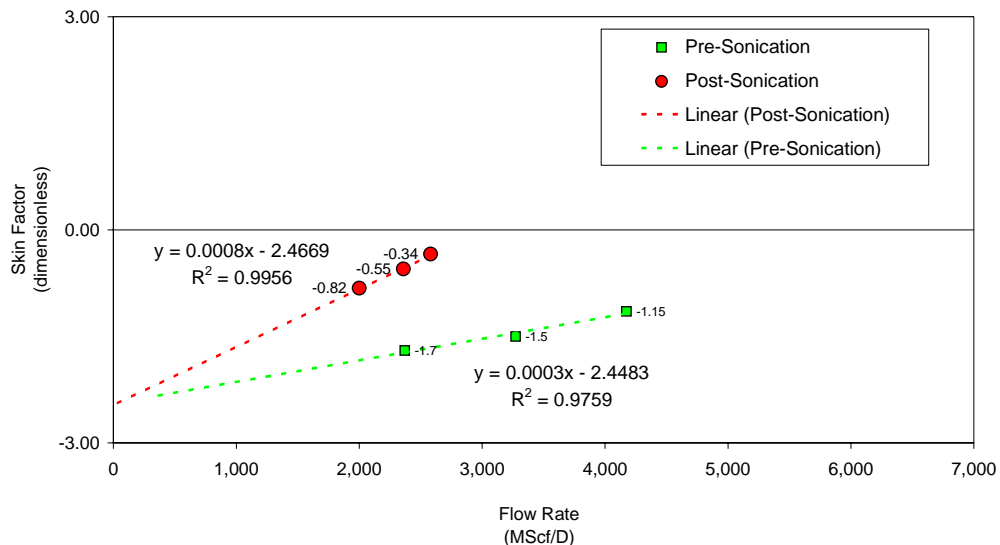
Figure 36: Rate vs Total Skin from MRPTT in Fienhold #18

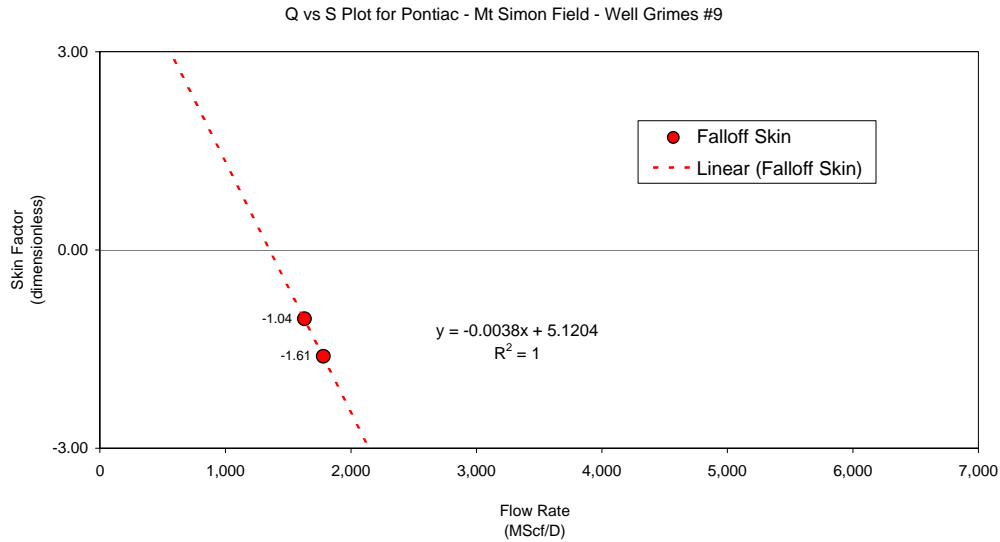
**Figure 37: Rate vs Total Skin from MRPTT in Grimes #9**

It is obvious that the non-darcy damage analysis in the Grimes #9 and L. Wilson #9 wells is contrary to theory (i.e., the slope of the rate versus total skin plot is negative). This is may be a manifestation of the “experimental error” being too large for the small variation in test rates (i.e., the non-darcy damage coefficient in these two wells may be negligible, and the variation of skin with rate could be within experimental error).

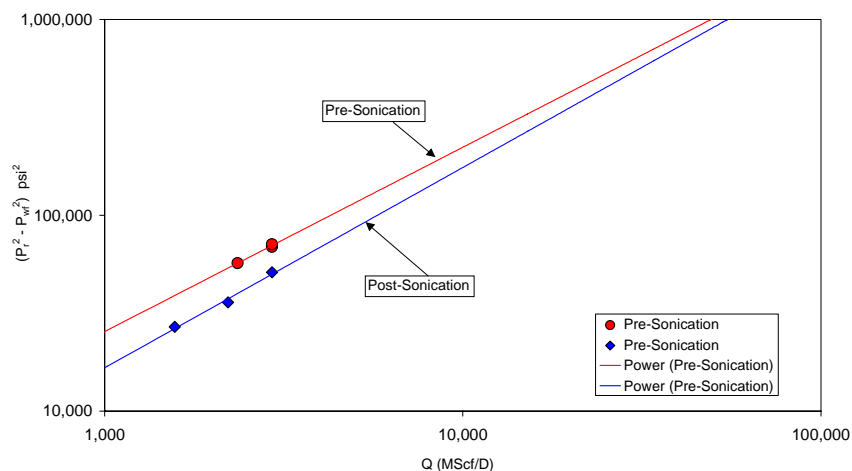
**Figure 42:** L. Wilson #9 backpressure plots for pre- and post-sonication tests

Backpressure plots showing both the pre-sonication and post-sonication tests in Wilson #9 well are shown in Figure 41 below. As evidenced from the L. Wilson #9 backpressure plots, there was some improvement in performance after the sonication treatment.

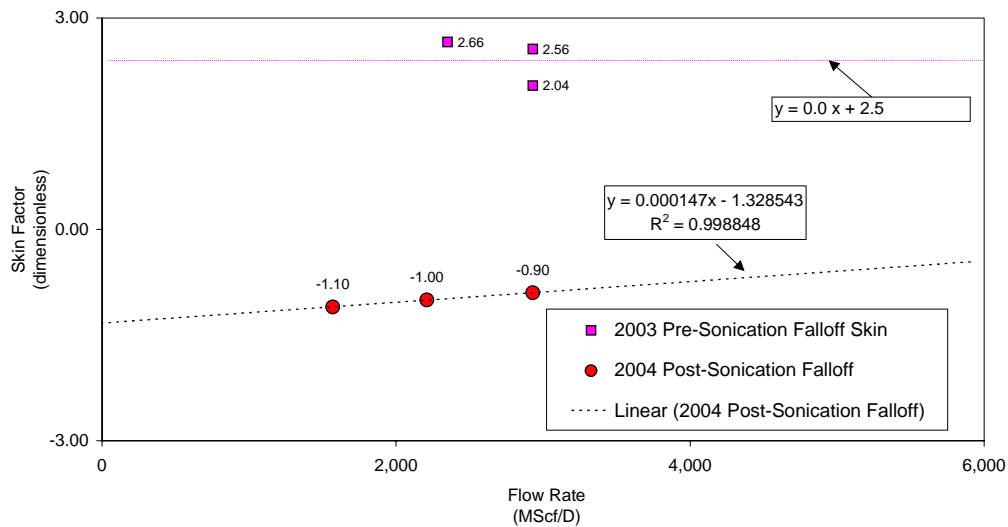
**Figure 46:** Rate vs Total Skin from MRPTT in L Wilson #9

Figure 45 shows a plot of total skin versus flow rate for the pre-sonication and post-sonication tests in the L Wilson #9. From this analysis, we estimate a mechanical skin value (y-intercept) and non-darcy D-value (slope).

Figure 45 suggests that the pre-stimulation non-darcy damage coefficient was negligible. This is consistent with a pre-stimulation  $n$  value of 1.0. Figure 6 also suggests that the post-stimulation non-darcy damage coefficient is small. This is consistent with a post-stimulation  $n$  value of 0.98.
