Evaluation of Sub-Sea Physical Environmental Data for the Beaufort Sea OCS and Incorporation into a Geographic Information System (GIS) Database

By Warren L. Horowitz, Oceanographer, MMS Alaska OCS Region

Locations of past Shallow Hazard Site Surveys and Pipeline Route Surveys for the Beaufort Sea Federal Outer Continental Shelf, Alaska

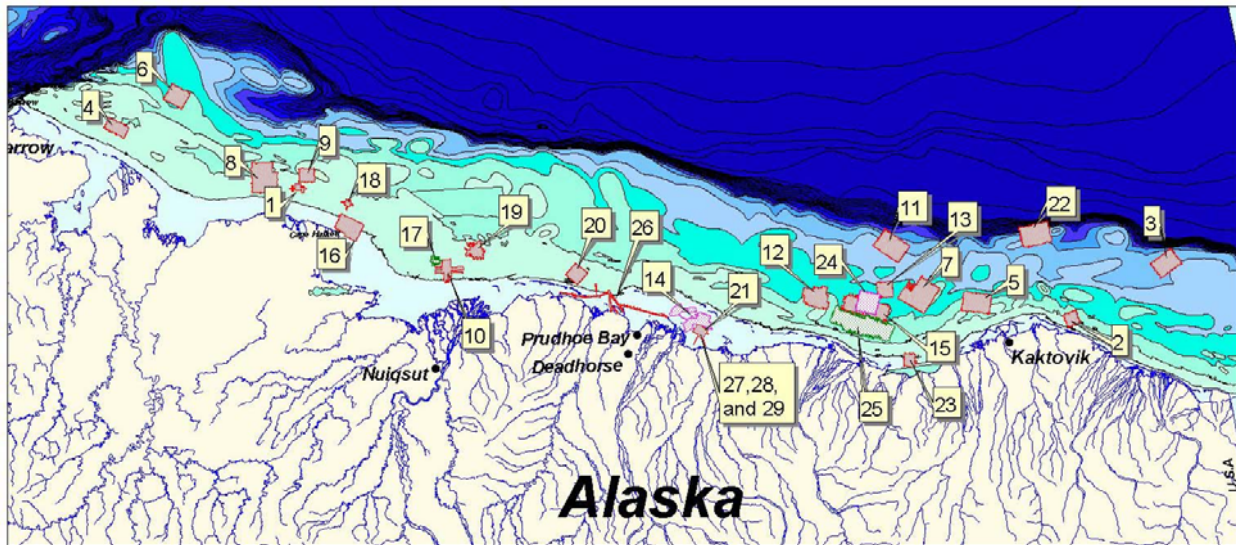
The following section provides the reader with a summary of the data collected for the site-specific and pipeline-route surveys. Almost all of the information in this section is taken from the final reports for each survey. The surveys are listed in alphabetical order by site name; locations are shown on the map below.

Map Site #	Site Name	Map Site #	Site Name
1	Antares	16	Mars
2	Aurora	17	Mukluk Island
3	Belcher	18	Orion
4	Cabot	19	Phoenix
5	Eric	20	Sandpiper Island
6	Canvasback (Gemini)	21	Tem Island
7	Corona	22	Thorgisl
8	Fireweed (ARCO)	23	Warthog
9	Fireweed (Shell)	24	West Maktar
10	Fur Seal	25	Wild Weasel
11	Galahad	26	Northstar Pipeline Route Surveys*
12	Hammerhead (624 & 625)	27	Liberty Boulder Patch Survey
13	Hammerhead (631)	28	Liberty Pipeline Route Surveys *
14	Karluk	29	Liberty Site Survey
15	Kuvlum
