Trigger for Atomic Holocaust Aircraft Detection on the DEW Line

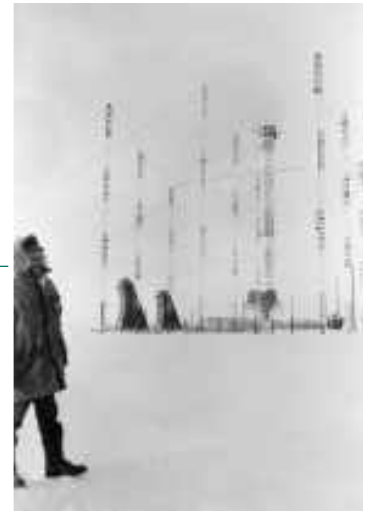
Royal Canadian Air Force officer T.H. Collins stands before a doppler antennae towering over the DEW Line Main Station at the Hall Beach in 1955. Photo courtesy Dept. of National Defence DND-CPU-PCN 1660.

Line with two kinds of electronic detection gear, a powerful gap-filler radar and a doppler radio detection system known as the "McGill Fence," developed under the leadership of McGill University physicist John S. Foster.¹ The fence operated on the DEW Line and the Mid-Canada Line, another link in the air defence system on the 55th parallel.

Transmitting and receiving gear connected to a set of 100-meter radio masts equipped each DEW Line station. Radio transmissions

between stations emitted lobes of electromagnetic radiation reaching from the ground to 30,000 meters. Station recording devices detected passing airplanes when they disturbed the energy field. The system provided intrusion warning, tracked aircraft, supplemented radar sightings, and covered gaps between radar stations. The system was an innovative and inexpensive solution to the need for automatic air traffic notification.

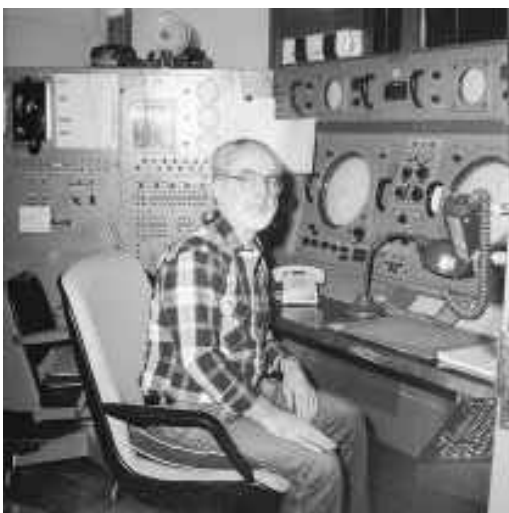
Radar technician Bob Virgin at the console of BAR-1, April 1993. Photo courtesy Johnson collection, Parks Canada.

Besides the passive notification provided by the "McGill Fence," each DEW Line station was equipped with powerful long-range search radar. These units, capable of tracking aircraft to 30,000 meters and almost 500 kilometers away, provided overlapping radar coverage.³ The rotating antenna was sheltered within the protective white hard shelled geodesic radome popularly attributed to Buckminster Fuller. Transmitting and receiving equipment and the consoles were housed in the building train immediately below the antenna tower.

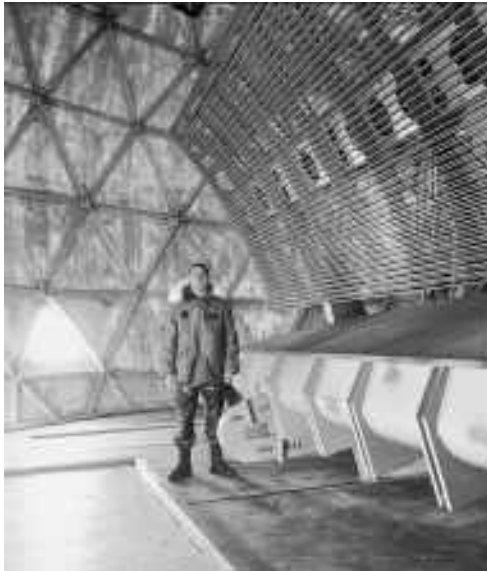
USAF Captain Joseph A. Miller beside the radar array in the geodesic dome, BAR-1, April 1993. Photo courtesy Johnson collection, Parks Canada.

According to Sam Lightman, technicians had two sets of radars, “We had a six-degree radar and a three-degree radar. Inside the big geodesic dome was a huge rotating antenna ... And it had twin beams—one aimed at six degrees and one aimed at three degrees to the horizontal.” The six-degree beam, also called the high beam, was designed to detect high flying airplanes. Lightman reported that in the year and a half

he worked on the DEW Line, the high beam never detected anything. Lightman and his colleagues could talk with high altitude U2 planes, but never saw them. The three-degree radar, or low beam, was more effective. With the three degree beams, technicians could detect everything from commercial jets to police and military aircraft.
