Measurement Description:

A 48 straw mechanical module was assembled with all the same parts and materials planned for a real module.

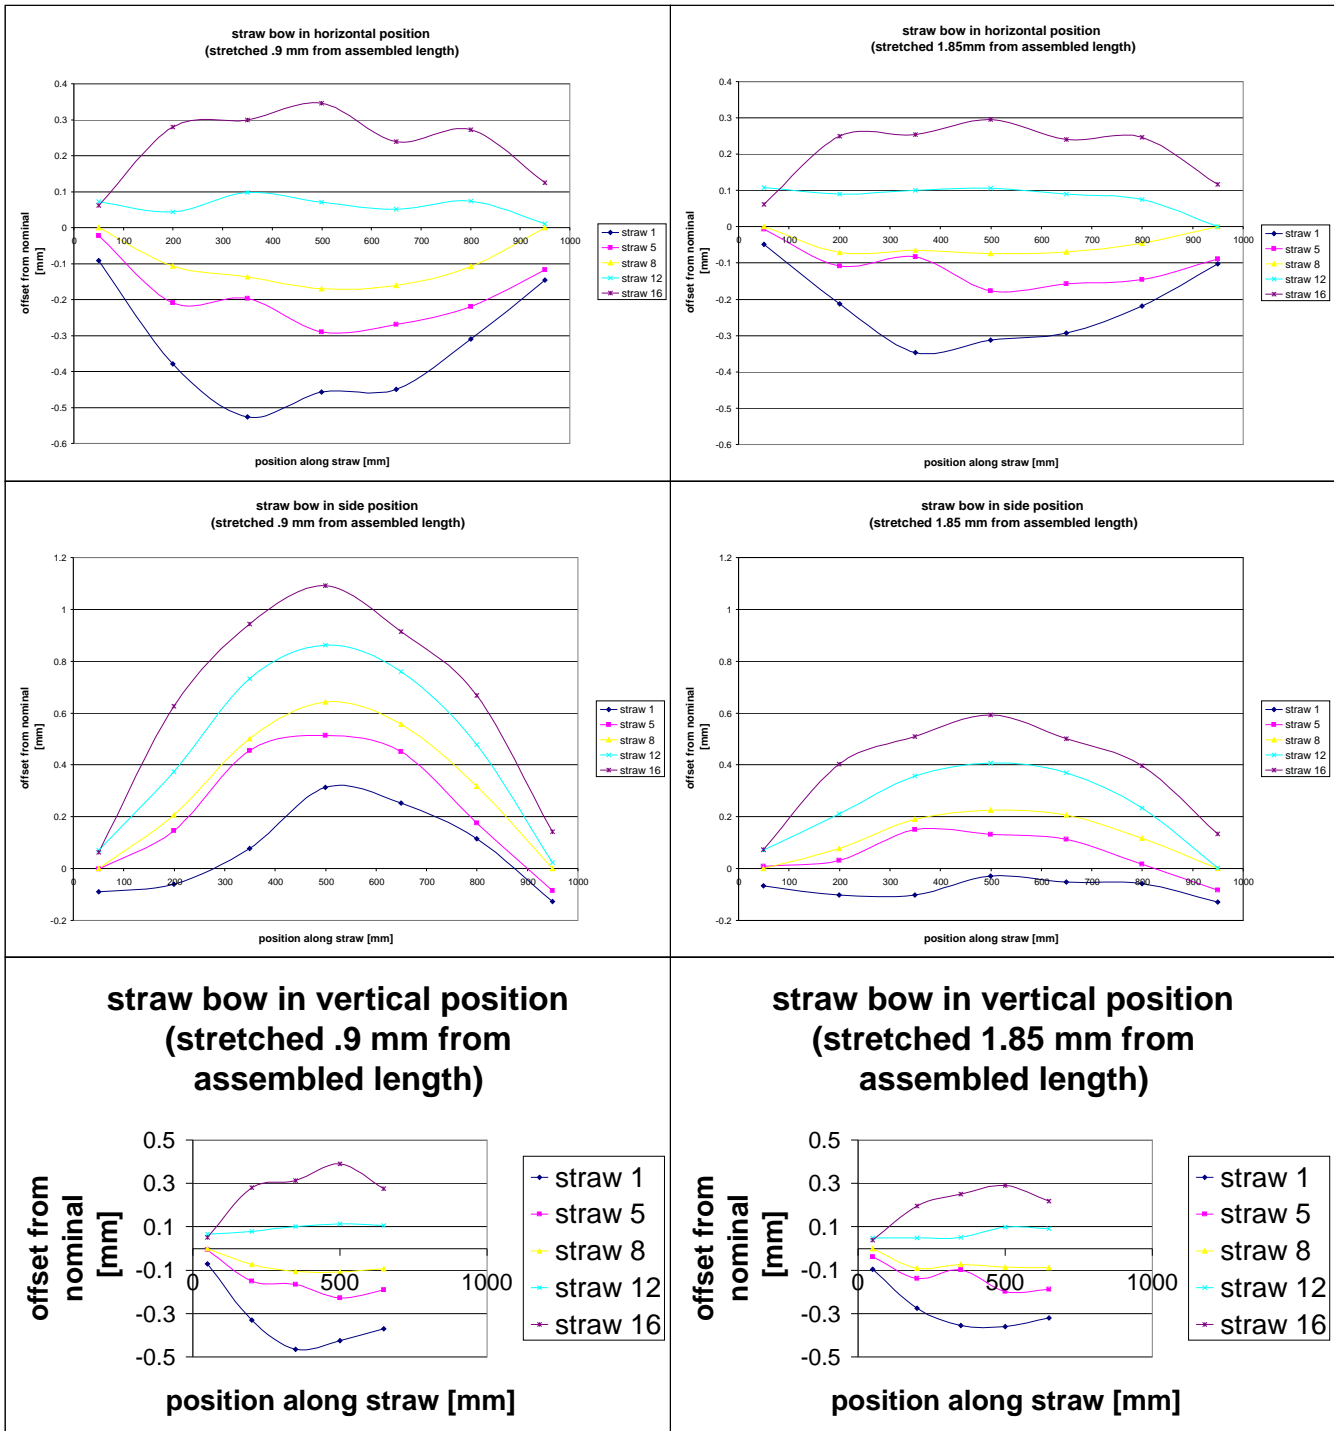
The module was mounted in the prototype frame with one frame end shimmed out by .5 mm. The frame is .4 mm longer than the module thus the module was stretch .9mm from its original length. It is clear from observing the "tufting" of the module sitting on the assembly fixture that straws are not straight in the 0 stretch condition. Thus some portion of the .9 mm stretch is due to straw straightening rather than actual straw elongation.

The edge of 5 straws were measured with a camera on a CMM with the straw plan in 3 orthogonal orientations. The entire straw could not be measured in the vertical position because of the height limit of the CMM. The repeatability of any measurement is +/- .025 mm

After the first three measurements additional shim was inserted to increase the stretch to 1.85 mm. The three measurements were repeated.

The coordinate system for the measurement was established from (2) tooling ball at one end of the frame. The measurement data is plotted after subtracting the nominal spacing of the straws and rotating the coordinate system to align the ends of straw 8 (closest to the center) with the horizontal axis.

Conclusions: The increase in straw tension does not dramatically improve the "tufting" of the straw module. This tufting may be due to form deviations (roundness and straightness) of the straws or end constraints at the module ends or some combination of the two. Further investigation is required including measuring individual straws to establish the form of a typical straw.
