**Mineralogical Study of Borehole MW-206
Asarco Smelter Site
Tacoma, Washington**

October 1, 1998

Prepared by
U.S. Environmental Protection Agency (EPA)
Office of Environmental Assessment
Region 10

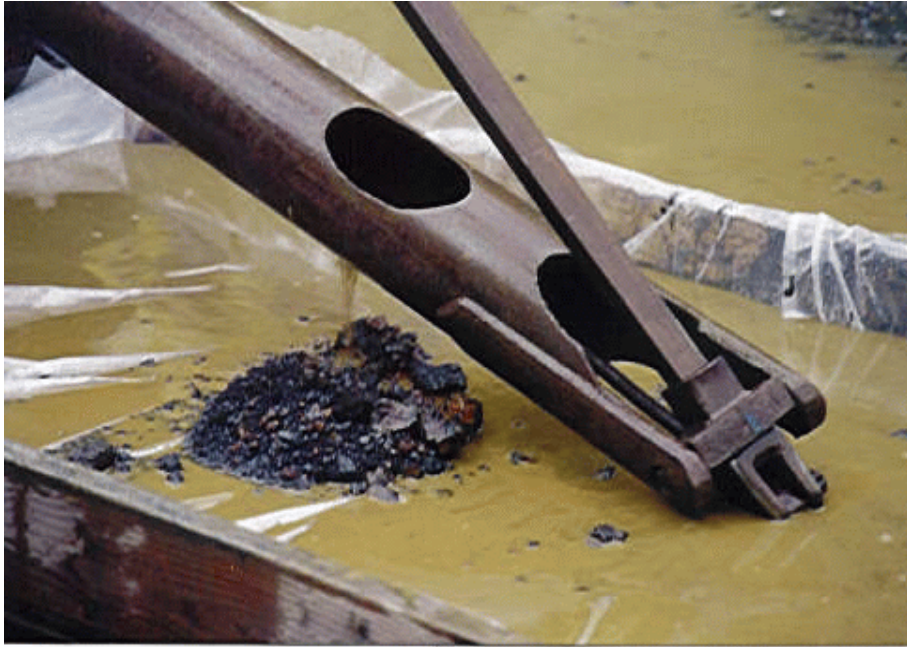
Figure 2. Slag fragments from 11.5 ft bgs removed from borehole MW-206 by the sand pump, November 19, 1997.

The borehole was drilled with a Model 71 Speedstar cable tool rig. Samples were extracted from the hole with a six-inch sand pump (Figure 2), and collected in 1-quart glass jars. The collection procedure included all size fractions from fines to cobbles. Because of the use of a cable tool and large sand pump, several cobble-sized fragments greater than 20 mm across were obtained. Samples MW-206-1 through MW-206-5 were collected at five-foot intervals within the slag fill from 5 to 25 ft below the ground surface (bgs) (Table 1). Sample MW-206-6 was collected from the underlying marine sand and gravel at 27 ft bgs. These six samples are representative of the full size range of material available from the sand pump. Grab samples of cobble-size slag fragments with observable mineral coatings were also collected at five intermediate depths between 12 and 19 ft (Figure 3), placed in a sample jar in individual bags marked for each depth and labeled as a composite sample. After obtaining the last sample at 27 ft bgs, custody of all samples was transferred from Hydrometrics to EPA on November 20 and transported to the Manchester Laboratory.

The most visually prominent secondary mineralization is reddish brown to brown coatings on slag surfaces in samples from below the water table (see Figures 2-3). The microprobe report notes that the coatings are either somewhat common or common in samples from 12-27 ft bgs, and absent or not observed in shallower samples at 5 and 10 ft (Table 3). The microprobe report describes the coatings as an iron hydroxide or iron silicon hydroxide. The XRD report identifies the predominant phase in the coatings on samples between 12-20 ft as ferrihydrite. Figure 7 shows corresponding microprobe and XRD data for coatings on slag fragments from sample MW 206-7. The scanning electron microscope BSE image is of a polished section that shows a spongy, fine-grained coating (Si and As bearing FeHOX , Figure 7) covering the larger-grained silicate slag matrix (fayalite). The XRD pattern of coating material scraped off the slag fragments shows a poorly crystallized variety of ferrihydrite termed two-line ferrihydrite for two broad diffraction peaks.

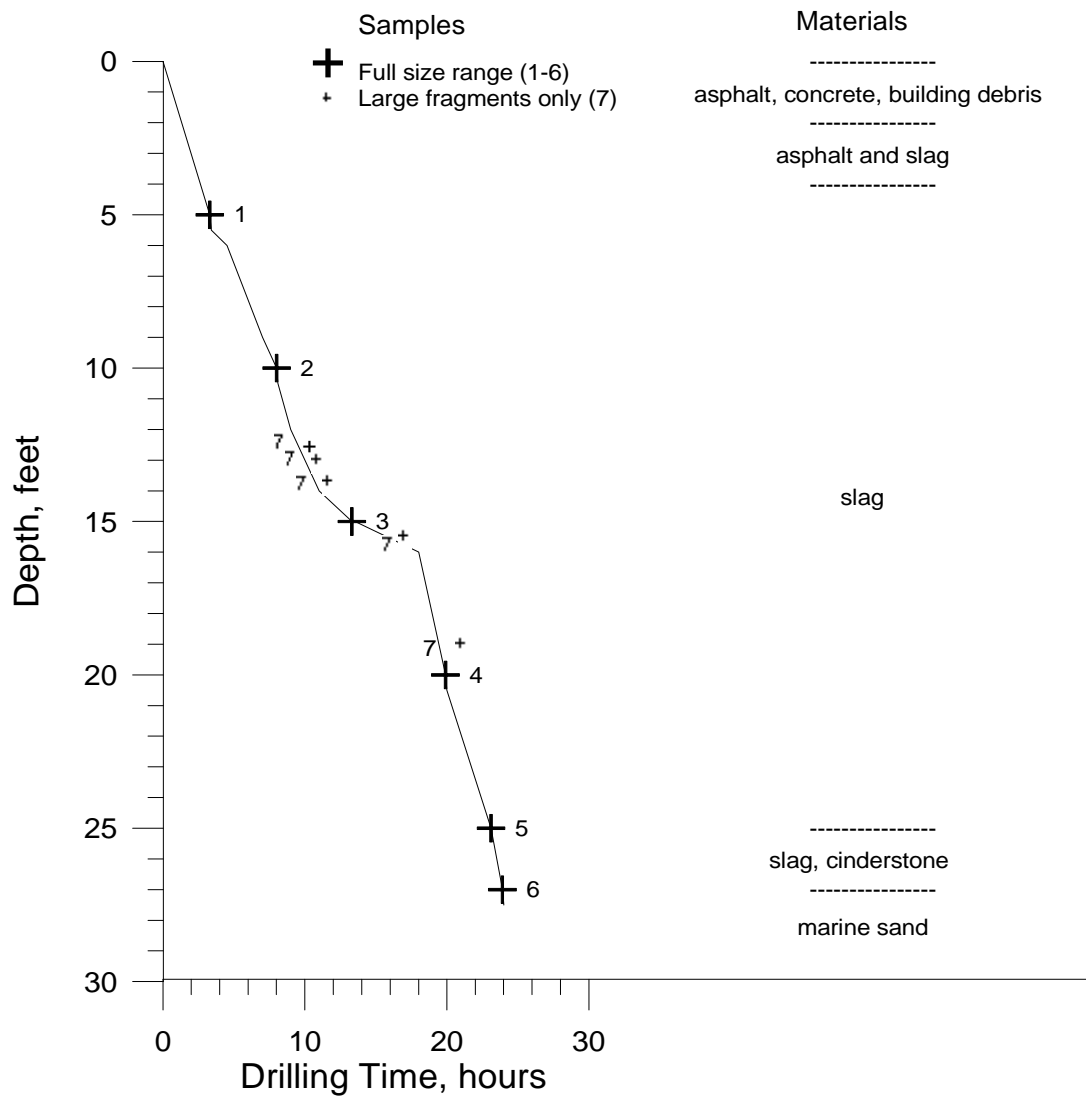
Figure 4. Distribution of samples with respect to depth and materials. The variation in drilling time indicates a massive section of slag occurs at a depth of 14-17 feet. Data are taken from the borehole log prepared by Hydrometrics, Inc.

voids. Figure 4 provides a diagram of sample location relative to depth and lithologic materials. The drilling time shown in Figure 4, as estimated from sample times and field notes, indicates variations in induration of the slag unit with higher rates occurring in less massive sections having greater void space.

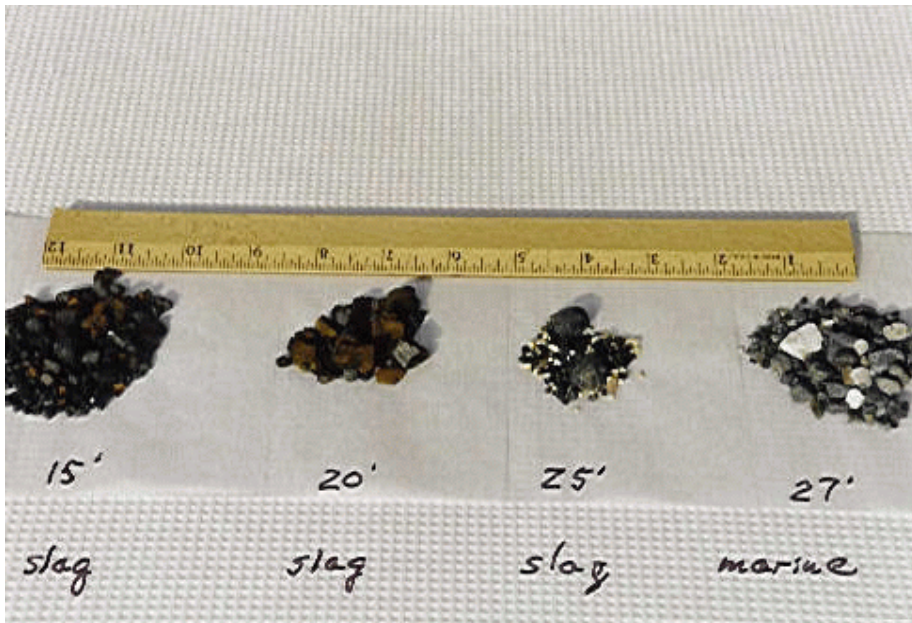
Figure 6. Coarse size fractions (2-20 mm) of four borehole samples from MW-206 from the depths noted. See text for discussion.

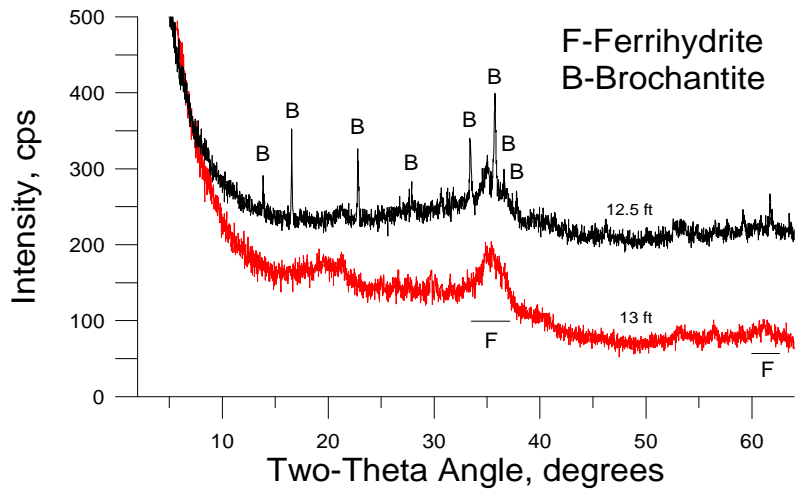
Figure 7. Scanning electron microscope BSE image and corresponding x-ray diffractograms of coatings on fayalite slag fragments from sample MW-206-7. Texture and EDS spectra of similar coatings indicate a composition of siliceous arsenic-bearing iron hydroxides; WDS analysis #979 shows 40% iron and 6820 mg/kg arsenic in the coating. XRD analysis of similar coatings show them to be predominantly 2-line ferrihydrite. Other minerals showing up in XRD patterns of coatings include small peaks for goethite and underlying silicates. The upper pattern shows major peaks for brochantite, which is observable under the microscope as emerald green crystals embedded in coating material on slag from 12.5 feet bgs. BSE image by Cannon Microprobe.

($\text{Cu}_4\text{SO}_4(\text{OH})_6$), identified by XRD in a ferrihydrite coating from 12.5 ft bgs (Figure 7), and a variety of arsenates dominated by symplectite ($\text{Fe}_3(\text{AsO}_4)_2 \cdot 8\text{H}_2\text{O}$) in a coating at 25 ft bgs. Other similar arsenates identified by XRD in the coating at 25 ft bgs include parasymplectite ($\text{Fe}_3(\text{AsO}_4)_2 \cdot 8\text{H}_2\text{O}$) and metakottigite [$(\text{Fe,Zn})_3(\text{AsO}_4)_2 \cdot 8(\text{H}_2\text{O,OH})$]. Corresponding microprobe data that is consistent with these minerals include copper iron sulfates in coatings at 12-19 ft and several metal arsenates occurring both in coatings and as pore fillings at 25 ft (Table 3). Figure 8 shows corresponding microprobe and XRD data for symplectite. The BSE image in Figure 8 is of a grain mount showing coarse-grained, radiating plates of symplectite crystals emerging from a coating on a slag fragment. The XRD pattern of coating scraped off a split of the same slag fragment shows prominent diffraction peaks for well crystallized symplectite and metakottigite.

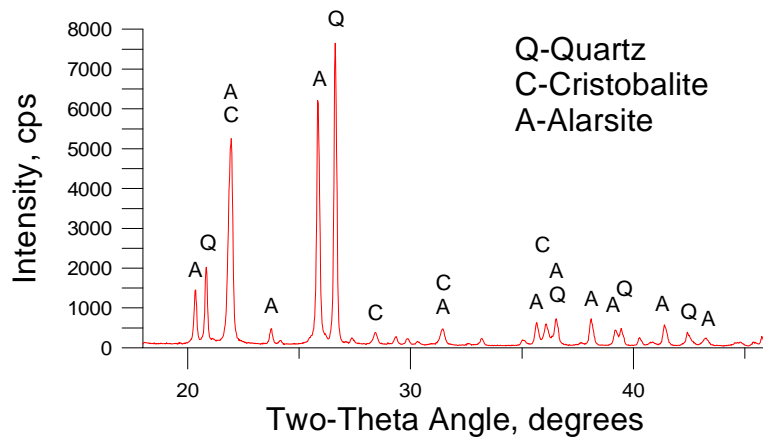
Figure 9. Scanning electron microscope BSE image and corresponding x-ray diffractogram of a fragment of silica sinter from splits of sample MW-206-5 (25 ft bgs). BSE image shows fine-grained alarsite filling the pore spaces between larger silica grains. Main peaks in XRD pattern are for quartz (SiO_2), cristobalite (also SiO_2), and alarsite (AlAsO_4). BSE image by Cannon Microprobe.

The most abundant arsenic-bearing mineral found at 25-ft bgs (MW-206-5) in borehole MW-206 is alarsite (AlAsO_4) and occurs as pore fillings in the silica sinter. The alarsite was identified both by XRD and microprobe. Although alarsite is probably a smelter waste product, it is discussed here with secondary minerals because of its mode of occurrence as a pore filling, similar to other secondary minerals. Alarsite is the mineral name for aluminum arsenate, more commonly known as an experimental laboratory compound. The natural mineral is found as a high temperature vapor-phase precipitate near volcanic fumaroles (Semenova and others, 1996). Alarsite would not be expected to be a primary phase in either slag or sinter. The similarity of the silica sinter to oven material suggests that the alarsite formed as a secondary vapor-phase precipitate in oven brick. The same phase is also found in the silt fraction of MW-206-5. Figure 9 shows corresponding microprobe and XRD data for alarsite. The BSE image is of a polished section of a sinter fragment embedded in mounting epoxy. Fine-grained alarsite (brighter grains in Figure 9) is scattered in the pore spaces among coarser grained silica. The XRD pattern for silica sinter fragments from a split of the same sample shows prominent diffraction peaks for well crystallized alarsite along with quartz and cristobalite which make up the silica matrix (Figure 9).
