**United States Senate**

**HEALTH, EDUCATION, LABOR AND PENSIONS COMMITTEE**

**Report on the August 6, 2007 Disaster  
At Crandall Canyon Mine**

**March 6, 2008**

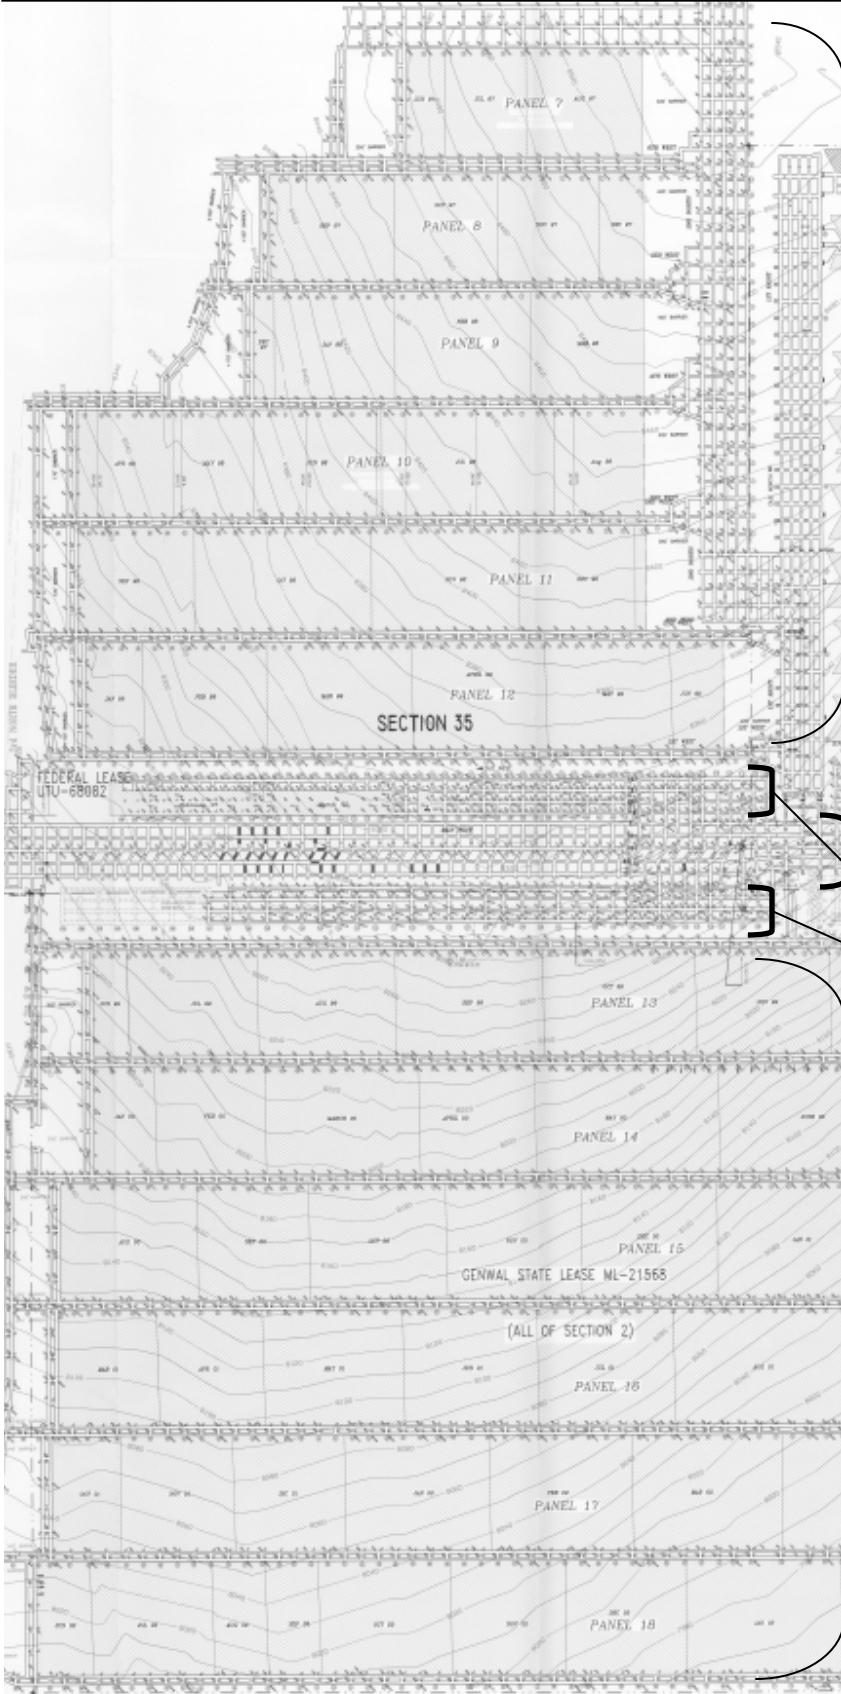
**CRANDALL CANYON MINE, MAIN WEST SECTION (AS OF JULY 2, 2007)**

“Mined out” longwall panels with no remaining coal or roof support. Pressures from these vast empty areas are transferred to barrier pillars

Main tunnels (used for haulage, transport)

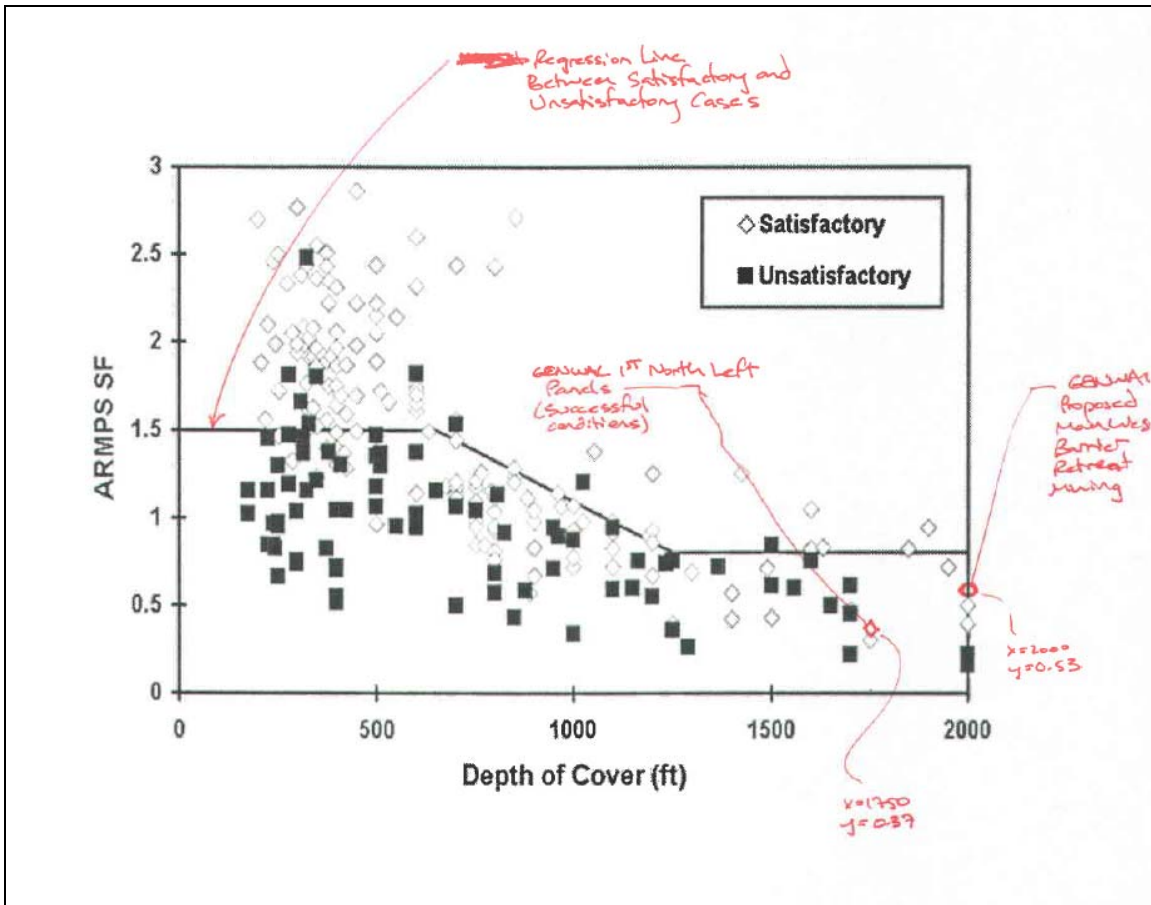
Exhibit 36.

Incredibly, Agapito's own engineers recognized that the stability factors ("ARMPS SF" in the chart below) for the pillars they designed were below safety benchmarks established by the extensive study NIOSH had performed in 1997. In the figure below, an Agapito engineer has written on a chart which appears in a 2002 NIOSH paper on deep cover retreat mining. The line through the middle of the chart demarcates the minimum pillar stability factor below which NIOSH found that pillars had failed, typically due to a bump or bounce (the engineer describes the line as "regression line between satisfactory and unsatisfactory cases"). At the right of the chart, the engineer clearly notes that pillar stability factor of the "proposed Main West barrier retreat mining" is below NIOSH's minimum safety benchmark.

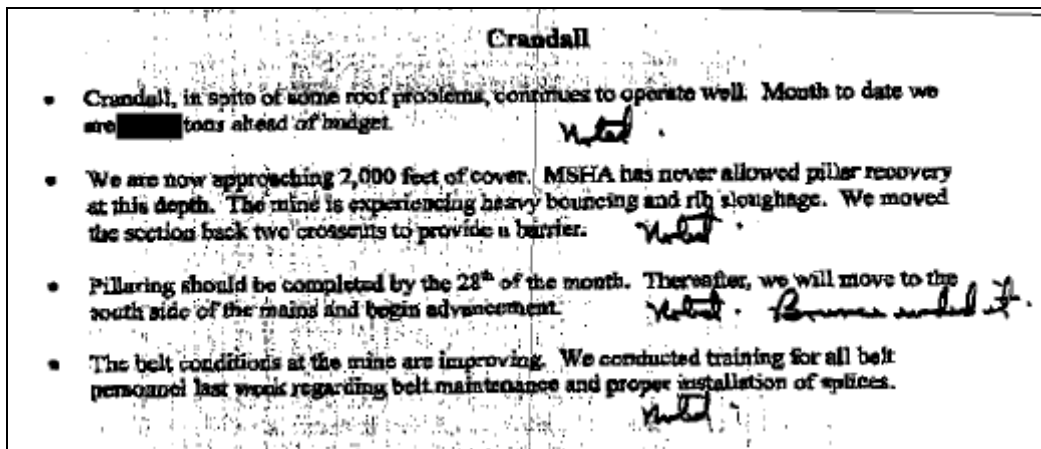
Exhibit 2.

Finally, a March 10, 2007 internal memo conclusively establishes that the company had ample warning of instability in the North barrier pillar and that management, including CEO Robert Murray, was aware of it. The memo to Mr. Murray noted the worsening mining conditions and increased instability in the area, stating that “The mine is experiencing heavy bouncing and rib sloughage.” Beside this description, Mr. Murray wrote “noted. Bounce ended it.”

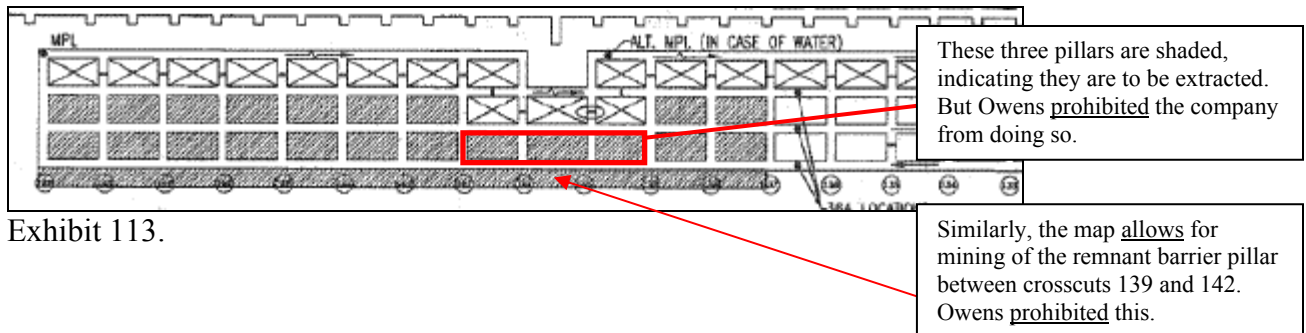
Exhibit 113.

In addition, Owens' required amendment to the roof control plan was not made to the ventilation plan amendment addressing retreat mining in the South barrier. The mine map approved by MSHA's ventilation department on June 1, 2007 had two errors: (1) it showed only five pillars protecting the sump area and (2) it allowed mining of the remnant barrier pillar south of these pillar rows (between cross cuts 139 and 142). The roof control plan that Owens approved required the company to change both of these features – leaving eight pillars in the sump area and prohibiting mining of the remnant barrier pillar in the area.

Internal MSHA documents show that this error was not corrected. Exhibit 114. Specifically, post-accident notes by William Reitze, supervisory mining engineer of the district 9 ventilation branch, state that the ventilation plan for the South Barrier allowed the remnant barrier pillar to be mined while the roof control plan prohibited it:
