HILL FIELD, PUMPHOUSE & WELL #4
(HILL FIELD, BUILDING 717)
(HILL FIELD, BUILDING 129)
(HILL FIELD, BUILDING S-717)
East side of Foulois Road, North of Golf Course Drive
Layton Vicinity
Davis County
Utah

HAER No. UT-85-AA

Hill Field, Pumphouse/Well No. 4
(Hill Field, Building 717)
(Hill Field, Building 129)
(Hill Field, Building S-717)
East side of Foulois Road, north of Golf Course Drive
Layton vicinity
Davis County
Utah

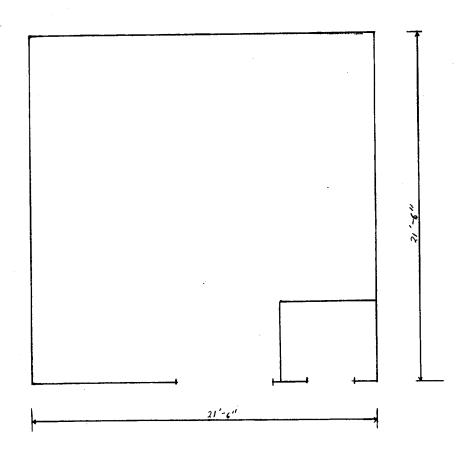
PLD6 - 717	
SCALE #"	= 1'-0"
841-167	BLOG WIR SUP
JOTAL SE.	462
SURVETED	2 AUG 18

Description: Building 717 is a small, square, one-story frame building with a concrete foundation. Its walls taper inward as they rise from the ground to the roof. It is clad in wood, with asphalt shingles covering its low hip roof. The roof itself is punctuated by a large circular metal vent which rises from its center. The west elevation has a central entrance with a metal door. This door is recessed into the wall and is covered with a steel grate for security. Immediately adjacent to this secured entrance is another door that projects from the face of the building. This wooden door is capped with a shallow gable; it leads into a small room that is not accessible from the interior. Both the north and south walls have a single wood double-hung window centered on the elevation and covered with steel grate. A large metal vent protrudes from the point on the roof.
