Plowman Sawmill (Lois Amyx Barn)
N. Bank of Payette River
Montour
Gem County
Idaho

HABS No. ID-47

PLOWMAN SAWMILL
(Lois Amyx Barn)

Statement of Significance: This substantially build structure originally housed a sawmill operation. Later it was converted to a barn.

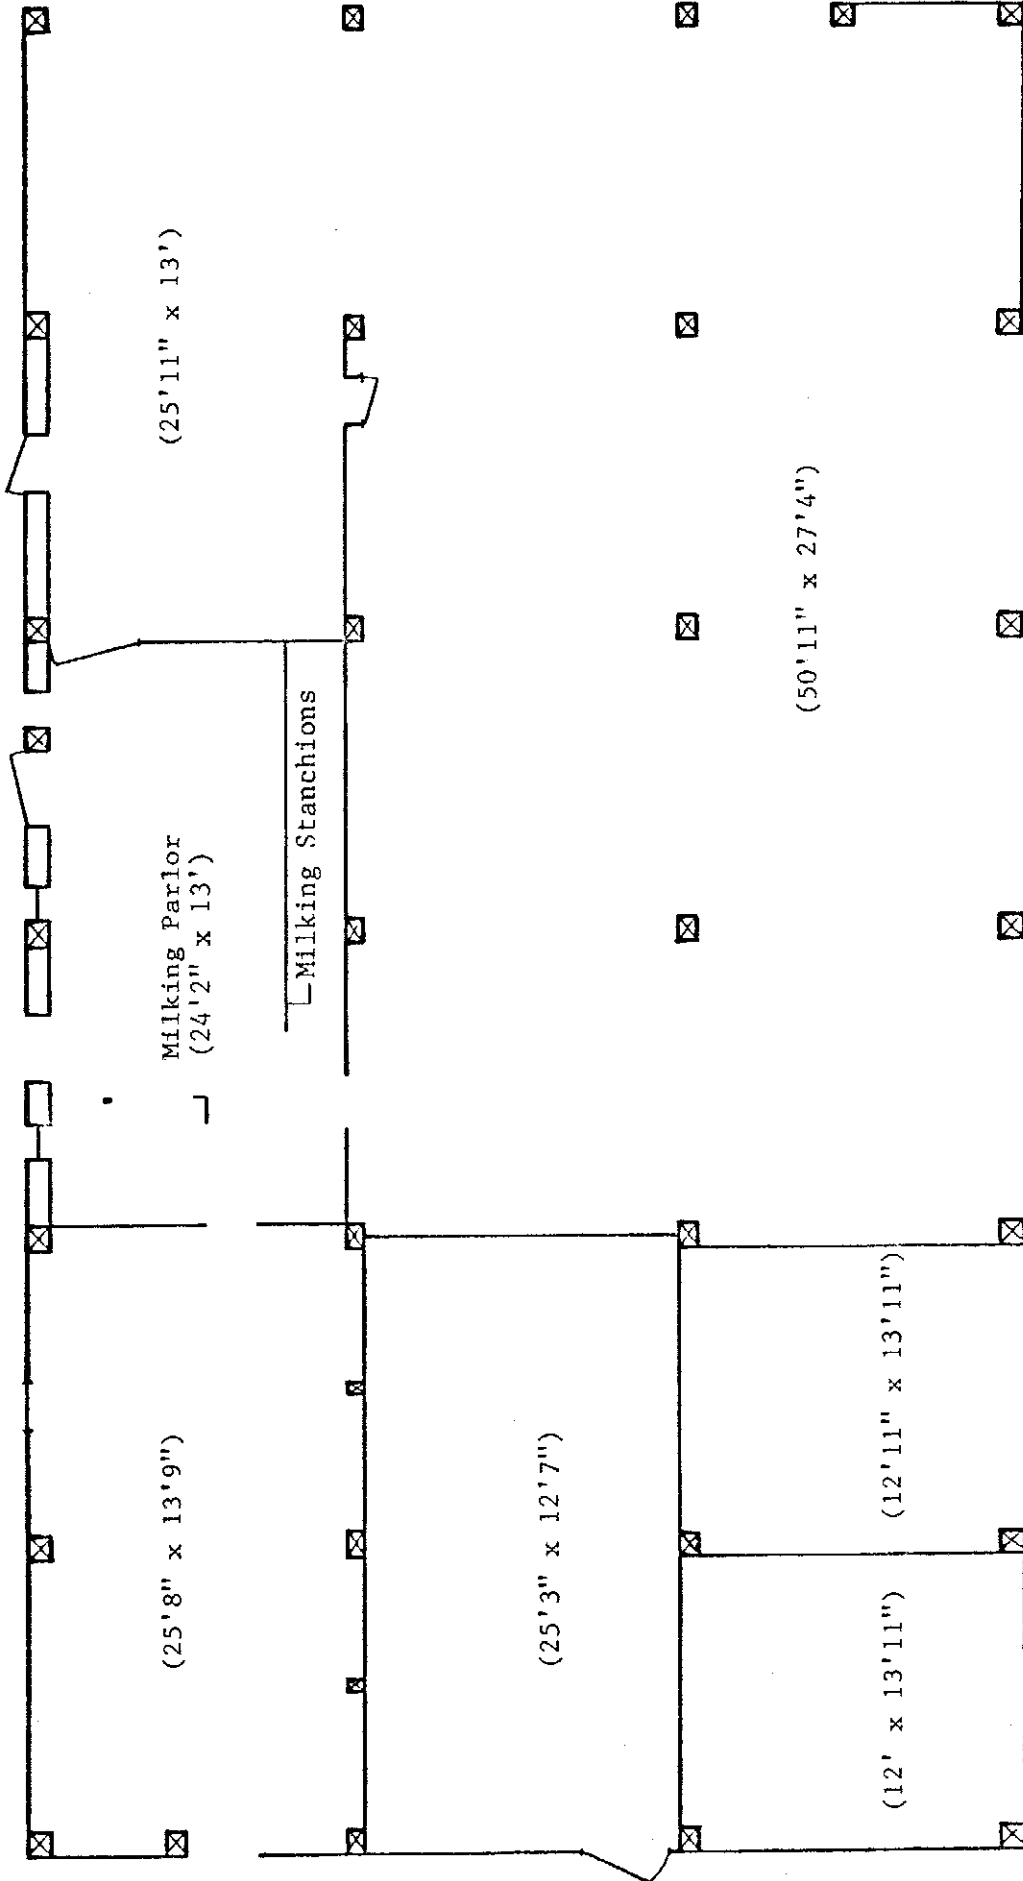
PLOWMAN SAWMILL - First Floor

1. Floor plans: At the lower level, the northwest end of the building is divided into three rooms. Following around the northeast side of the building, next to the room at the north corner there are two more rooms. The

Approx 1/8 Scale (now used as a barn)

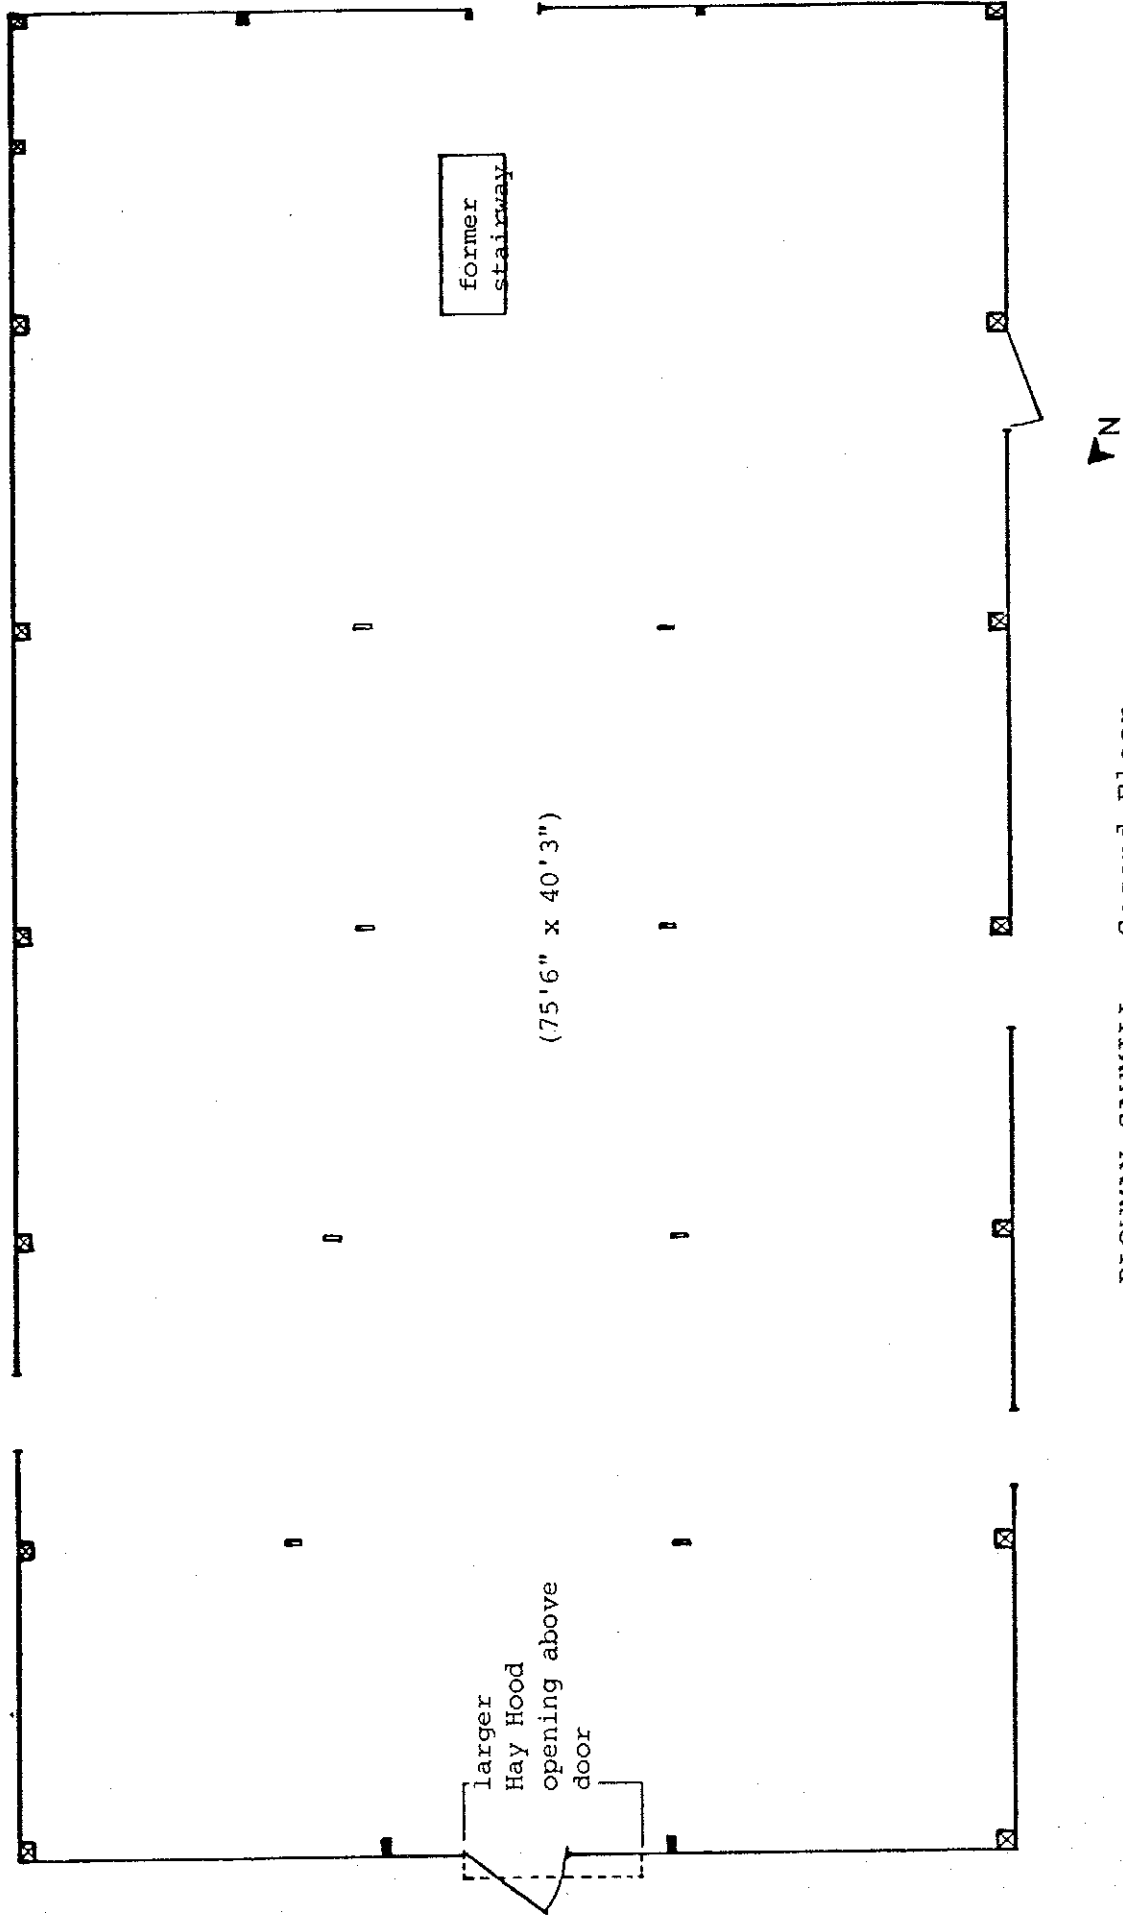
PLOWMAN SAWMILL - Second Floor
approx. 1/8 scale (now used as a barn)

upper level is one large space.

At the upper level the flooring in most of the center bay on the southeast end and the adjoining bay on the northwest is principally vee-grooved matchboards. The rest of the upper-level flooring appears to be of the same material as the exterior siding and in some places is in poor condition.
