ORNL-3500
UC-25 - Metals, Ceramics, and Materials
TID-4500 (23rd ed.)

FABRICATION OF THE HEAT EXCHANGER
TUBE BUNDLE FOR THE MOLTEN-SALT
REACTOR EXPERIMENT

R. G. Donnelly
G. M. Slaughter

OAK RIDGE NATIONAL LABORATORY
Oak Ridge, Tennessee
operated by
UNION CARBIDE CORPORATION
for the
U. S. ATOMIC ENERGY COMMISSION

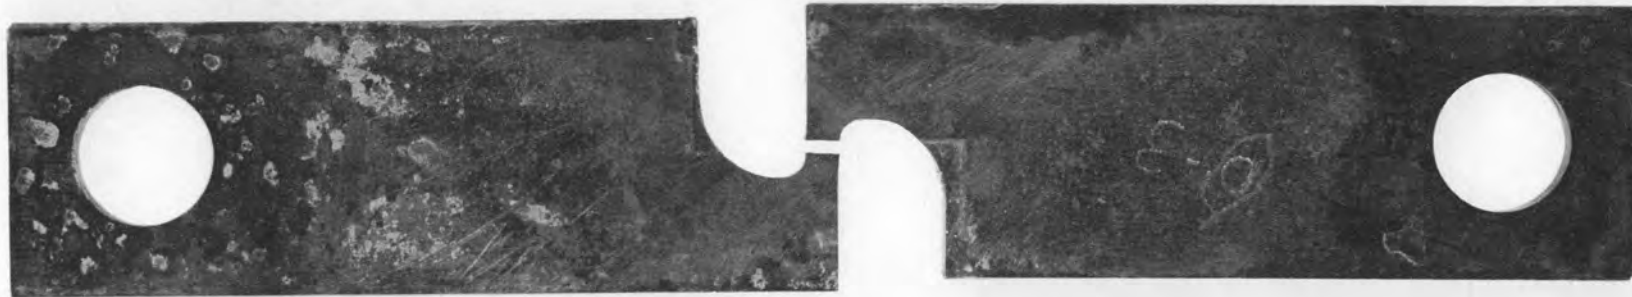
UNCLASSIFIED
Y-44199

Fig. 4. Typical Miller-Peaslee-Type Shear-Test Specimens. Note the clean shear at the brazed joint on the specimen tested at 1300°F and the elongated and rotated joint on the specimen tested at room temperature. In both cases, separation was in the brazed joint.

In order to obtain strength information on this type of joint, Miller-Peaslee-type shear-test specimens,⁸ as shown in Figs. 3 and 4, were furnace brazed and tested at room temperature and at the reactor operating temperature of 1300°F. The results of these tests are listed in Table 3.

Test Temperature	Shear Strength (psi) ^b		
	Min	Max	Av
Room	54,400	67,000	59,000
1300°F	15,300	17,000	16,100

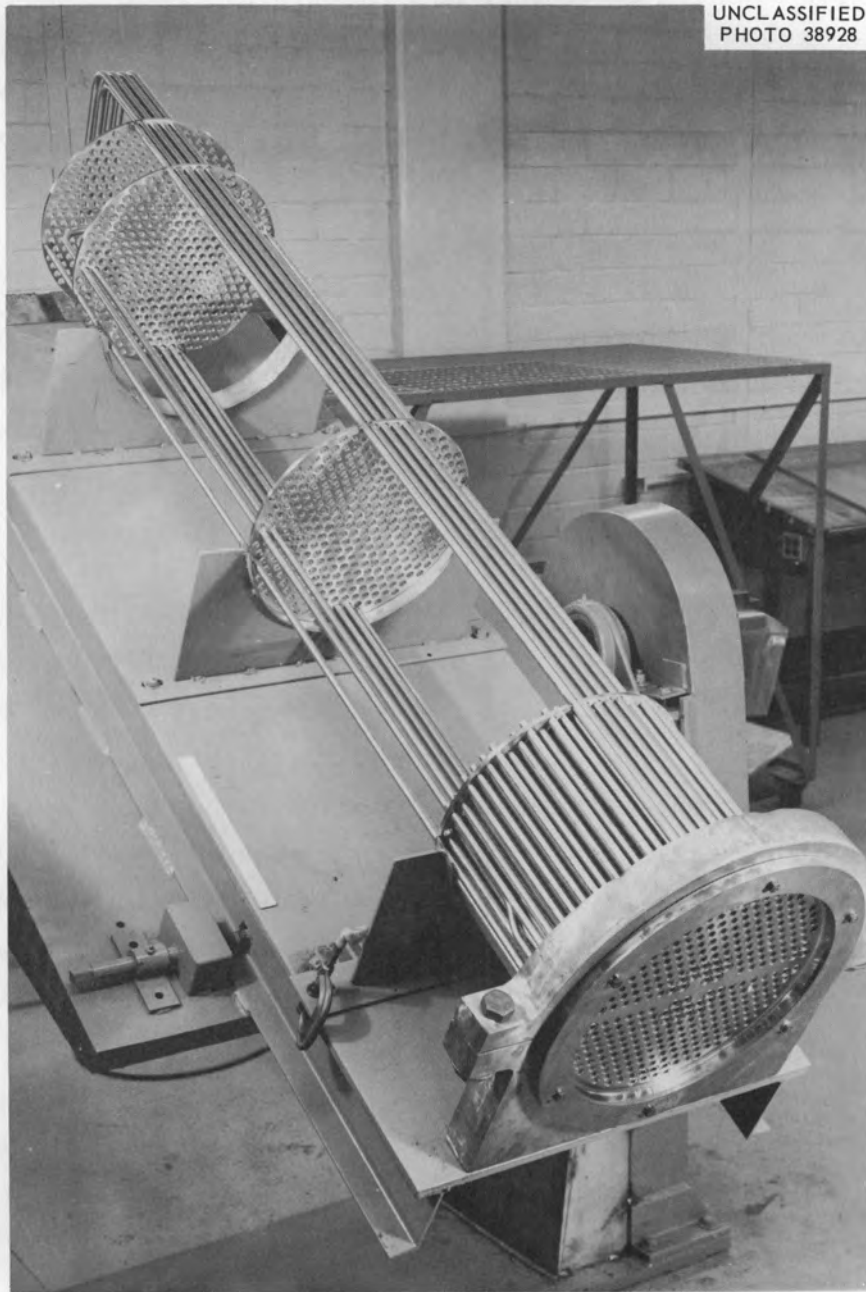
Fig. 8. Completed Sample Heat Exchanger Positioned in Welding-
Inspection Fixture.

It was, of course, essential that the fabrication of the actual heat exchanger core be an unqualified success on the first attempt. Sufficient material in the form of INOR-8 tube sheet forgings and tubes was available for only one heat exchanger core, and replacement would have meant about a one-year delay and a large financial expenditure. In addition, the size of the unit made it necessary to ship the heat exchanger to an outside vendor where it was to be brazed in a newly fabricated retort. With these facts in mind and because of additional uncertainties remaining (such as the effect of large mass variations during brazing, retort integrity, assembly of long U-tubes, etc.), it was decided to build a full-size sample heat exchanger core to gain further assurance of all stages of fabrication. The sample, which is shown completed in Fig. 8, contained nine full-length U-tubes and 54 welded and back-brazed joints. These joints were positioned in the center of the tube sheet and at 3, 6, 9, and 12 o'clock positions around the periphery. All additional tube holes were rough drilled and a full complement of dummy stainless steel tubes was fitted in order to simulate the expected gas and radiant heat baffling effects. For economy, the tube sheet was machined from rolled plate instead of from a forging as in the actual heat exchanger. Aside from these few points,

the sample was machined, assembled, welded, shipped, brazed, and inspected in exactly the manner planned for the actual unit.

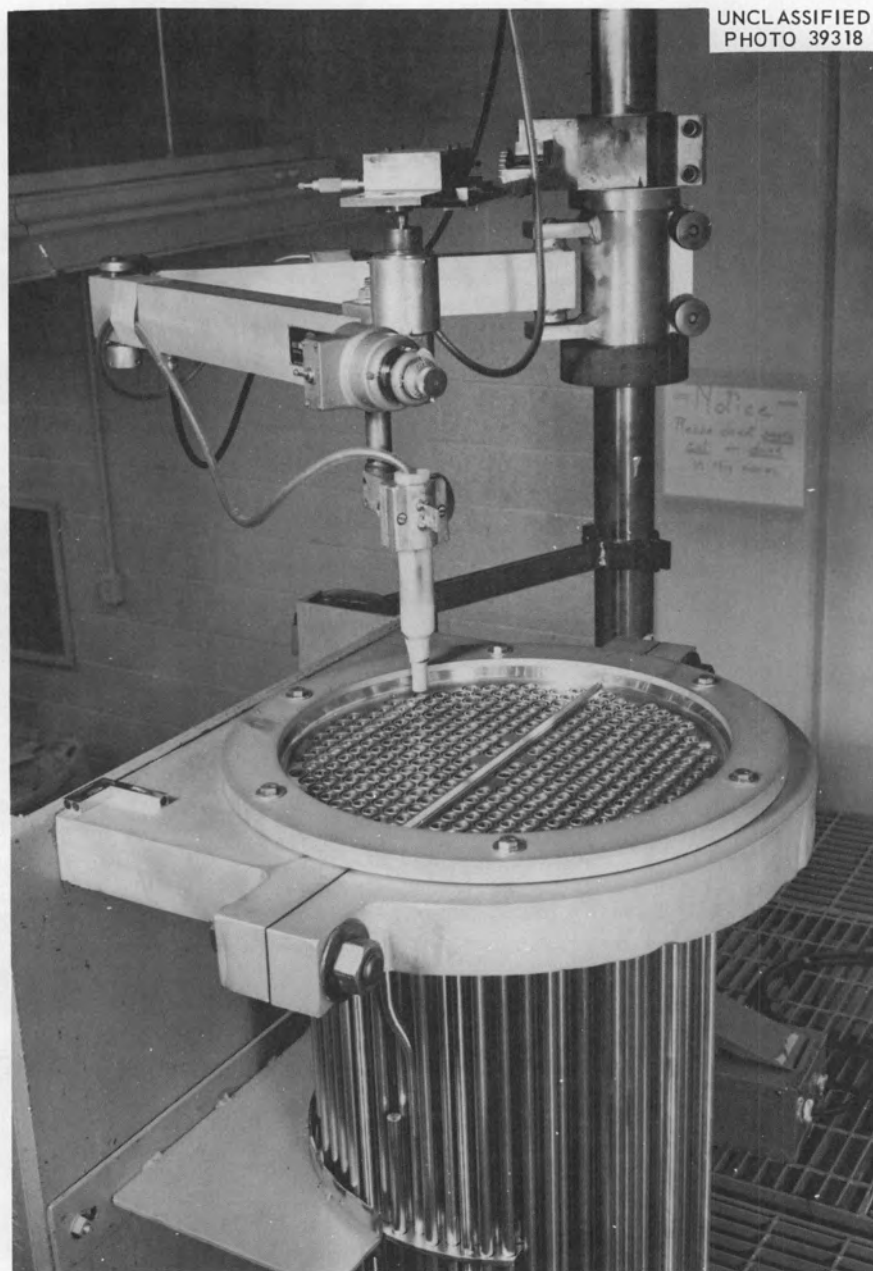
Fig. 11. Specially Built Torch Positioned for Welding.

After a final degreasing and inspection of the tube sheet, all brazing alloy rings were inserted and locked in place by upsetting the face of the tube sheet around the edge of the trepans. The tube sheet was then mounted in the assembly-welding fixture and the supporting structure of rod and baffles installed, as shown in Fig. 10. Several tubes with compound bends were also installed at this point since the final bends had to be made after being threaded through all the baffles. The U-tubes were assembled and welded one row at a time starting adjacent to the diametral flow separator and working outward. The welding conditions used were those presented previously. The setup for welding is shown in Fig. 11. The torch assembly, specially made for this application by the Union Carbide Nuclear Division, Y-12 General Machine Shops, was provided with both coarse and micrometer adjustments for centering over a joint. The torch was also adjustable in the vertical direction. Circular movement was provided by a magnetic plate cam and knurled-pin follower located above the torch next to the micrometer adjustment.

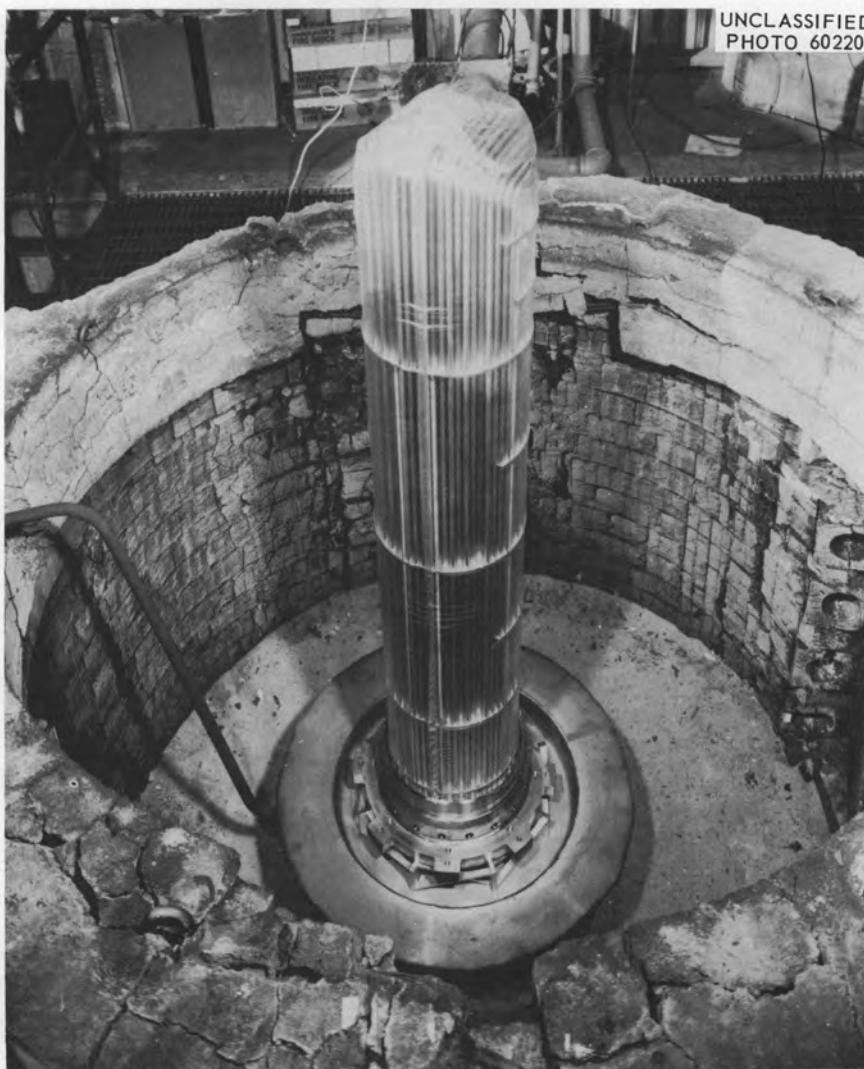
Fig. 13. Tube Bundle Positioned in Furnace Pit on Retort Base with Protective Bag Still in Place.

After welding and radiographic inspection, the tube bundle was assembled in the shipping container (Fig. 12) and sent to Wall Colmonoy Corporation, Detroit, Michigan, for retort brazing in dry hydrogen. Furnace runs were made on the empty retort to clean the inner surface and obtain an oxide-free environment for the actual brazing operation. The tube bundle was then removed from the shipping container and positioned in the furnace pit on the retort base, as shown in Fig. 13, with the protective bag still intact. After leveling and positioning the various thermocouples, the bag was removed and the retort top lowered into place (Fig. 14) and seal-welded at the edge-weld preparation. The retort was then leak checked, vacuum purged, and filled with dry (-80 to -85°F) hydrogen at a rate of 145 cfh. After purging with hydrogen for $1/2$ hr, the furnace top was set in place (Fig. 15) and the brazing cycle started.

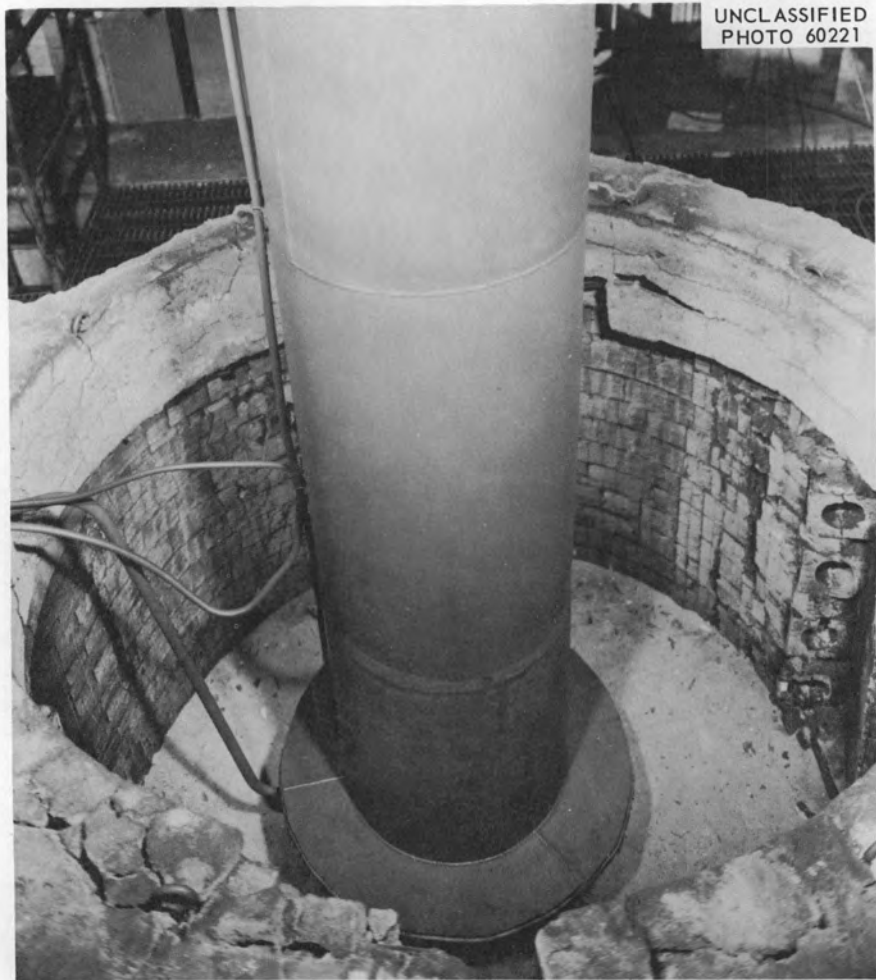
Fig. 14. Retort Top in Place for Seal Welding.

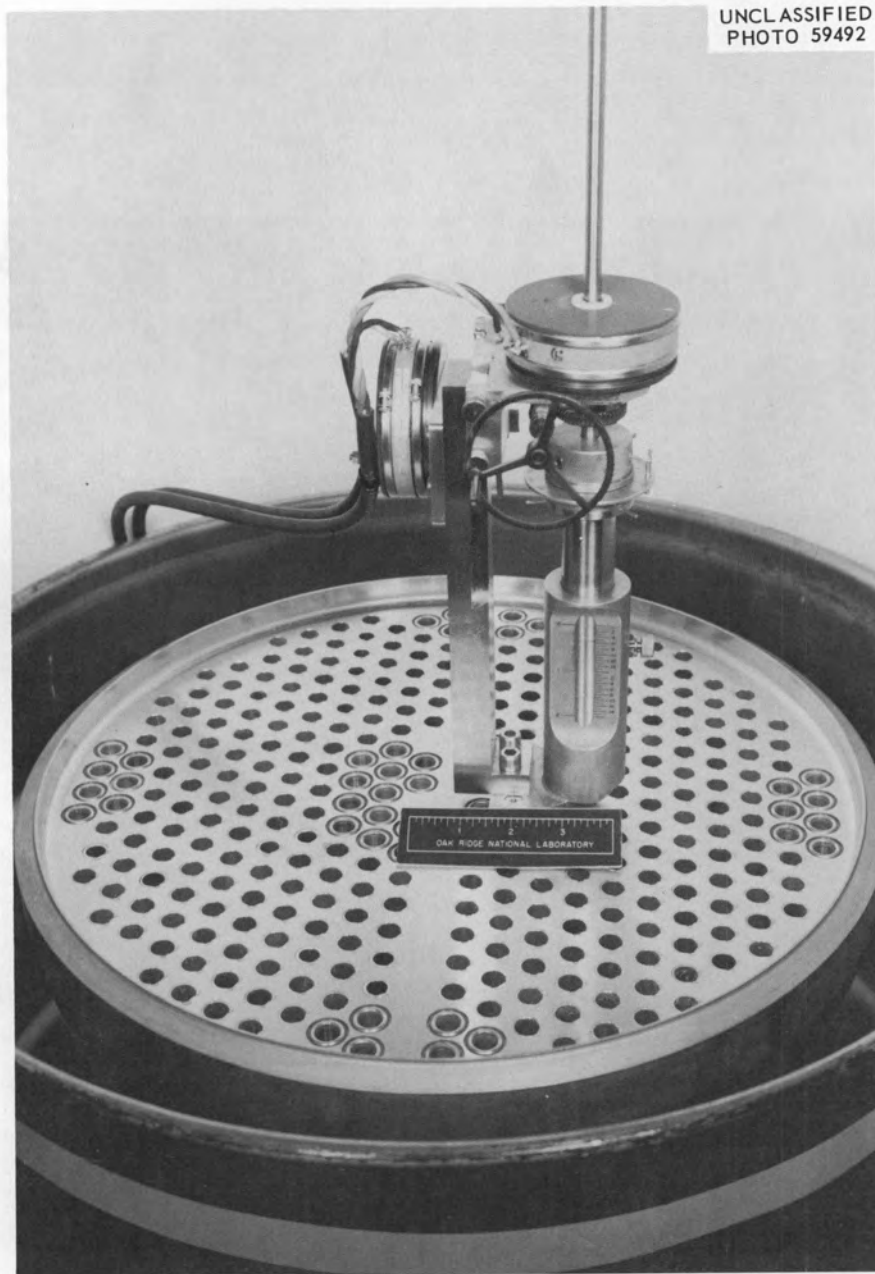
Fig. 17. Ultrasonic Probe Device Set up on Sample Heat Exchanger To Inspect Tube-To-Tube Sheet-Brazed Joints.

With the tubes filled with water, the ultrasonic probe, which contains a sending and receiving crystal mounted at a preset angle to each other, was rotated 360 deg around the inside of the tube and indexed down the tube in steps to fully cover the brazed area. The device, set up for inspecting the sample heat exchanger, is shown in Fig. 17. This inspection revealed somewhat more porosity in the brazed joints of the actual heat exchanger than was observed in the large sample. Nevertheless, judging from signals from standardized defects, it was believed that this porosity was scattered and of small size and that the back brazes should certainly be an effective secondary seal in case of inadvertent weld failure in service. Figure 18 shows the completed tube bundle mounted on the fixture.
