# Evaluation of deep-seated crib block fires and direct application fire suppression agents

**M.A. Trevits and A.C. Smith**

**J.E. Urosek and M.P. Valoski**

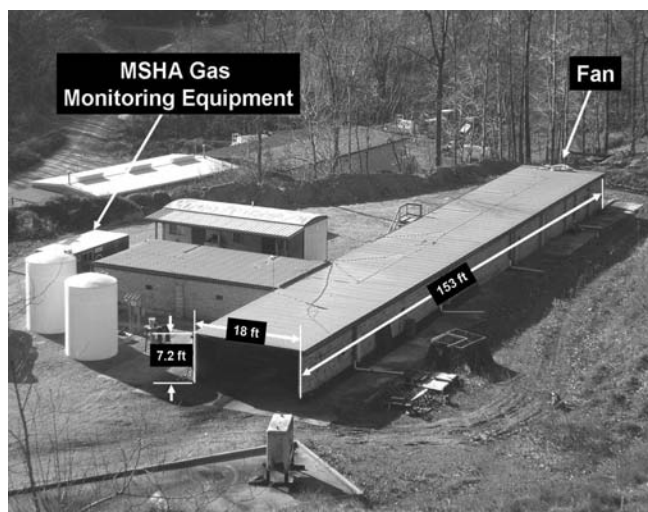
Figure 1 — Fire suppression facility.

The FSF was configured to simulate a 46-m- (150-ft-) long mine entry. The interior height of the simulated mine is 2.2 m (7.2 ft) and the width is 2.4 m (8 ft). The roof of the simulated mine is made of corrugated steel bridge planks, the ribs are made of 203-mm- (8-in.-) thick mortared solid concrete blocks, and the floor is made of reinforced concrete. The interior roof is covered with a 50.8-mm- (2-in.-) thick layer of Fendolite M-II® (a specialized fire resistant mixture of vermiculite and Portland cement) and a 25.4-mm- (1-in.-) thick layer of Fendolite M-II® has been placed on the ribs.<sup>2</sup> For ventilation, a 1.8-m- (6-ft-) diameter variable-speed axivane fan (equipped with a pneumatic controller to adjust fan blade pitch) has been installed at one end of the simulated mine. The fan can provide blowing sustained airflow up to about 5.84 m/s (1,150 fpm) over the cross-section of the entry. Two doors, which permit access to the inside of the FSF, are located about 14 m (47 ft) from the fan. Figure 1 shows the exterior of the FSF.

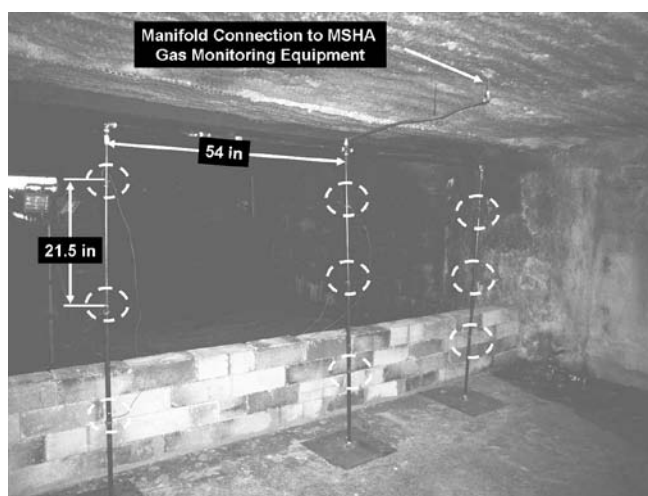
Figure 2 — Layout of a gas-monitoring array. (Circled areas show gas monitoring points and thermocouples.)

The components of the fire gases were measured using three gas-monitoring arrays. The first was a nine-point array located 6.46 m (21.2 ft) from the trailing edge of the crib block sets. The array consisted of an interconnected network of 12.7-mm- (1/2-in.-) diameter black iron pipe set across the width of the mine entry. A total of nine 3.175-mm- (1/8-in.-) diameter holes were drilled into vertical sections of the pipe to sample the fire gases. The holes in the pipe were spaced equally apart from the roof-to-floor and across the width of the entry (Fig. 2). A thermocouple was also positioned at each gas sampling point to measure the temperature of the fire gases. The gases collected at each sample point were mixed together in a manifold that penetrated the FSF roof. The manifold was connected to a Tygon® tubing line that led to the MSHA gas monitoring truck. The second gas-sampling array was configured in the same manner as the first and was located 29.1 m (95.5 ft) from the trailing edge of the crib block sets. The third gas-sampling array was positioned near the second gas-sampling array and consisted of four 3.175 mm (1/8 in.) holes drilled into 25.4-

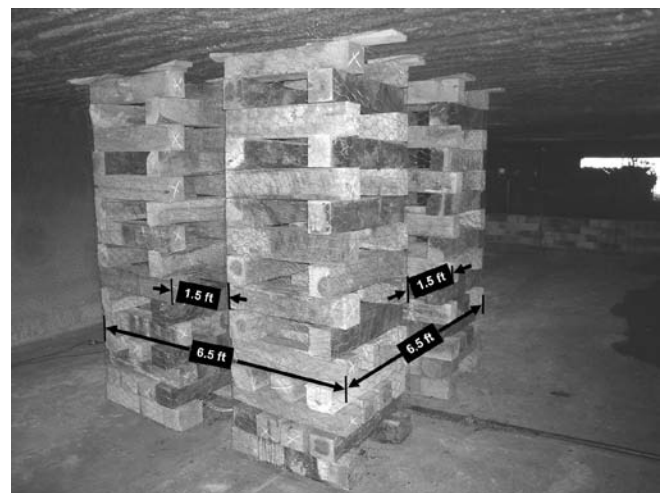
**Figure 3** — Typical crib block set-up prior to a test.

The crib blocks were secured to the roof with wedges as needed. To insure the maximum stability of each crib set, for the longest period of time, each crib set was wrapped with poultry fencing that was affixed to the wood with staples. Figure 3 shows the typical crib block set-up prior to a test.

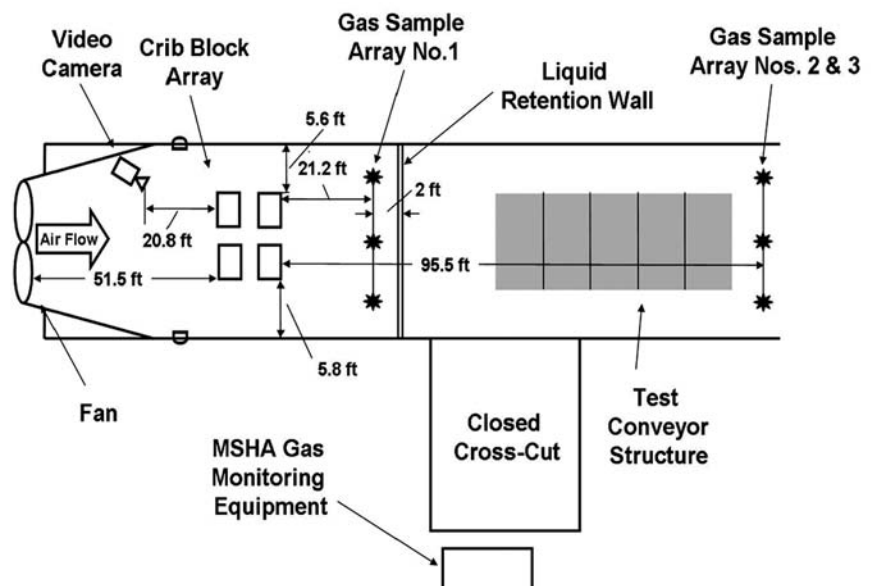
**Figure 4** — FSF typical set-up for a crib fire test.

The layout of the FSF for the crib block tests is shown in Fig. 4. The crib blocks were located 15.8 m (52 ft) from the fan and 10.4 m (34 ft) from a simulated conveyor structure in the FSF. The crib block sets were placed 0.45 m (1.5 ft) apart and were positioned near the center of the entry. As mentioned

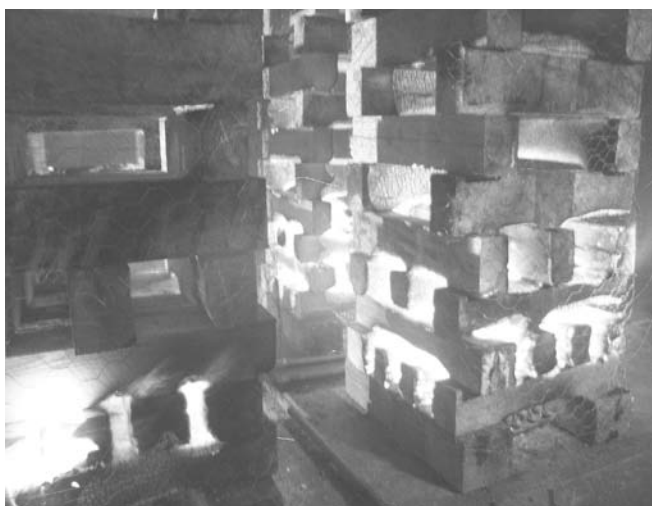
**Figure 5** — Control test – Burning crib block sets.

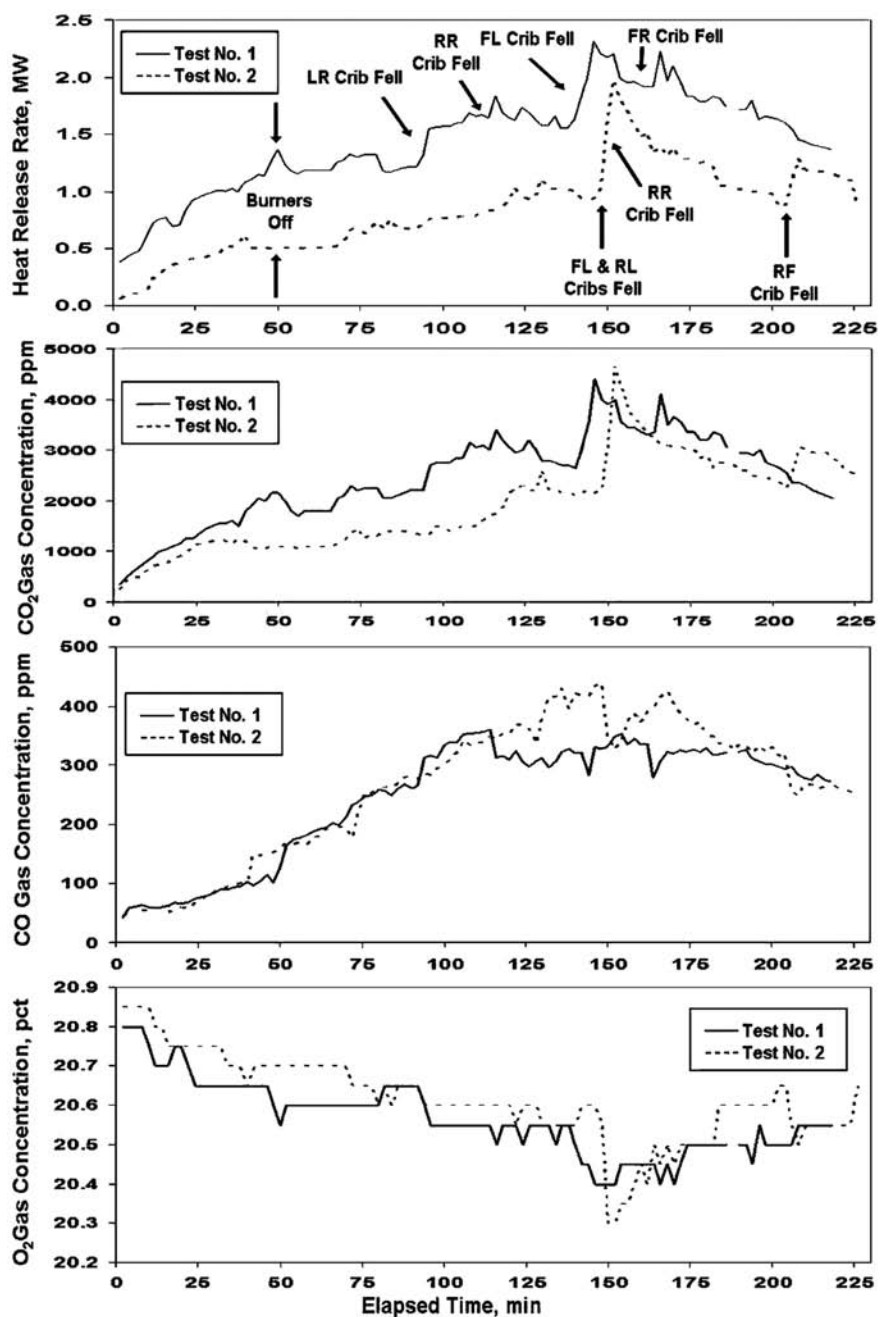
**Figure 6a** — Plot of estimated heat release rate and products of combustion for crib block Tests 1 and 2.

A plot of the estimated heat release rate and the products of combustion for both tests are shown in Figs. 6a, 6b and 6c. From the figures, it appears that Test 1 emitted a larger amount of heat and produced a larger amount of CO<sub>2</sub> and less CO, suggesting more complete combustion of the crib blocks than in Test 2. Also, the gas chromatograph data (Fig. 6c) shows that H<sub>2</sub>, C<sub>2</sub>H<sub>2</sub>, C<sub>2</sub>H<sub>4</sub> and C<sub>2</sub>H<sub>6</sub> gases were observed in the combustion product air stream during both tests, and these gases are most likely the products of incomplete combustion and pyrolysis of the wood. During Test 1, the concentration of hydrogen and the hydrocarbon gases appeared to follow the general trend of the CO gas concentration. This same relationship was observed in the H<sub>2</sub>, C<sub>2</sub>H<sub>2</sub>, C<sub>2</sub>H<sub>4</sub> and C<sub>2</sub>H<sub>6</sub> gas concentrations measured during Test 2.

Each time a crib block set fell, the geometry of the wood changed, and the fire burned more intensely for a period of time. The change in the intensity of the fire is reflected as an increase in the estimated heat-release rate immediately following one of these events along with the associated increase in the products of combustion. The increase in fire intensity is most likely due to the close proximity of the fallen burning crib blocks and the associated heat build-up.

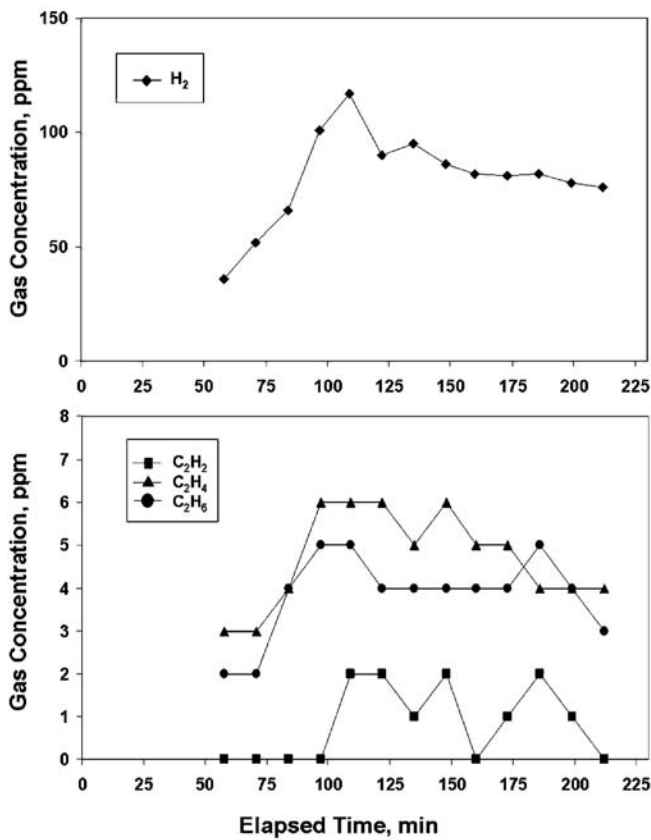
Figure 6b — Gas chromatograph data for Test 1.

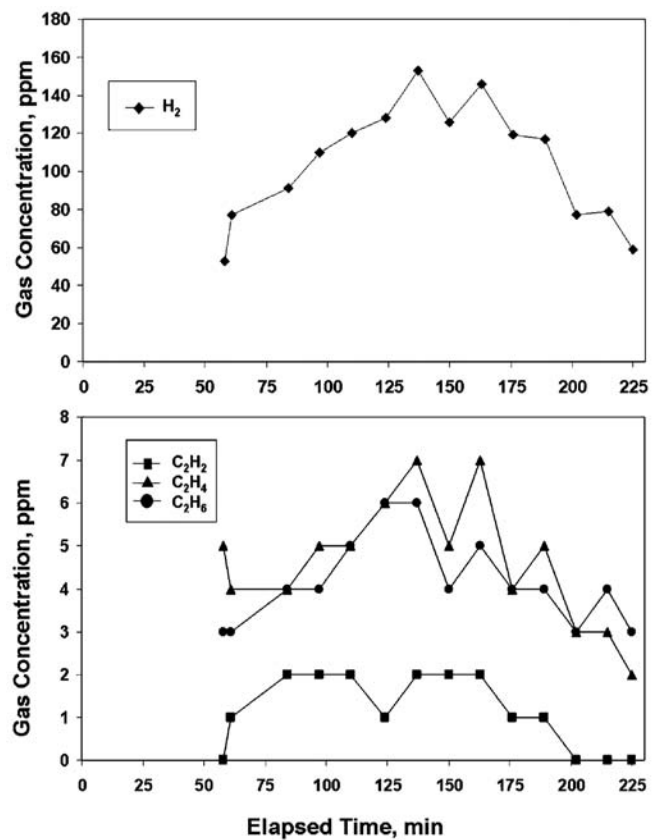
Figure 6c — Gas chromatograph data for Test 2.

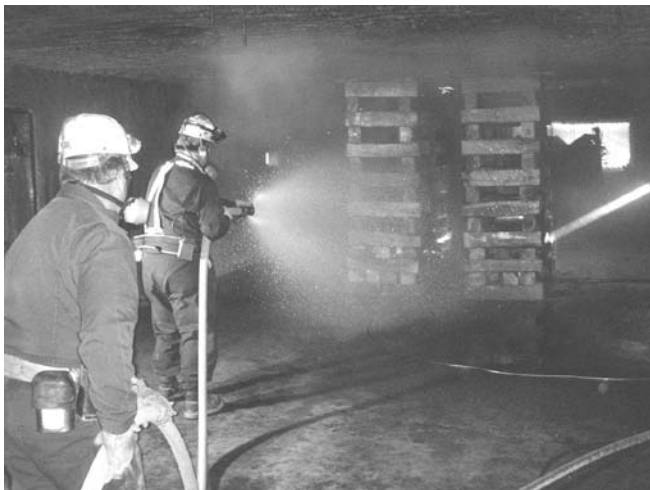
Figure 7 — Use of fire hose during crib block fire Test 3.

The individuals selected to apply the water to the fire were NIOSH technicians who had previously served as coal miners and had training and experience in the use of a fire hose. The technicians were instructed to apply the water until they observed that the fire had been extinguished. For personal safety reasons, the technicians were also instructed not to progress past a line that had been drawn on the entry floor (perpendicular to the trend of the entry) about 457 mm (18 in.) upwind from the leading edge of the crib block sets. This location was selected because it would keep the technicians out of the smoke and away from the heat of the fire. Water was applied to the fire for about four minutes when the technicians decided the fire had been extinguished, and a total of 1,135 L (300 gal) of water was used (Fig. 7). Observations of the wood showed that the horizontal surfaces appeared to be wet and water was observed to be actively dripping from the vertical surfaces. About four minutes after the water application was completed,

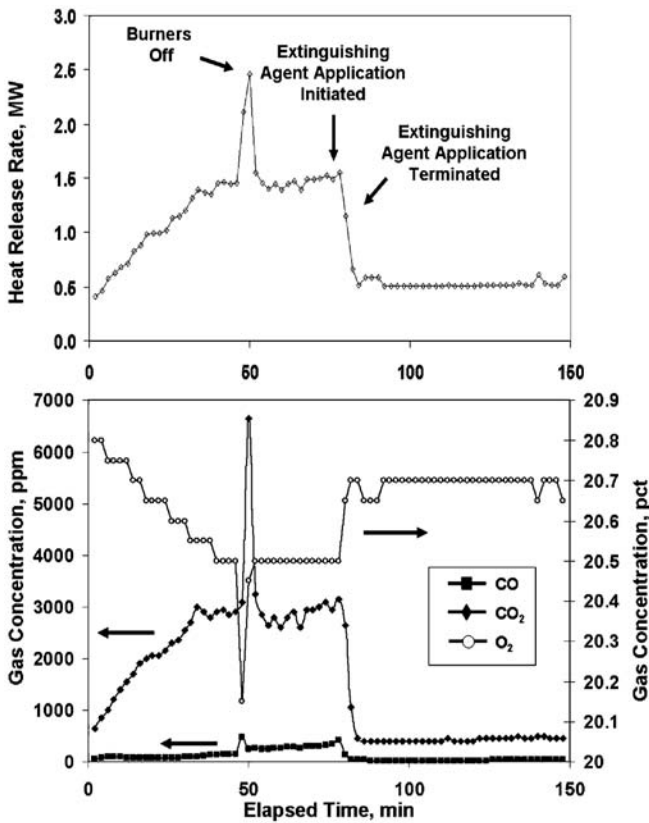
**Figure 8a**—Plot of estimated heat release rate and products of combustion for crib block Test 3.

Figures 8a and 8b are plots of the estimated heat release rate and the products of combustion for this test. As observed in the control tests, the fire showed an increase in heat output and CO<sub>2</sub> production during the intense burning event or when the crib block sets shifted or fell. CO production increased at a steady rate with only slight changes when the fire intensified or when the crib block set shifted or fell. As expected, the heat output of the fire and the production of combustion gases declined dramatically as the water was applied (refer to Figs. 8a and 8b). As observed in the controls tests, the fire also pro-

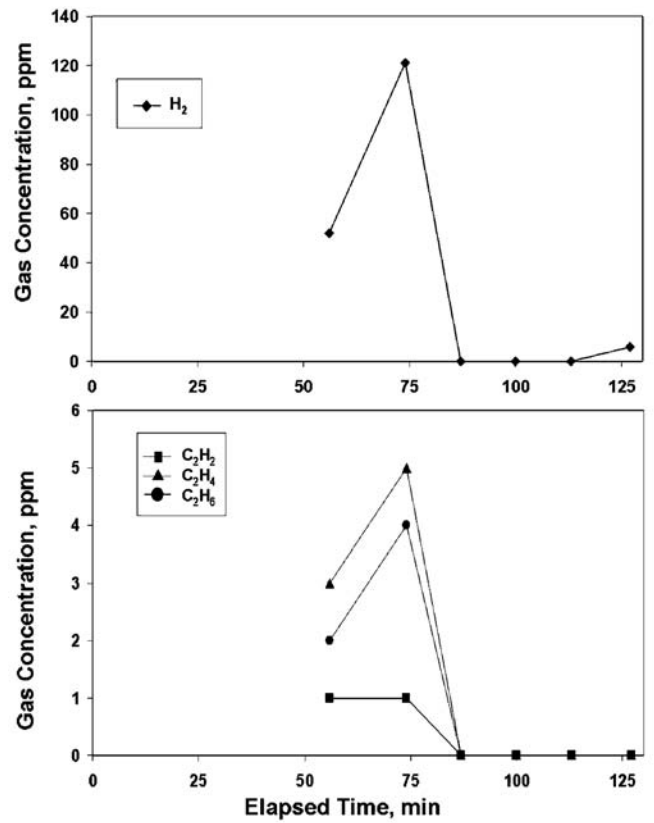
**Figure 8b**—Gas chromatograph data for Test 3.

duced  $H_2$ ,  $C_2H_2$ ,  $C_2H_4$  and  $C_2H_6$  gases, which are considered to be the products of incomplete combustion and pyrolysis of the wood. Unfortunately, because this test was of a short duration and only a very limited set of gas chromatograph data was collected during this test, it is therefore difficult to make comparisons with the other gas species.

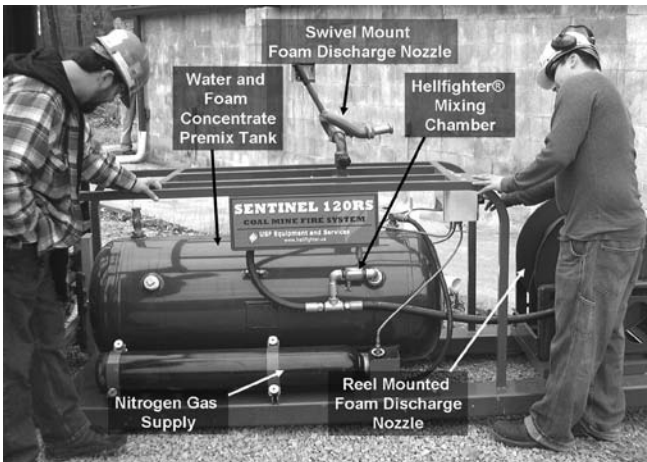
**Figure 9**—USF Sentinel® unit used during crib block fire Test 4.

The system used was a Sentinel 120RS unit supplied by USF Equipment and Services (a research partner in this test). The Sentinel 120RS is a self-contained fire-fighting system that uses the patented Hellfighter<sup>®</sup> mixing chamber to create foam (USF Equipment and Services, 2006). The system used was capable of producing  $9.07 \text{ m}^3$  (2,400 gal) of gas enhanced foam using a mixture of water, a small amount of Mine Fire Fighting Foam<sup>®</sup> (MFFF) concentrate and nitrogen gas (Fig. 9). The system can discharge up to  $18.9 \text{ L/s}$  (300 gpm) of gas-enhanced foam. Prior to the entry into the FSF, the NIOSH technicians were instructed on the proper use of the Sentinel unit and application of the foam product on the fire. As in the previous test, the technicians were instructed to apply the gas-enhanced foam until they observed that the fire had been extinguished.

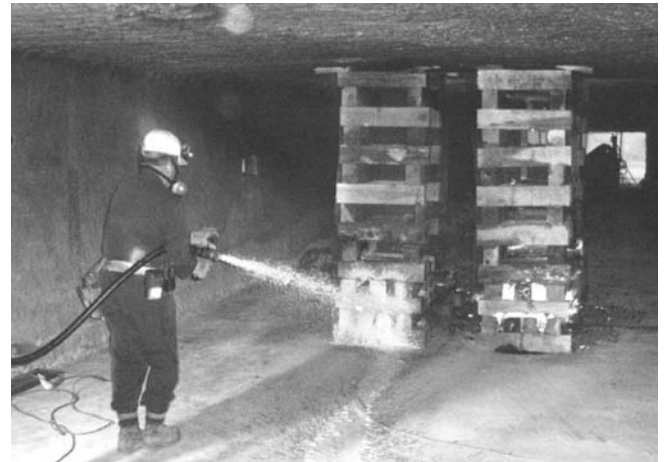
**Figure 10**—Use of gas-enhanced foam during crib block Test 4.

Gas-enhanced foam application began 103 minutes into the test, and about 1 minute later, the right rear crib block set fell down (Fig. 10). Foam application continued for about 8 minutes when the technicians decided that the fire had been extinguished. A total of 9.07 m<sup>3</sup> (2,400 gals) of gas-enhanced foam (the entire capacity of the system) was used. At about 40 minutes

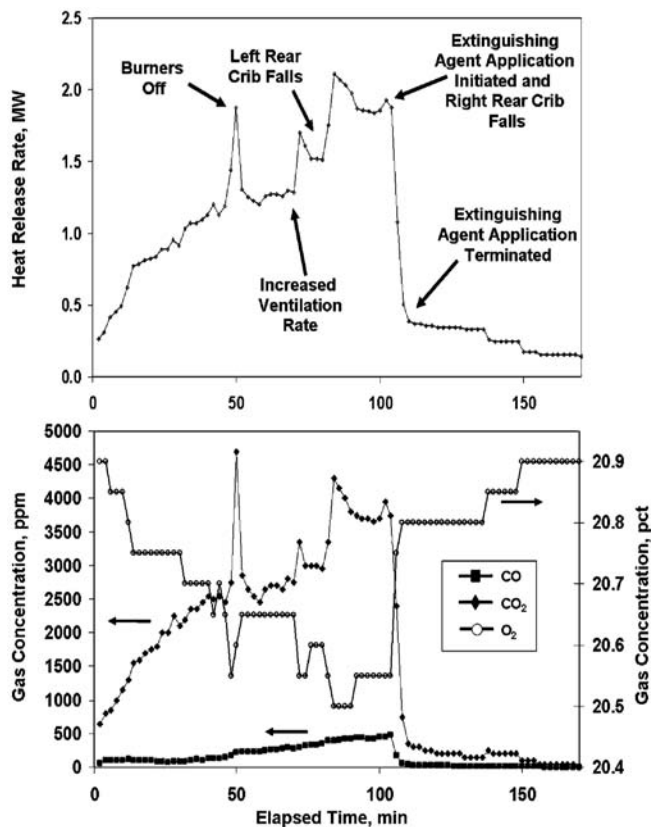
Figure 11a — Plot of estimated heat release rate and products of combustion for crib block Test 4.

Figures 11a and 11b are plots of the estimated heat release rate and the products of combustion for this test. As observed in the previous tests, the fire showed an increase in heat output and  $\text{CO}_2$  production during the intense burning event or when a crib block set fell.  $\text{CO}$  production increased at a steady rate with only slight changes when the fire intensified or when the crib block set fell. The heat output of the fire and the production of combustion gases declined dramatically when the foam extinguishing agent was applied (refer to Figs. 11a and 11b). As in the previous tests, the fire produced  $\text{H}_2$ ,  $\text{C}_2\text{H}_2$ ,  $\text{C}_2\text{H}_4$  and  $\text{C}_2\text{H}_6$  gases. The change in concentration of these gases appeared to follow the same general trend of the  $\text{CO}_2$  gas concentration.

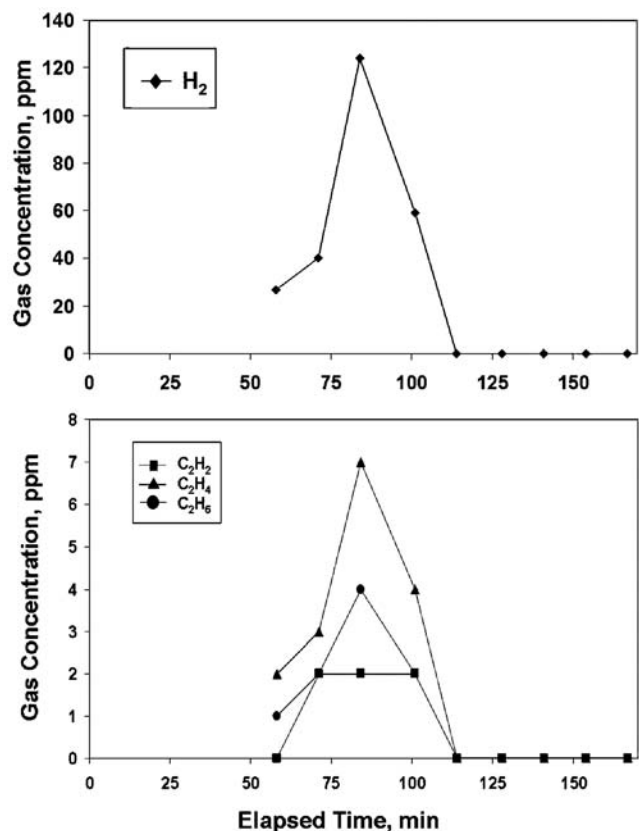
Figure 11b — Gas chromatograph data for Test 4.

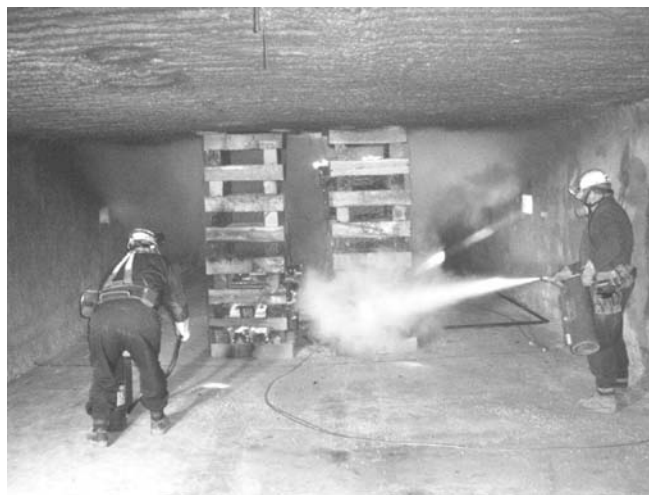
**Figure 12** — Use of fire extinguishers during crib block fire Test 5.

The fire test was initiated in the same manner as the previous tests. Once the gas burners were turned off, the fire for some unknown reason did not achieve a stable condition for a long period of time. At about 121 minutes into the test the rear left crib set fell, whereupon the fire intensified with some smoke rollback. At about 123 minutes into the test, the rear right crib set shifted into the front right crib set followed by an increase in fire intensity as flames were observed at the roof with smoke rollback. Approximately 3 minutes later, the fire returned to about the same level observed before the event occurred. At 128 minutes into the test, the rear right crib set fell followed by an increase in fire intensity shortly thereafter. Use of the fire extinguishers on the fire began at 161 minutes into the test when the estimated heat release rate of the fire had generally stabilized. The extinguishing work continued for about four minutes until the all of the available material was applied (Fig. 12). A total of about 45 kg (100 lbs) of ABC powder was used on the fire. The powder was observed on the horizontal surface

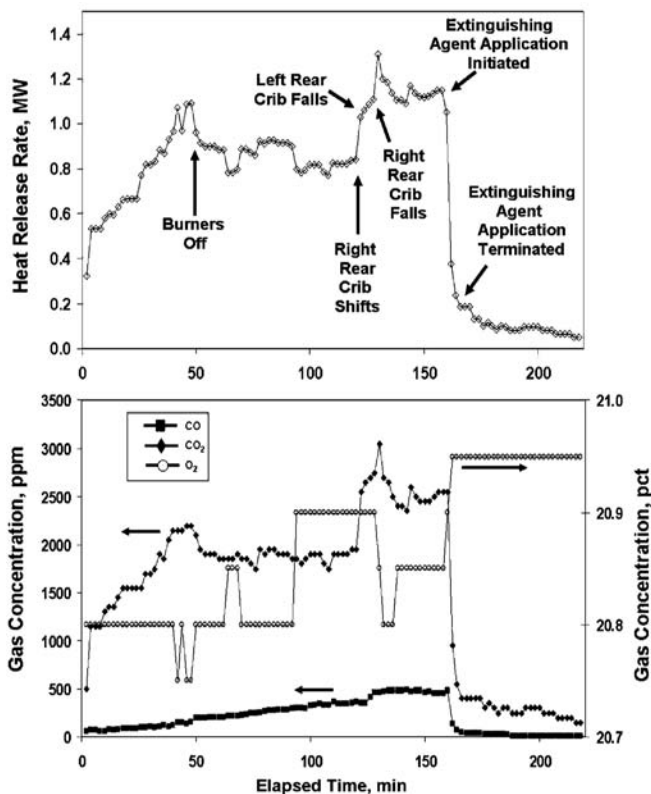
Figure 13a — Plot of estimated heat release rate and products of combustion for crib block Test 5.

As shown in Fig. 13a, the increase in heat output of the fire and  $\text{CO}_2$  production was related to the changing geometry of the wood pile as a crib block set fell.  $\text{CO}$  production increased at a steady rate with only slight changes when the fire intensified or when the crib block set fell. The heat output of the fire and the production of combustion gases declined dramatically as the extinguishing agent was applied. As in the previous tests, the fire produced  $\text{H}_2$ ,  $\text{C}_2\text{H}_2$ ,  $\text{C}_2\text{H}_4$  and  $\text{C}_2\text{H}_6$  gases (refer to Fig. 13b). The change in concentration of these gases appeared to follow the same general trend as the  $\text{CO}_2$  and  $\text{CO}$  gas concentrations.

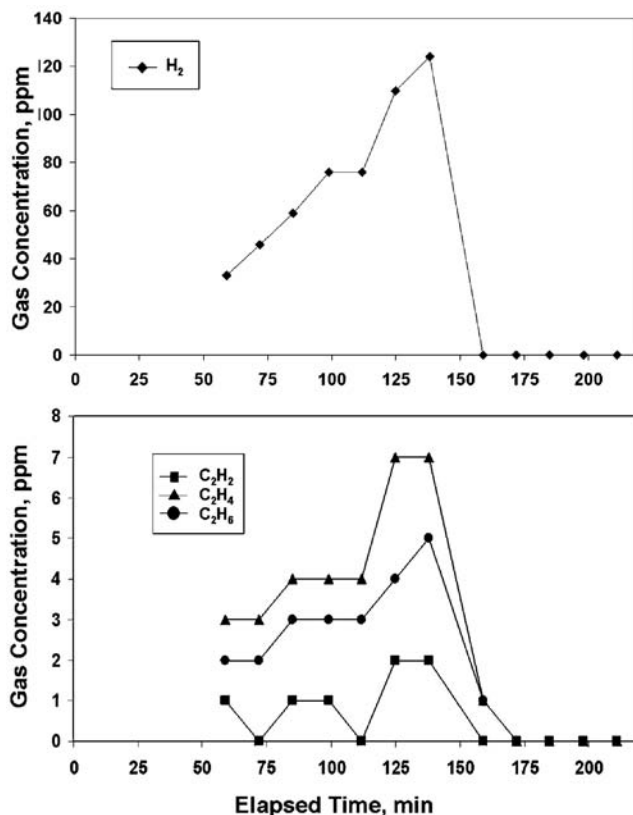
Figure 13b — Gas chromatograph data for Test 5.
