DOCKET NO. SA-228

EXHIBIT NO. 20B

**CARGO COMPARTMENT FIRE PROTECTION IN LARGE COMMERCIAL  
TRANSPORT AIRCRAFT (DOT/FAA/AR-TN98/32)**

DOT/FAA/AR-TN98/32

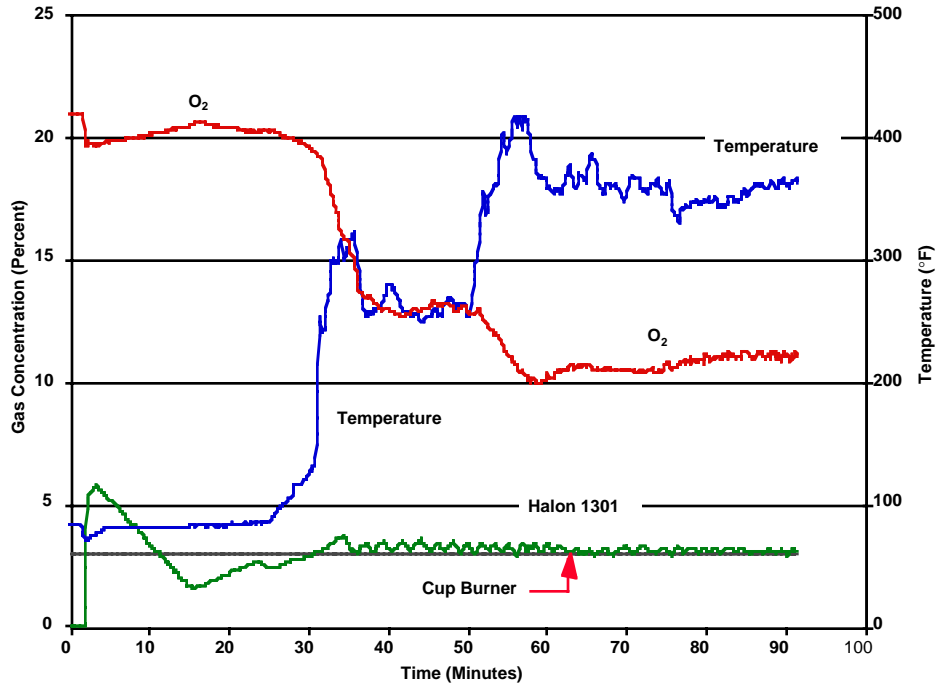
FIGURE 1. GAS AND TEMPERATURE PROFILES IN CARGO COMPARTMENT DURING BULK-LOADED FIRE SUPPRESSION TEST WITH HALON 1301

The results of these 90-minute tests were generally similar to previous shorter duration tests conducted with these agents. [8] The cargo compartment ceiling temperatures ranged from 300 to 450°F while the fires were suppressed and the oxygen concentrations were reduced to 10% to 15%. The depletion of oxygen was caused both by smoldering fires and the displacement of air by suppression agents. Figures 1 and 2 show the ceiling temperatures, oxygen concentrations, and agent concentrations measured in the cargo compartment for the tests with Halon 1301 and HFC-125, respectively. One anomaly was observed during the test with HFC-125. Shortly after the concentration from the initial discharge had decayed down to the cup burner value of 8.8% and the metering system had started, there was an ignition of combustible gases in the smoke layer above the cardboard boxes. The flame front progressed along the entire length of the compartment at the ceiling level. This caused a sharp rise in ceiling temperature and a drop in oxygen concentration. The fire was suppressed for the duration of the test after this event. A similar event had previously been observed in a test using HFC-125 with a containerized fire load. This type of behavior had not been observed with Halon 1301 or other gaseous candidate replacement agents. Further testing is planned in an attempt to understand this anomaly.

Of particular interest for these longer duration tests was the generation and accumulation of agent decomposition products in both the cargo compartment and in the normally occupied passenger cabin area above it. Figure 3 shows the hydrogen fluoride (HF) concentrations in the cargo compartment for the two tests. The values in the graph are the average concentrations of HF over each 10-minute interval. The higher concentrations of HF between 20 and 40 minutes with HFC-125 are due mainly to the open flame that was present when the combustible gases along the ceiling ignited. This open flame produced significantly more decomposition products than the smoldering suppressed fire. Previous testing showed higher concentrations of HF even where there was no ignition of combustible gases when HFC-125 was used as the suppression agent rather than Halon 1301. This result is expected because not only does HFC-125 contain more fluorine per molecule than Halon 1301, but higher concentrations of HFC-125 are also

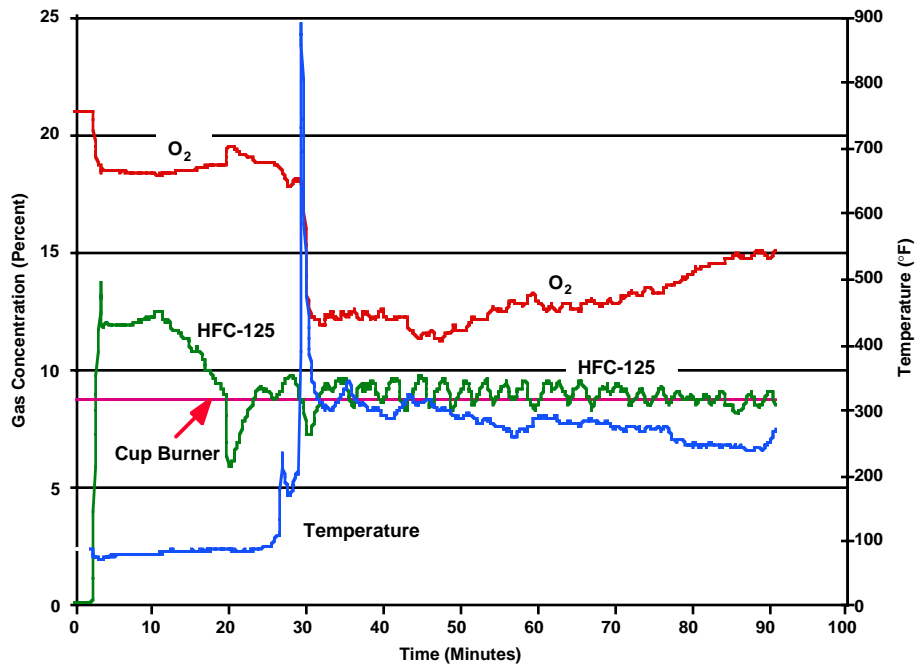
FIGURE 2. GAS AND TEMPERATURE PROFILES IN CARGO COMPARTMENT DURING BULK-LOADED FIRE SUPPRESSION TEST WITH HFC-125

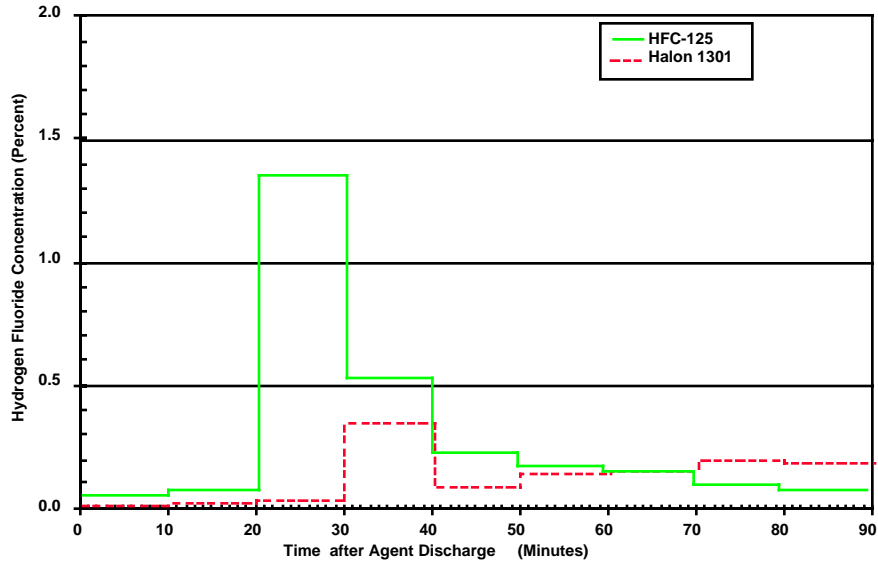
FIGURE 3. HYDROGEN FLUORIDE PROFILES IN CARGO COMPARTMENT DURING BULK-LOADED FIRE SUPPRESSION TESTS WITH HALON 1301 AND HFC-125

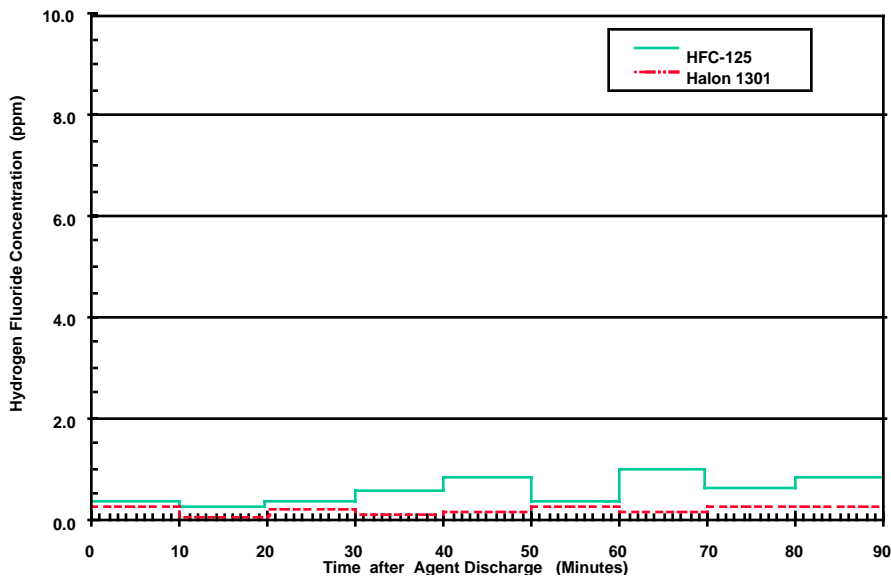
required compared to Halon 1301. Figure 4 shows the HF concentrations in the passenger cabin above the cargo compartment. HF concentrations are again higher in the test with HFC-125 for the same reasons as stated above. However, the data show that there is not a significant accumulation of HF in the cabin area. The fuselage ventilation system exhausts the decomposition products out of the cabin at a rate similar to the inflow rate of these products. The measured levels for both tests were well below the maximum Occupational Safety and Health Administration (OSHA) 15-minute exposure limit of 6 parts per million (ppm) and the Immediately Dangerous to Life and Health (IDLH) limit of 30 ppm.

FIGURE 4. HYDROGEN FLUORIDE PROFILES IN PASSENGER CABIN DURING BULK-LOADED FIRE SUPPRESSION TESTS WITH HALON 1301 AND HFC-125

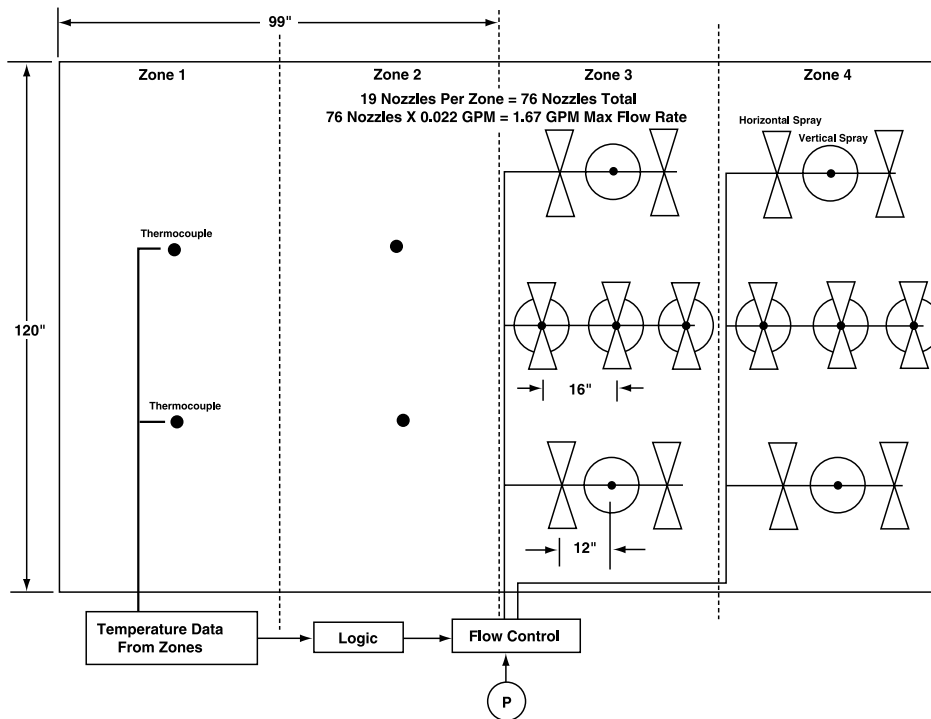
The water mist system was supplied by Environmental Engineering Concepts (EEC). These systems are commercially available under the trade names Microcool<sup>®</sup> and Enviromist<sup>®</sup> Fog Systems and are primarily used for environmental cooling and vegetable hothouse humidification. The system used for the cargo compartment testing was co-designed by the FAA and EEC and consisted of a high-pressure pump, four zone control valves, and the basic piping and nozzles. The water mist system, designed to minimize the amount of waste water by applying the mist to the areas of the fire, was divided into four zones that could be individually activated (see figure 5). Each zone contained 19 nozzles and covered an area of approximately 4 by 10 feet. The nozzles were oriented to spray mist both horizontally and vertically (down) to maximize mixing and coverage. The mist was automatically controlled by two thermocouples mounted in the ceiling of each zone. The control of the spray activation could be adjusted prior to each test. During the test, when either of the zone thermocouples exceeded the preset value, a signal was sent to open the zone control valve, discharging the mist in that zone. The water mist pressure was adjustable from 800 to 1200 psi, as supplied by an electrically driven pump.

FIGURE 5. WATER MIST SYSTEM SCHEMATIC

A B727 aft cargo compartment test article was used to evaluate a high-pressure water mist system. The test article measured approximately 120 inches wide by 200 inches long at the ceiling (the floor of the compartment covered significantly less area due to the curvature of the fuselage). The compartment volume was approximately 550 cubic feet. The ceiling and sidewall were constructed of the original fiberglass cargo liners; the forward and aft bulkheads were made of aluminum. Two thermocouples trees were installed along the compartment centerline with three probes each located at 1-, 2-, and 3-foot levels. Video and photographic equipment were placed in the aft bulkhead to monitor test progress.

After the initial shakedown tests were conducted to observe the operations of the system, a bulk-loaded test was configured. During the test, ten 18- by 18- by 18-inch boxes filled with shredded paper were loaded onto the floor of the compartment and a centrally located box was ignited. The system control parameters were preset to activate mist when the temperature exceeded 200°F and to deactivate when the temperature fell below 180°F. The fire was allowed to burn without intervention for 90 minutes, during which several of the zones cycled on and off dozens of times. At no time did any of the measured ceiling temperatures exceed 300°F. Approximately 10-12 gallons of water were discharged, which is only 7%-8% of the total quantity of water available if all nozzles were discharging throughout the 90-minute test.

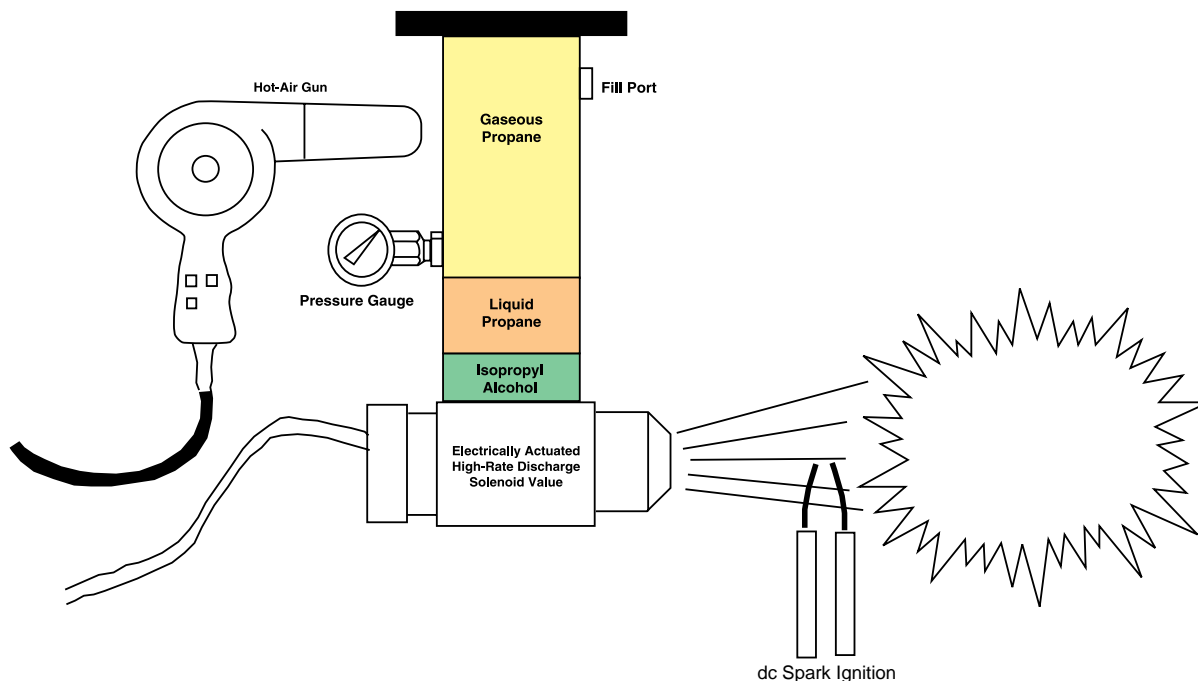
The initial simulator design was a steel pipe pressure vessel mated to a high-rate discharge (HRD) electrically actuated solenoid valve (see figure 6). The vessel contained ports and valves to transfer the base product (initially isopropyl alcohol) and hydrocarbon propellant (typically propane). The contents are heated by blowing a hot-air gun against the surface of the steel vessel, effectively raising the pressure of the contents. When the pressure was sufficient to burst a standard strength can, approximately 210 psig, the contents were released over a set of direct current (dc) spark igniters. A high-voltage transformer produced the electric spark to bridge the 1.2-cm gap between the pair of electrodes.

FIGURE 6. EXPLODING AEROSOL CAN SIMULATOR

Initial tests were performed in an unconfined area to observe the flame propagation and explosion pattern and to test the general operation of the simulator. The early tests used a mix of constituents representative of a large hairspray can (16 ounces) consisting of 3.5 ounces (weight) of liquid propane and 2.5 ounces (weight) of isopropyl alcohol. Several trials were conducted at various pressures, but the HRD valve failed to perform above 200 psig. At this pressure, a large

The initial simulator setup was mounted externally on the forward bulkhead of a B727 cargo compartment. The discharge port of the HRD valve was installed through a cutout in the compartment bulkhead such that a majority of the simulator was situated external to the compartment. The pressure vessel was again filled with the 3.5 ounces of propane and 2.5 ounces of isopropyl alcohol as in the initial tests. After heating the vessel to increase the internal pressure to 200 psig, the mix was released into the compartment over the spark igniters. The ensuing explosion caused severe damage to the entire compartment, including the collapse of the forward and aft bulkheads. The cabin floor above the compartment ceiling liner was blown out of place and landed several yards away from the test article. There was also evidence of severe overpressure inside the structure as several rivet heads on the exterior skin surface failed under tension.

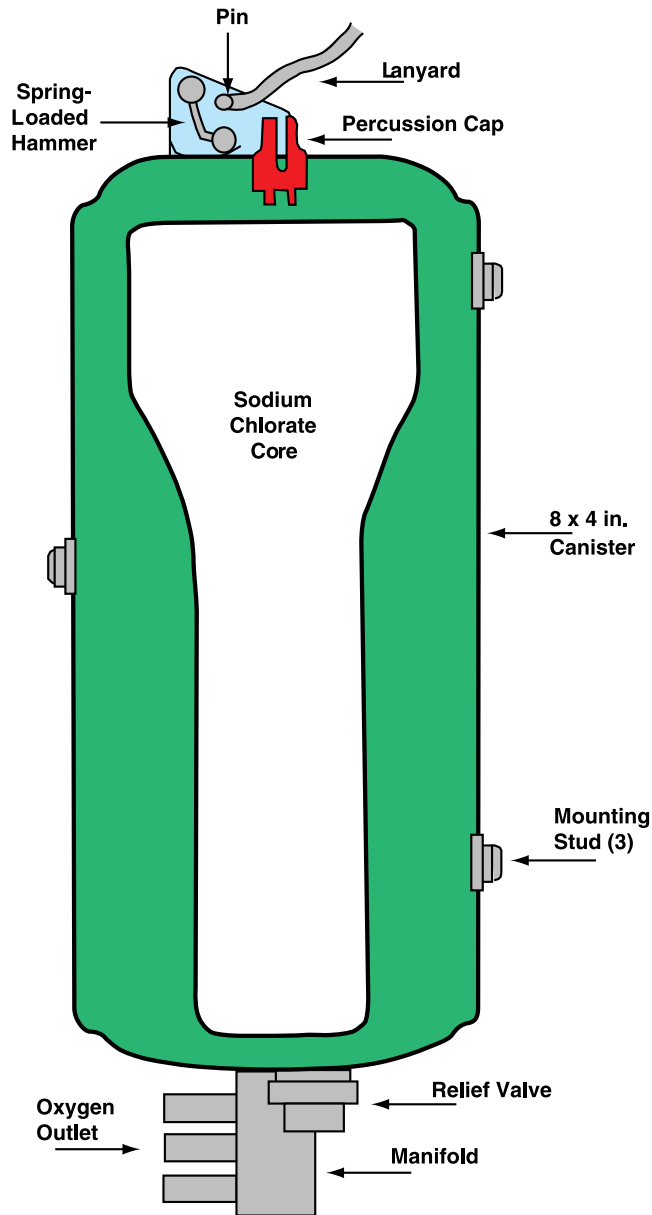
Most commercial transport aircraft use oxygen canisters to supplement or replace cabin air for passenger breathing in the event of a cabin depressurization. Figure 7 shows the design of a common oxygen canister. The main components are the chemical core composed of sodium chlorate and iron particles, a stainless steel housing, a means of initiating the chemical reaction (such as a spring-loaded hammer striking a percussion cap), and outlets for the gaseous oxygen generated. Because the oxygen-producing reaction is exothermic, the steel housing is insulated from the chemical core to maintain the temperature of the housing below 500°F. As discussed earlier, the activation of improperly packaged and shipped oxygen canisters in the forward cargo compartment was the probable cause of the fatal ValuJet in-flight fire. [5]

FIGURE 7. CHEMICAL OXYGEN GENERATOR

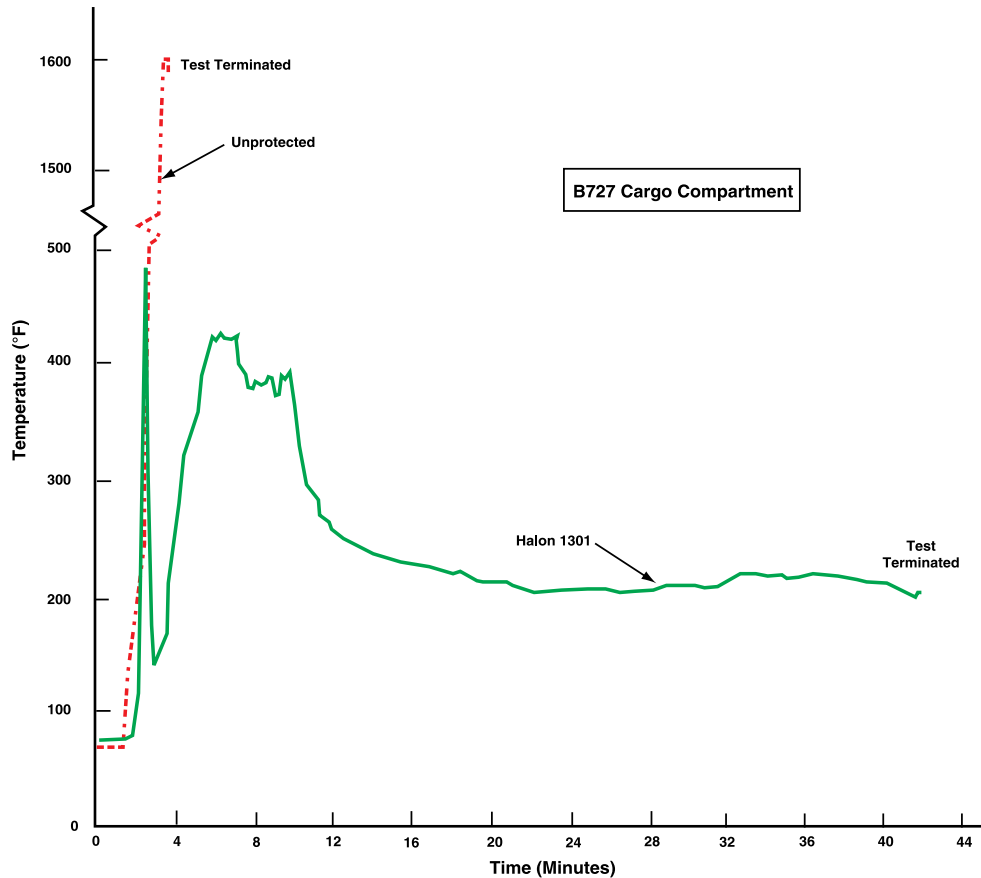
The third test was a repeat of test two without using any suppression agent. Temperatures at the ceiling rapidly reached the point where the liner would be breached and the test was immediately terminated (see figure 8).

FIGURE 8. COMPARISON OF CEILING TEMPERATURES DURING A CARGO FIRE INVOLVING 12 OXYGEN CANISTERS WITH HALON 1301 SUPPRESSION AND UNPROTECTED

The second test was similar to the first with the following exceptions. Only 12 generators were used; all were stored in one cardboard box. Only a single layer of boxes filled with shredded paper was used. In this test the fire was detected much faster than in the first test (see figure 8). Temperatures at the ceiling never exceeded 500°F. As in the first test, upon discharge of Halon 1301 the visible flaming was immediately extinguished. However, in this test the ceiling temperature was maintained at about 400°F for approximately 10 minutes and decreased to approximately 200°F for the next 30 minutes. After the fire was extinguished, it was discovered that only 2 of the 12 generators had activated.

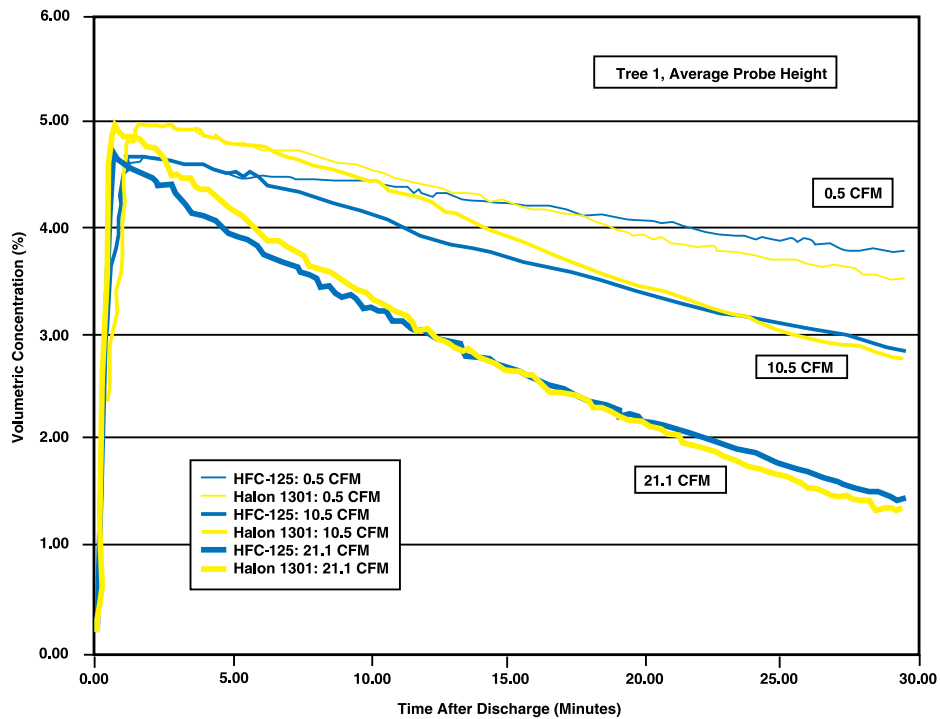
A comparison of the HFC-125 and Halon 1301 concentration histories at the three leakage rates for the sampling tree nearest the leak duct is shown in figure 9. The data represents the average concentration measured at the six sampling heights and from replicate tests at each leakage rate. The higher peak concentrations of Halon 1301 were expected due to the difference in charged weight; 5.8 pounds and 4.45 pounds for Halon 1301 and HFC-125, respectively. Also, the Halon 1301 decays faster than HFC-125 due to its higher vapor density; however, the difference in decay rate lessens as the leakage rate increases. It appears that HFC-125 can be used as a simulant for Halon 1301 provided that suitable conversion equations are used to correlate the concentrations of Halon 1301 and HFC-125.

FIGURE 9. AGENT CONCENTRATION HISTORY AT DIFFERENT LEAK RATES

Discharge tests with HFC-125 and Halon 1301 were conducted and compared in a 300-cubic foot cargo compartment. The air leakage rate in the test article could be set at 0.5, 10.5, or 21.1 cubic feet per minute (CFM). The main instrument was a Heat Technology Laboratory (HTL)

Halonyzer, a 12-channel continuous gas analyzer calibrated for HFC-125 in air and Halon 1301 in air. Gas samples were taken from six sampling tree elevations at two locations. To obtain similar storage bottle discharge characteristics for both agents, the bottle was filled with the equivalent liquid fraction, as used previously, [14] and pressurized with nitrogen to 375 pounds per square inch absolute (psia).
