# Ambient Vibration and Earthquake Strong-Motion Data Sets for Selected USGS Extensively Instrumented Buildings

## Open-File Report 2004-1375

The objective of this report is to present background information for a study comparing the dynamic characteristics of thirteen buildings obtained using strong-motion and ambient vibration records. Ambient vibration testing is an attractive method of measuring the dynamic characteristics of real buildings, since it does not disrupt building occupants and the necessary equipment is small, light, and very portable. However, because of the low amplitude range of the ambient vibration ( $10^{-5}$  g), dynamic characteristics obtained from ambient vibration should be different from those obtained from strong-motion ( $>0.1$  g) records due to non-linear effects (Çelebi 1993, Çelebi 1998).

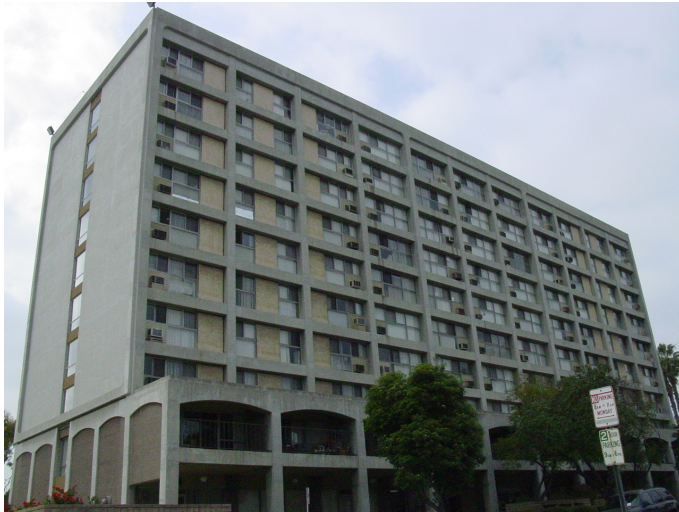
Figure 3. Exterior view of 7215 Bright. Ave. (photo by Janise Rodgers)

The ten-story Whittier Lutheran Towers building, shown in Figure 3, was designed in 1973. The structural system consists of a ductile reinforced concrete moment frame with shear walls. The building's instrumentation, shown in Figure 4, consists of three tri-axial Kinemetrics SMA-1\* analog accelerographs at the basement, 5<sup>th</sup>, and 10<sup>th</sup> floors. A number of earthquakes, most notably the nearby 1987 Whittier Narrows quake and several large aftershocks, have been recorded by the instrumentation system.

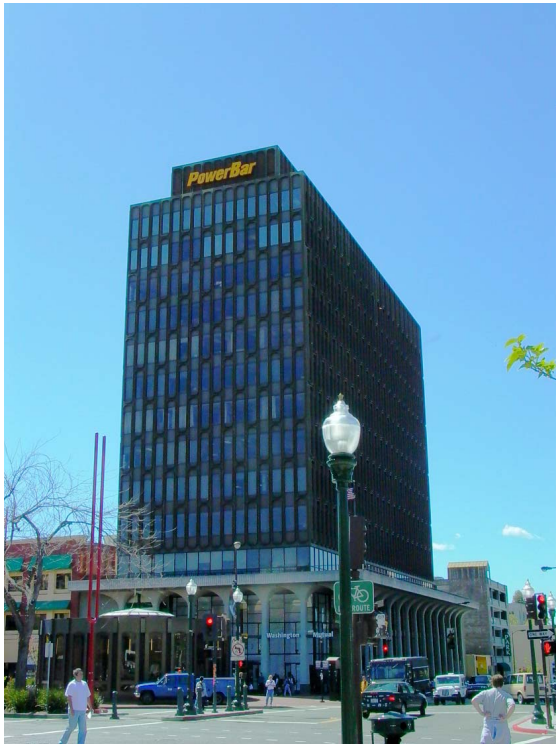
Figure 5. Exterior view of 2150 Shattuck Ave. (photo by Arnold Acosta)

The former Great Western Savings building, now adorned with a large “Powerbar” sign and accordingly dubbed the Powerbar building, was constructed in 1969. The fourteen-story building, shown in Figure 5, was constructed using an proprietary lift-slab structural system, with floors poured at the base of two concrete towers and then jacked into place. Due to the building’s proximity to the Hayward Fault (1.5 km), it underwent a limited-scope, voluntary retrofit in 2000 described in Mar et al. (2000) following a vulnerability assessment. The building’s current instrumentation scheme and ambient vibration measurement locations are shown in Figure 6. The instrumentation configuration differs slightly from that in place at the time of the 1989 Loma Prieta earthquake. Channels 10 and 11 were removed from service during a recent asbestos abatement program and have yet to be reinstalled.

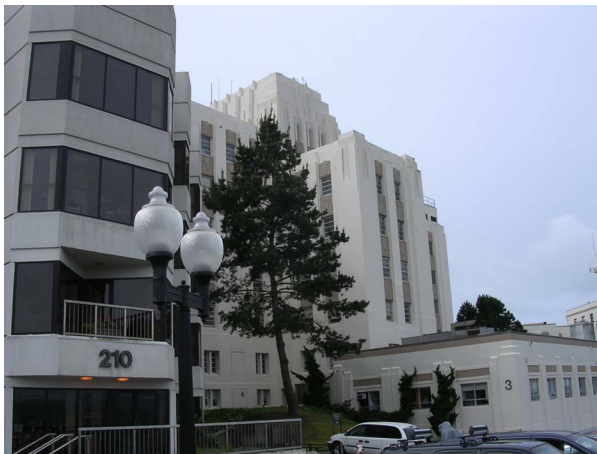
Figure 7. Exterior view of 4150 Clement St., Building 2 (photo by François Dunand)

Main Building Two of the Veterans Administration (VA) Hospital in San Francisco was constructed in the early 1930s. This seven-story C-shaped structure, shown in Figure 7, now forms the ‘backbone’ of the hospital’s nine irregular, interconnected buildings, which are laid out roughly in a delta-wing shape. The lateral force-resisting system consists of nonductile reinforced concrete frames and walls. A remodel and seismic upgrade were performed in 1988-89 before the M6.9 1989 Loma Prieta earthquake. The instrumentation and ambient vibration measurement locations are shown in Figure 8. Permanent instrumentation at the time of the Loma Prieta earthquake consisted of two tri-axial analog accelerographs, which have recently been replaced by tri-axial digital instruments.

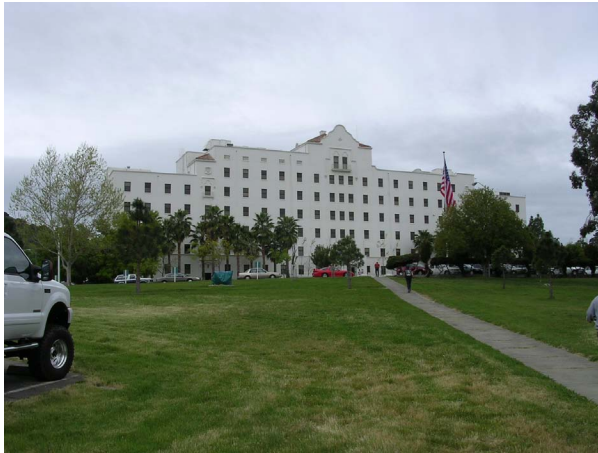
Figure 9. Exterior view of 4951 Arroyo Rd. (photo by François Dunand)

The seven-story Livermore VA Hospital, shown in Figure 9, was constructed between 1947 and 1955. The building is T-shaped and has a lateral force-resisting system consisting of reinforced concrete walls and framing. The building has had some seismic strengthening, also with reinforced concrete, but the extent is presently unknown. The instrumentation and ambient vibration measurement locations are shown in Figure 10. These analog instruments recorded the 1989 Loma Prieta earthquake and several smaller local events.

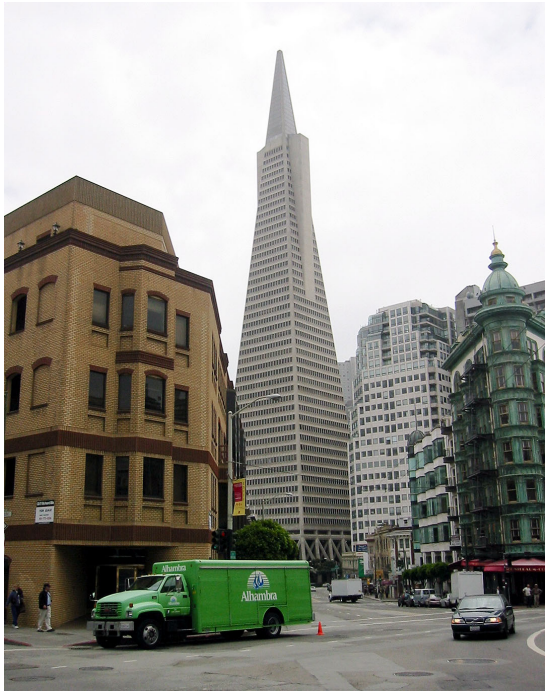
Figure 11. Exterior view of 600 Montgomery St. (photo by Dan Radulescu)

The Transamerica Pyramid, shown in Figure 11, has been one of the tallest and most recognizable of San Francisco's buildings since its construction in 1972. The building has 48 stories above ground, plus a spire, which brings its total height to over 850 feet. Its lateral force-resisting system consists of steel moment frames which slowly step back to accommodate the sloped exterior walls. The building is extensively instrumented as shown in Figure 12, and its instruments recorded the 1989 Loma Prieta earthquake. The building's accelerometers are now connected to a real-time monitoring system which streams data to a limited number of clients via secure internet connection. Ambient vibration data was acquired using this real-time system; no ambient velocity data was taken.

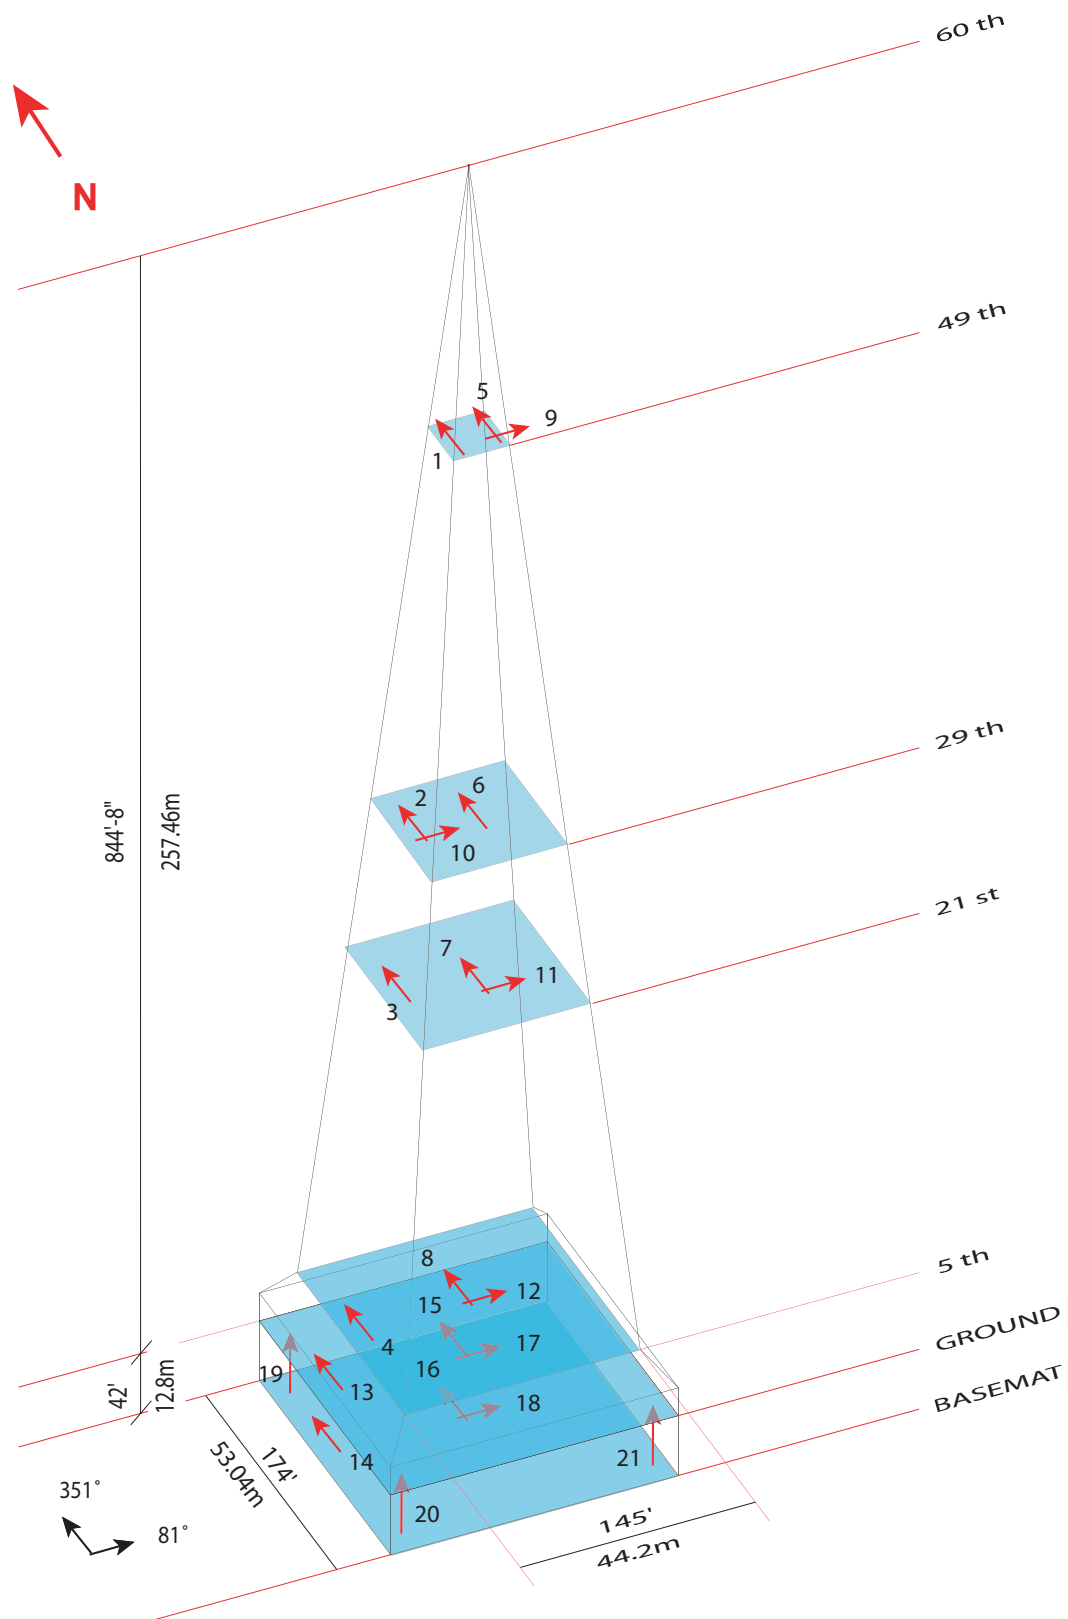
Figure 12. Instrumentation scheme for 600 Montgomery St. Lower floor channels are: 14, 15, 18, 19, 20, 21 atop basemat, 13, 15, 17 at ground level, and 4, 8, 12 at 5<sup>th</sup> floor.

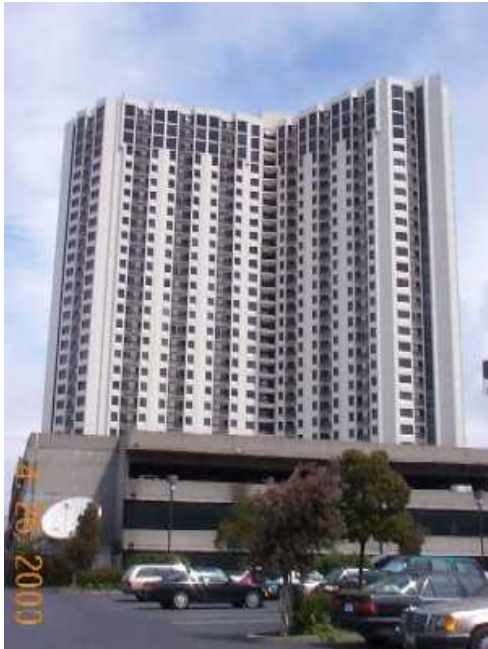
Figure 13. Exterior view of 6363 Christie Ave. with adjacent reinforced concrete parking garage in foreground (photo by Kent Fogleman).

The thirty-story Pacific Park Plaza building in Emeryville, shown in Figure 13, was constructed in 1984. The lateral force resisting system is a ductile concrete moment-resisting frame. The building has a delta wing plan (i.e. three wings equidistant at 120 degrees) and several re-entrant corners at the wing ends. There is a thin layer of young Bay Mud underlying the site. The building was extensively instrumented by the USGS with sensors configured as shown in Figure 14. The structural array is complemented by free-field and downhole instruments. The structural array and free-field instruments recorded the 1989 Loma Prieta earthquake on analog recorders, but all recorders at the site have since been replaced with digital ones.

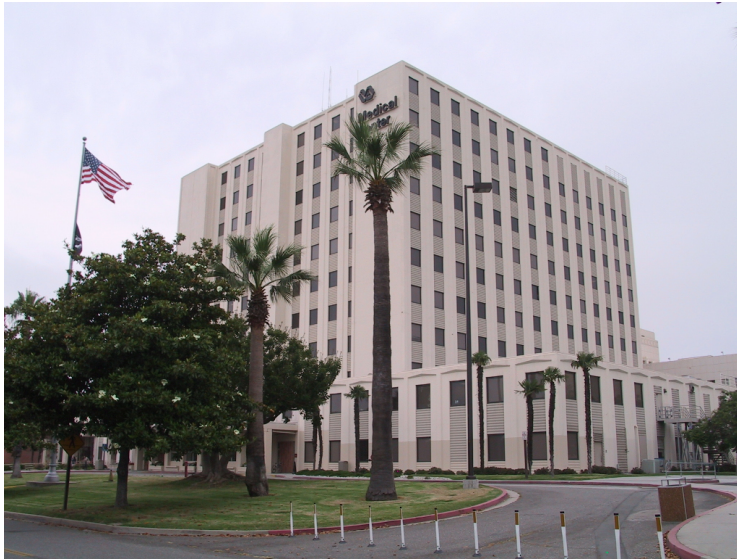
Figure 15. Exterior view of 5901 E. 7<sup>th</sup> St. (photo by Arnold Acosta)

The Long Beach VA Hospital, shown in Figure 15, is an 11-story non-ductile concrete structure constructed in the 1960s. The building was damaged in the M6.7 1994 Northridge earthquake and subsequently retrofitted with base isolation. The building's instrumentation scheme both before and after the retrofit are shown in Figure 16. The pre-retrofit scheme consisted of tri-axial analog instruments, which were replaced with a modern digital structural array following the retrofit. Several significant earthquakes were recorded prior to the retrofit, but no sizable earthquakes have been recorded since. Ambient vibration data was acquired using the permanent instrumentation system; no ambient velocity data was taken.

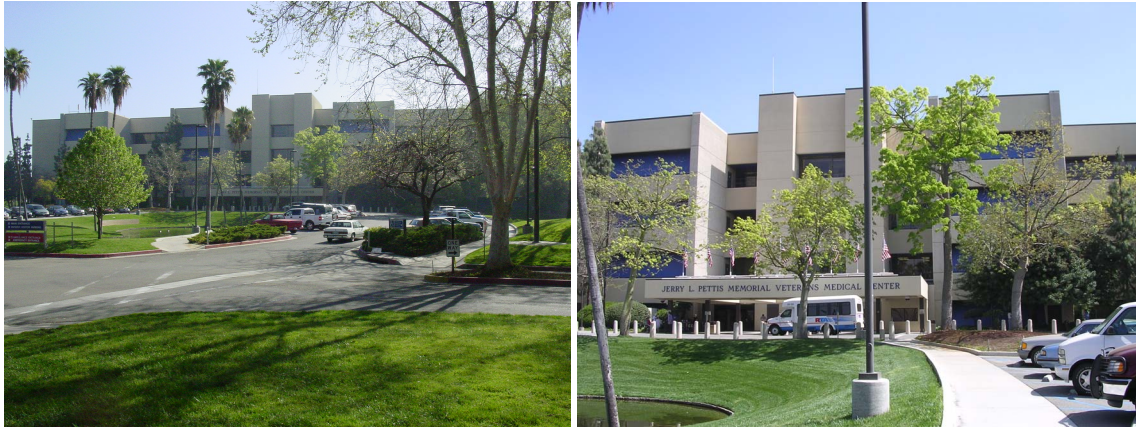
Figure 17. Wide-angle (left) and close-up (right) exterior views of 11201 Benton St. (photos by Janise Rodgers and François Dunand)

The Loma Linda Veterans Administration hospital, shown in Figure 17, is a very large building which was constructed in the late 1970s. The structure has many reentrant corners, though no setbacks. The lateral force-resisting system consists of reinforced concrete shear walls. The building is situated in the vicinity of the San Jacinto fault zone. The building's current instrumentation configuration is shown in Figure 18. Currently, only the digital tri-axial instrument in the basement is being maintained, but this situation may improve soon. A number of earthquakes have been recorded by the analog structural array in the building, and a moderately sized strong-motion data set is available.

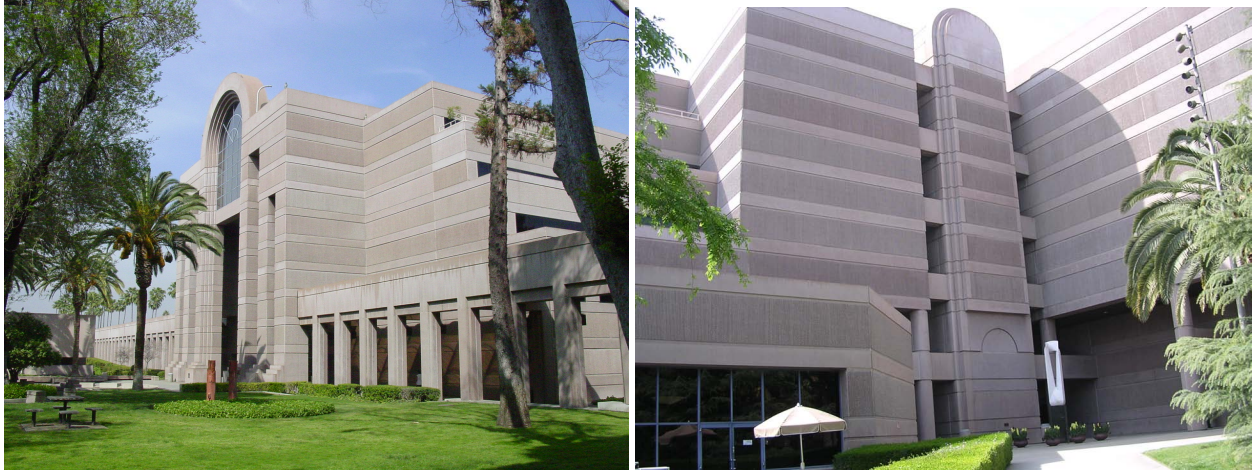
Figure 20. Front (left) and rear (right) exterior views of 345 N. Arrowhead Ave. (photos by Janise Rodgers and François Dunand)

The five-story San Bernardino County Services Building was constructed in 1984. The building's structural system is a dual system with steel moment-resisting frames in the N-S direction and steel concentrically braced frames in the E-W direction. As shown in Figure 20, the building's geometry is basically L-shaped but very irregular, with numerous setbacks and re-entrant corners. Instrumentation consists of a 12-channel structural array and a separate tri-axial instrument in a basement mechanical room on the building's south side. Analog recorders were installed in 1987, and upgraded to digital recorders in 2002.

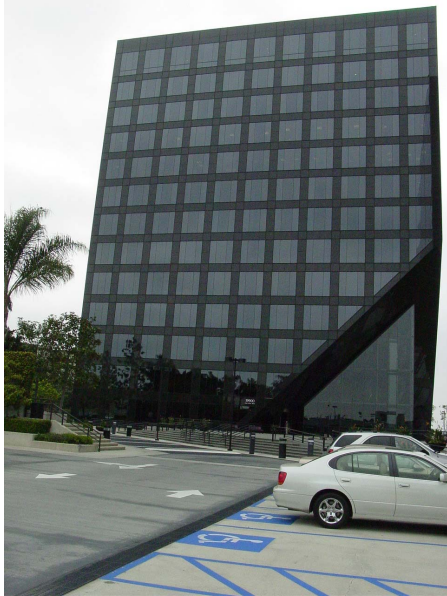
Figure 22. Exterior view of 1990 MacArthur Blvd., Tower 2 (photo by Janise Rodgers)

The 13-story Brinderson Towers are two nominally identical buildings which were constructed in the period from 1988 to 1992. The lateral force-resisting system of both buildings is a dual steel moment frame / eccentrically braced frame system. Both buildings have a notch in one corner at the base, as shown in Figure 22. The buildings are very regular otherwise. Tower 2 was instrumented with a 12-channel structural array in 1990 by the USGS. Several earthquakes, including the 1992 Landers and 1994 Northridge earthquakes, have been recorded by the structural array, and a small strong-motion data set is available.

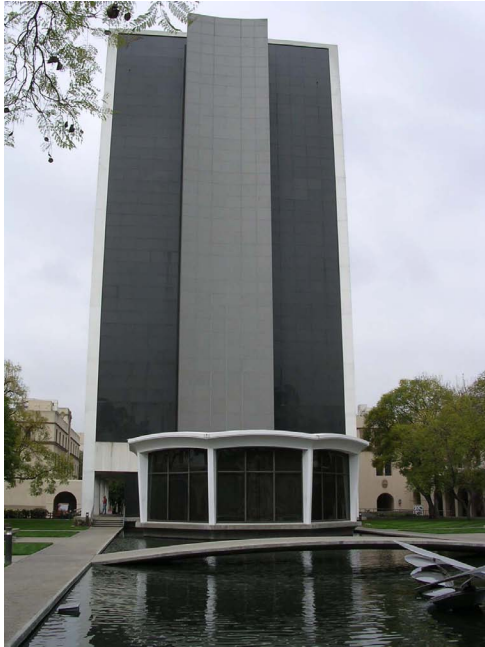
Figure 24. Exterior view of Millikan Library (photo by François Dunand)

Caltech's nine-story Millikan Library, shown in Figure 24, is one of the most extensively-studied buildings in the world. The building was constructed in 1966-67, and has recorded the building's response to a large number of earthquakes. An eccentric mass shaker is located on the roof, and numerous forced-vibration experiments have been conducted. The building's lateral force-resisting system consists of reinforced concrete shear walls in both directions. Early instrumentation consisted of tri-axial analog accelerometers at the basement and roof. The instrumentation was subsequently upgraded to the digital scheme shown in Figure 25, and there are now instruments on every floor, which are connected to both standard digital recorders and a web-based real-time monitoring system.

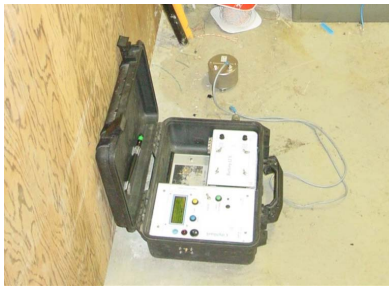
The ambient vibration tests carried out on each building were performed with vibration measurement equipment comprising two CityShark<sup>TM\*</sup> acquisition systems, each connected to one velocimeter (velocity transducer) as shown in Figure 26. The CityShark<sup>TM\*</sup> system was developed specifically for ambient vibration measurements (Chatelain et al. 2000). The analog/digital conversion processor is 24-bit. The sampling frequency can be chosen from five values between 50 samples per second (sps) and 250 sps. The gain can be set between 1 and 16384. The duration of recording can be set at any value between 1 and 60 minutes. This system is portable with its own battery and does not need a PC to run. The data are stored on a flashcard. The velocimeters are Lennartz LE-3D<sup>\*</sup> with 3 components and a weight of 1.8 Kg. The natural (eigen) frequency is 1 Hz and the upper corner frequency is more than 80 Hz.

Figure 26. The CityShark<sup>\*</sup> recorder and the Lennartz LE-3D<sup>\*</sup> velocimeter

The CityShark<sup>\*</sup> files are made of a header with record information, followed by three columns corresponding to the vertical, local north and local east components of the ambient motion. The units of these columns are counts and the conversion procedure is:

To obtain Volts : multiply by 2500000.0/32767.0 and divide by the Gain (see header)

To obtain 10<sup>-6</sup> m/s : divide the volts by 400.0 for the velocimeter Lennartz LE-3D<sup>\*</sup>
