MINERALS MANAGEMENT SERVICE

ASSESSMENT OF PERFORMANCE OF
DEEPWATER FLOATING PRODUCTION FACILITIES
DURING HURRICANE LILI

FINAL REPORT

Report No: GMH-3704-1377 Rev 1

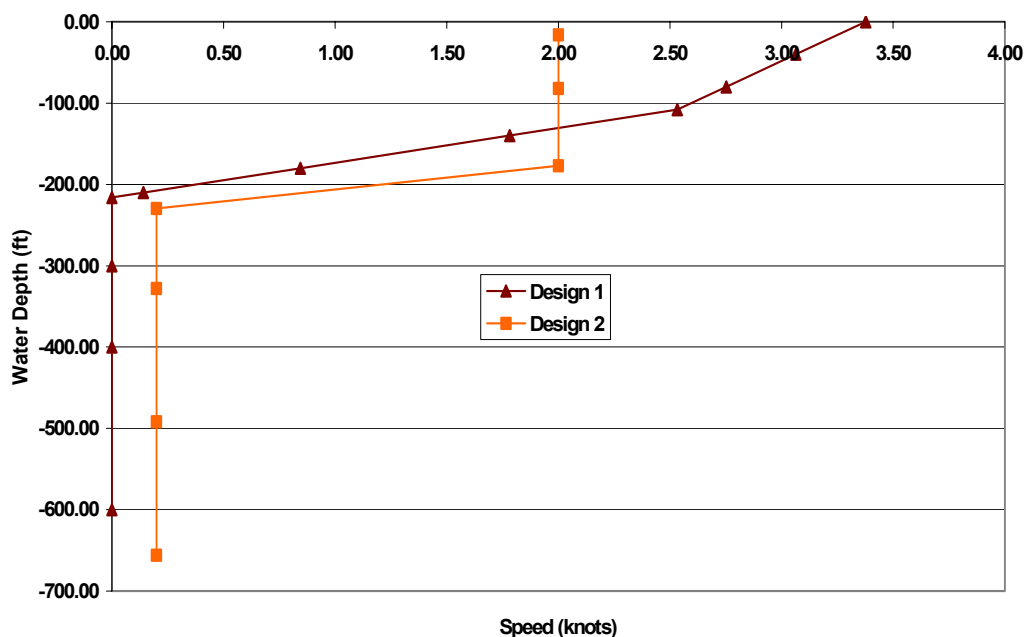
Figure 2 – Sample Design Current Profiles

2.3.3 Figure 2 shows typical design current profiles. A slab-type profile such as Design Profile 2 in Figure 2 is given by API RP 2A¹⁰ and has been applied in comparative studies⁵⁰ and also extensively used in the design of platforms in the Gulf of Mexico. The mixed layer depth (of the order of 250 ft) and current velocity (of the order of 1.9-2.0 knots) are based^{51,52} on regression statistics applied to results of numerical models calibrated against major events such as Betsy, Camille and Carmen. A sheared profile such as Design Profile 1 has been applied to response-based studies⁸⁷ and preferred in more recent platform designs.

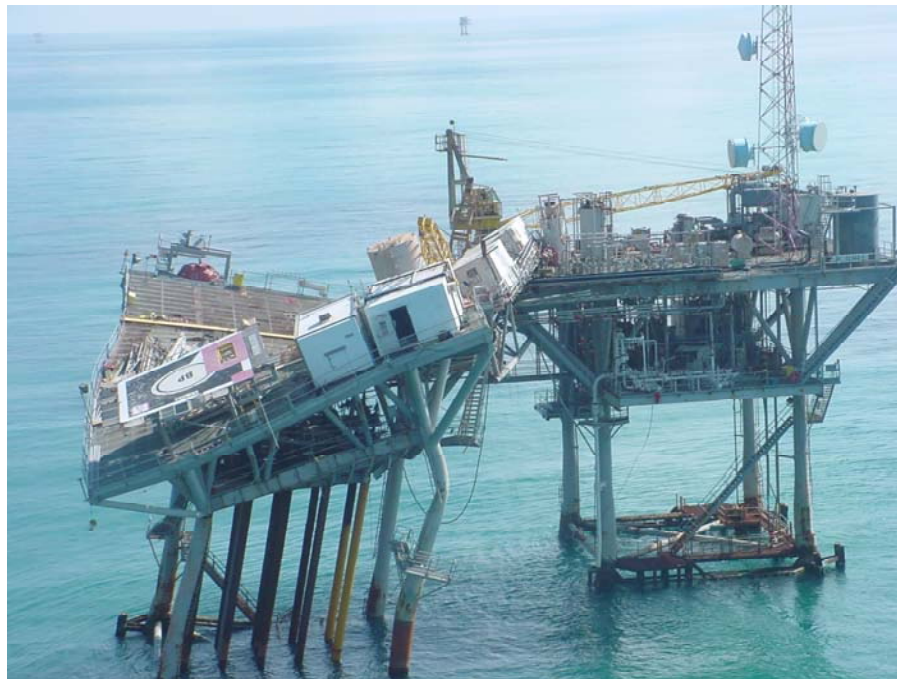
Figure 6 – Fixed Platform Damaged by Hurricane Lili

3.1.3 Hurricane Lili caused significant damage to some fixed offshore production platforms, Figure 6, as well as to mobile drilling units.

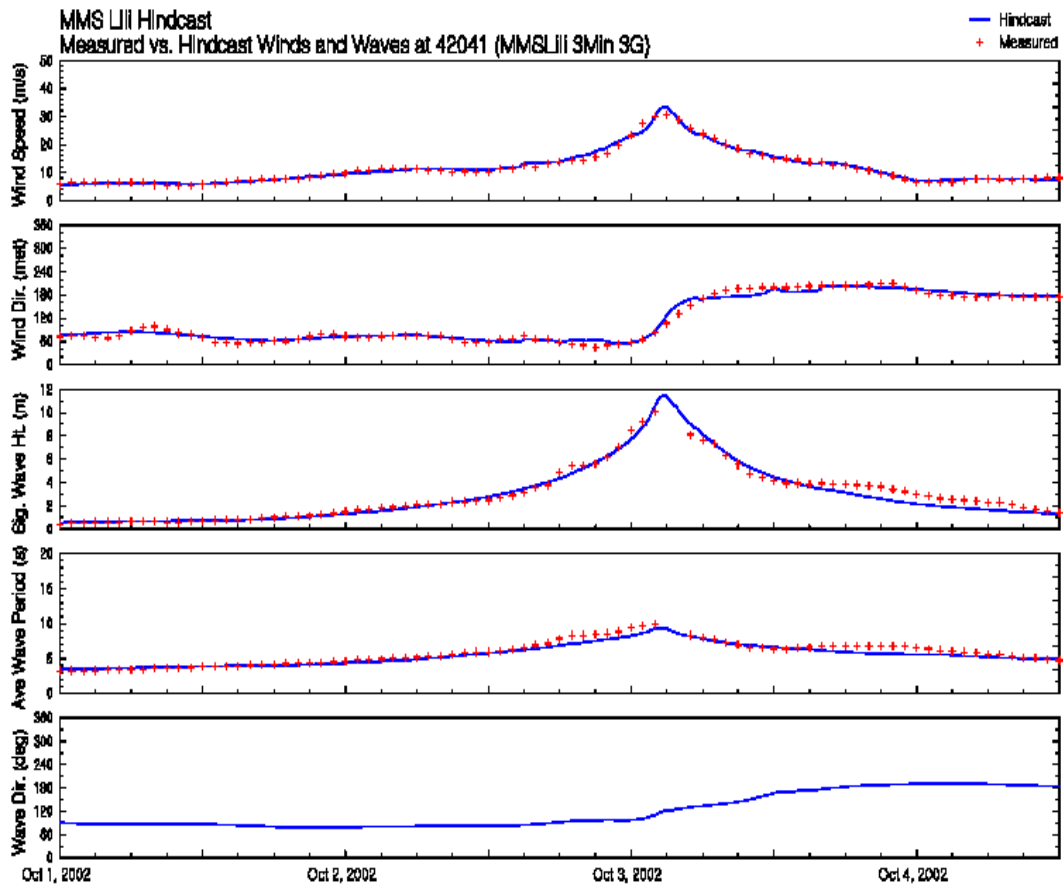
Figure 10 –Data for Buoy 42041²

- 3.3.4 Figure 10 shows good agreement between the hindcast and the measurements for Buoy 42041 in terms of winds and seastates. The results of the hindcast model for the Buoy 42041 location show the maximum wave height and wind speed at that location during the early hours of October 3rd, 2002 at around 3:00am GMT. A peak significant wave height of 33.1ft was measured at 1:00am GMT. A larger significant wave height of 40.4ft was measured at 3:00 GMT but later dropped by NDBC due to quality control concerns. Further contact with NDBC indicated that this higher significant wave height value is reasonable but was not considered 100% reliable due to signal parity problems.

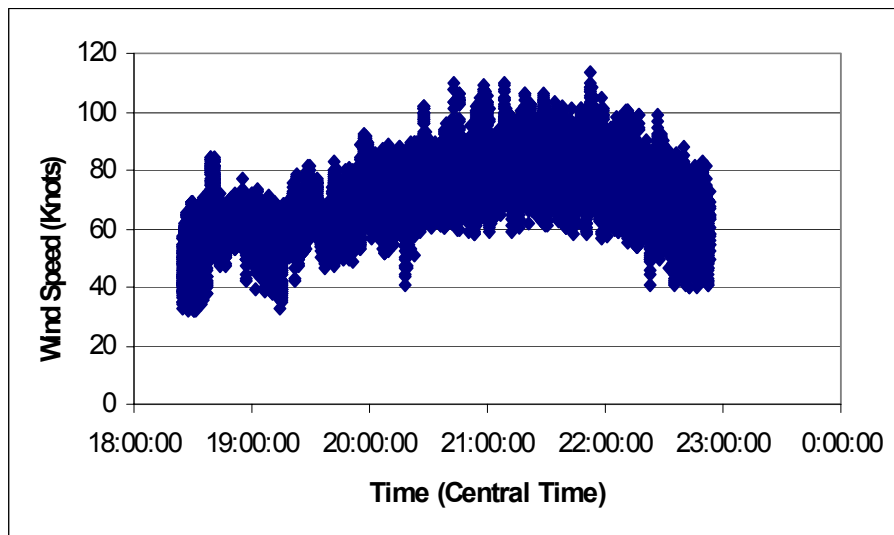
- 3.3.5 Unfortunately, lightning damaged the wave probe at Brutus and no measured wave data is available from any of the floating production units.
- 3.3.6 The wind measurements at Brutus (recorded according to Central Standard Time) indicate peak winds occurring at around 4:00 am GMT (22:00 pm CST). It can be observed that peak wind speeds were only sustained for a period of about 2.0 hours as shown in Figure 11 and not 3.0 hours as usually adopted in design.

Figure 11 – Time Series, Wind Speed, Anemometer 21 (from 0:00 am GMT to 6:00 am GMT)

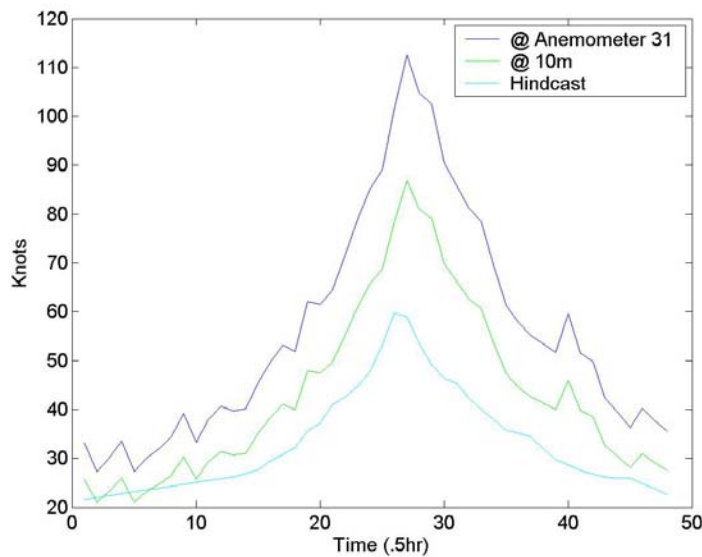
- 3.3.8 The 1/2-hour mean wind velocity at ten meters above sea level was estimated from the wind velocities measured by the anemometers at Brutus based on the ‘API’ wind profile. The results are given in Figures 13 and 14 and the hindcast wind velocities were lower than those calculated from the measurements. The maximum 1/2-hour mean wind velocity at 10m above sea level calculated from the measurements reduced by 5% when adopting the ‘NPD’ wind profile⁹⁰ thus reducing the discrepancy.

Figure 14 - Half-hour Wind Velocity at Anemometer 31 during Hurricane Lili

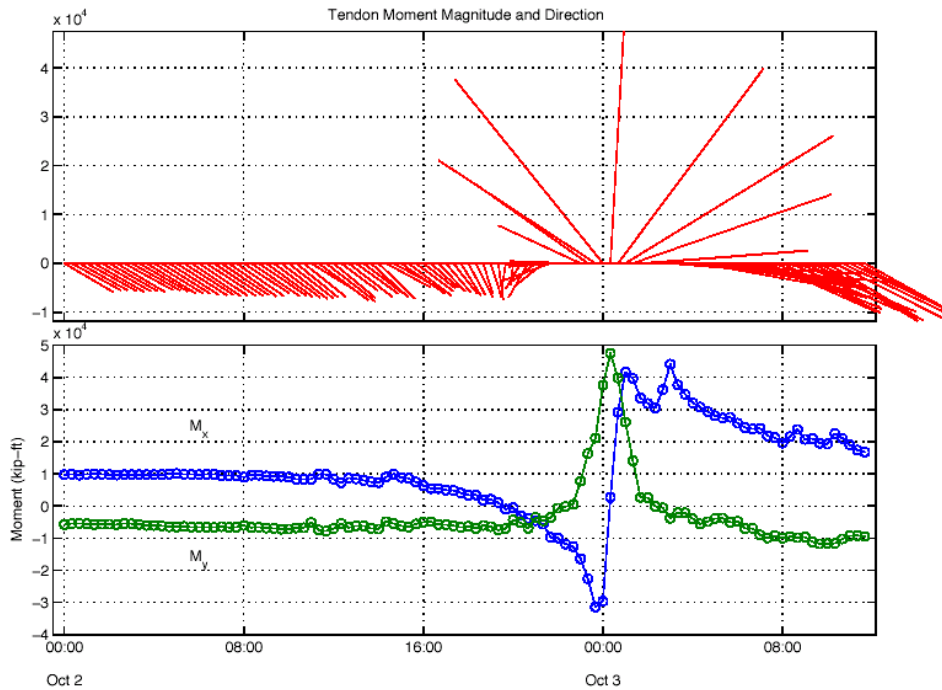
3.4.4 A similar change in wind direction was also inferred from the mean moment on Typhoon calculated from the measured tendon tensions⁶⁴, Figure 18.

Figure 18 – Mean Overturning Moment, inferred from Tendon Tensions⁶⁴

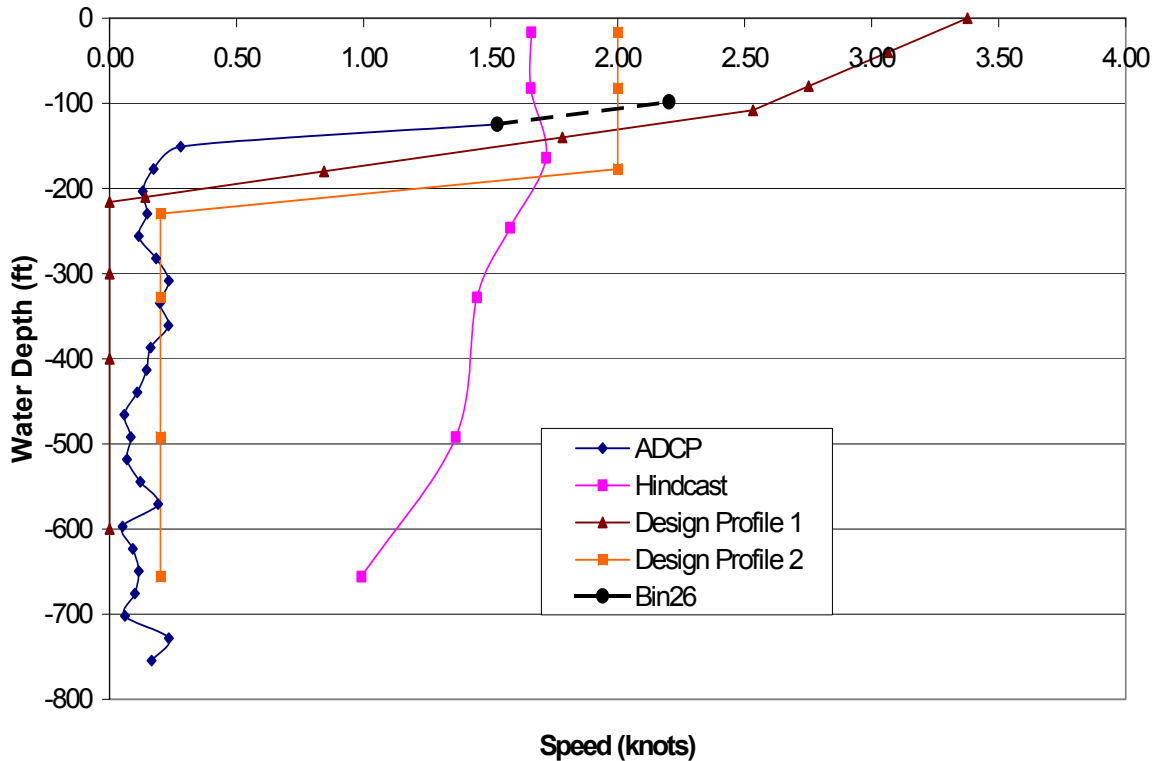
3.5.13 Figure 21 shows the current profile measured by the ADCP unit (excluding data above 29m below the surface) in comparison with sample design current profiles and the hindcast current profile at the time of the peak hindcast waves at Genesis.

Figure 21 – Current Profiles at the Time of Hindcast Peak Waves (October 3rd 3:40 AM GMT)

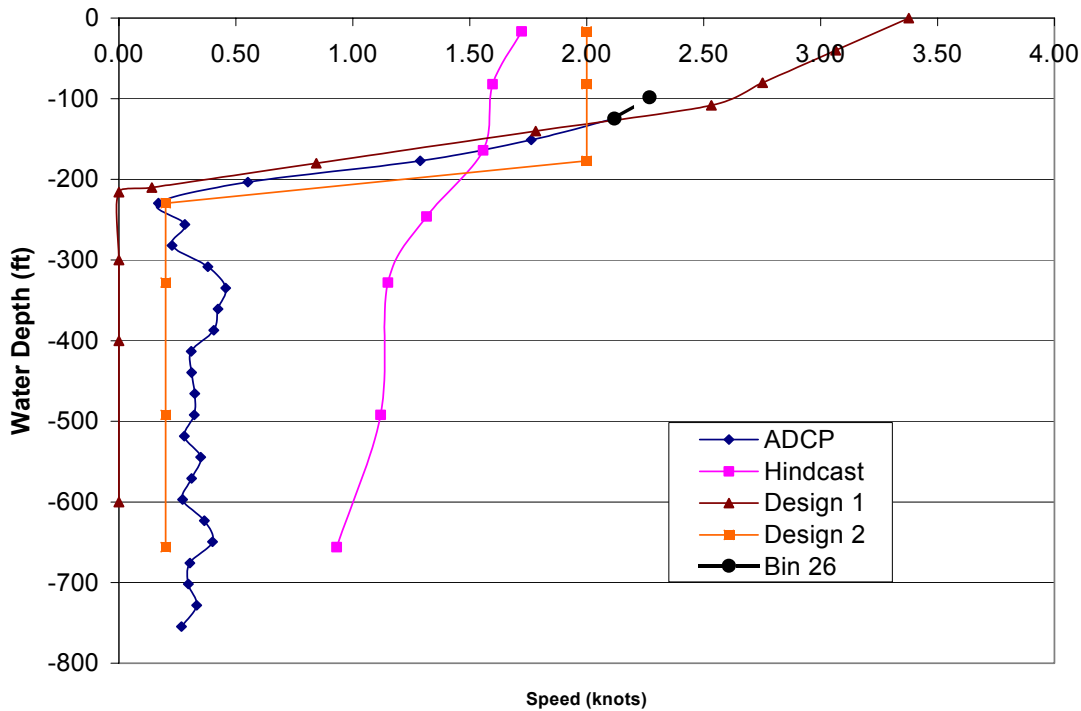
3.5.14 Figure 22 shows the same comparison for 27 hours after the occurrence of the peak hindcast winds at Genesis. The seastates here have subsided to a significant wave height of less than 13ft.

Figure 22 – Inertial Current Profile (October 4th 6:50 AM GMT)

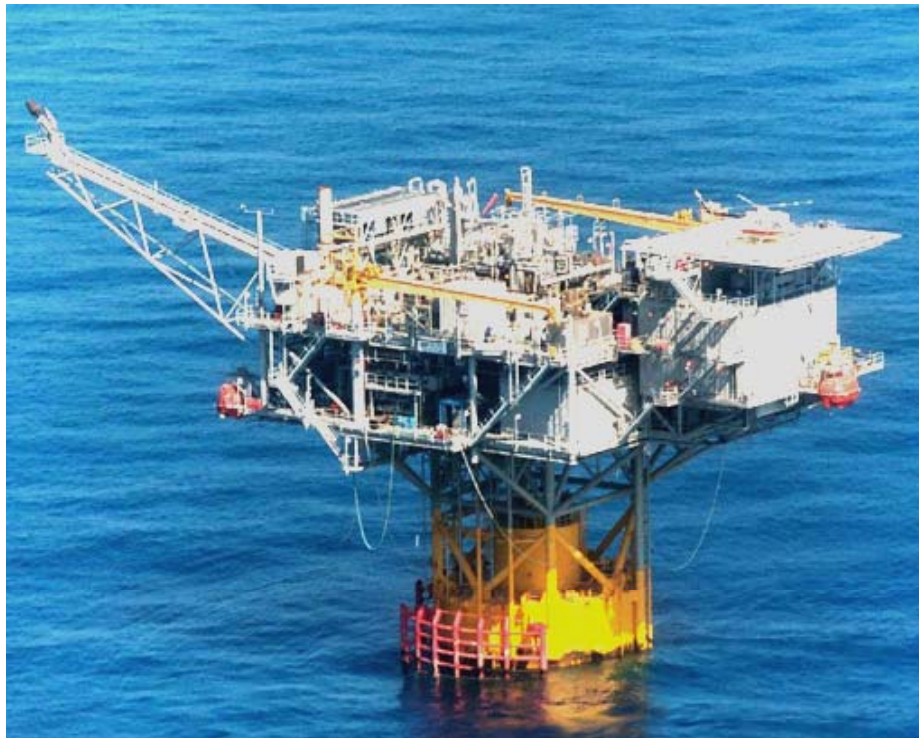
- 4.1.1 Typhoon, Morpeth and Allegheny are of Atlantia Offshore's wet tree SeaStar® design⁷³⁻⁷⁵, consisting of a mono-column hull that includes tendon porches extending radially outward, a conventional trussed deck structure and a tubular structure for the deck to hull transition. It provides a stand-alone production facility to support a number of subsea wells. Wells are tied-back to the platform via flexible production risers or steel catenary risers (SCRs).

Figure 23 – Allegheny TLP (Payload 4,000 tonnes, Water Depth 3,300ft)⁷³

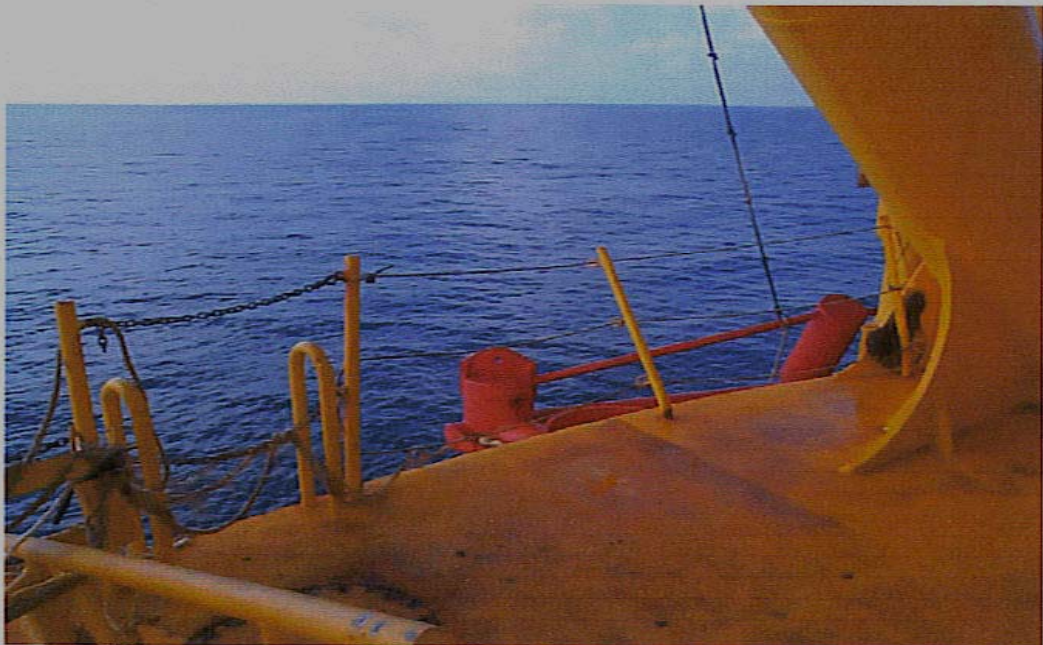
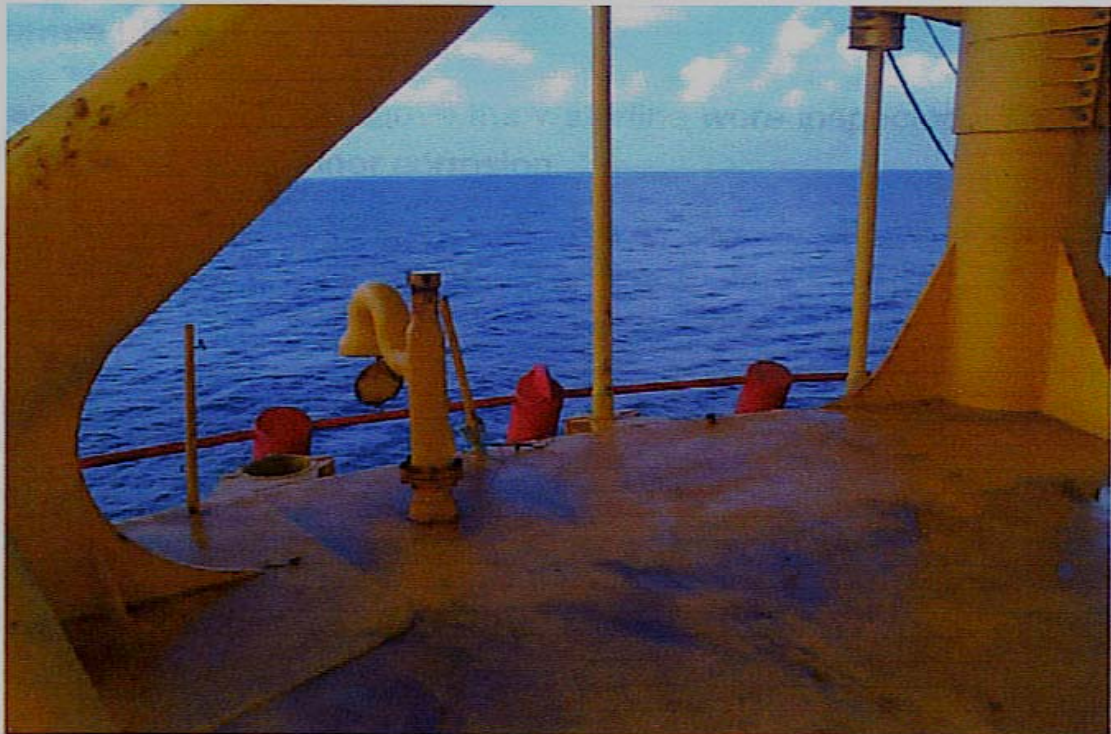
- 4.1.3 Overall, the platform was found to be structurally sound with no structural failures or cracks. Inspection of the underwater portion of the hull, appurtenances, top connectors, tendon porches, tendons and pile connector did not indicate any damage. No signs of scour in the seabed were found.
- 4.1.4 Minor damage was observed to ladders, ladder cages and handrails due to Lili, Figures 24 and 25.

Picture 2.6-3 – Missing or Bent Handrails due to Hurricane Lili

Picture 2.6-2 – Missing or Bent Handrails due to Hurricane Lili

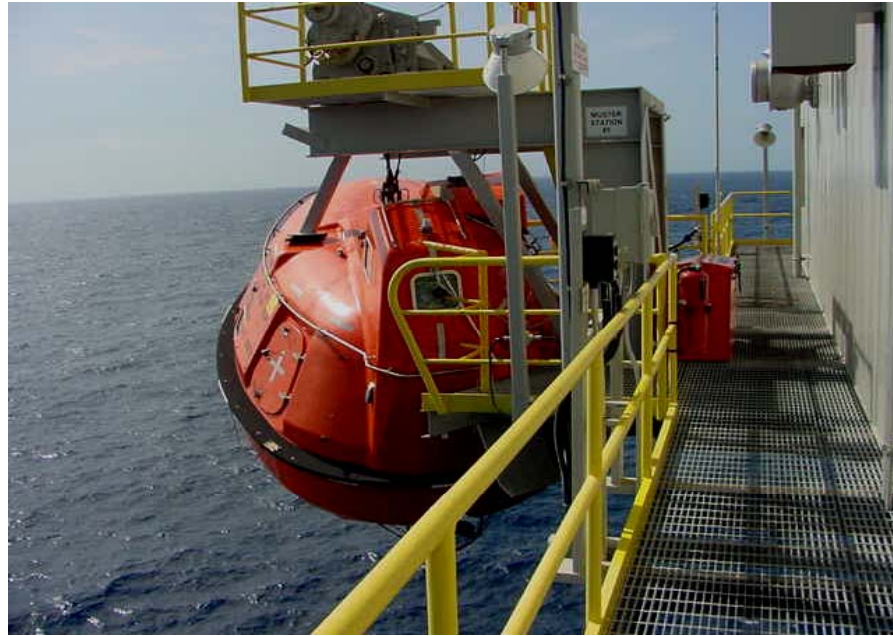
Figure 28 – Damage to Lifeboats at Typhoon

4.1.8 Lifeboats were damaged possibly due to failure of its securing equipment, Figures 27 to 30.

Damage was observed to deck equipment in some units due to the motions during Lili. A review of the procedures for securing critical equipment during major environmental events is recommended. Damage was also observed to equipment located in the air gap of some of the units. Such damage appears to be consistent with design predictions for wave crest, wave run-up and green water loading but a more detailed assessment should be carried out in the future.

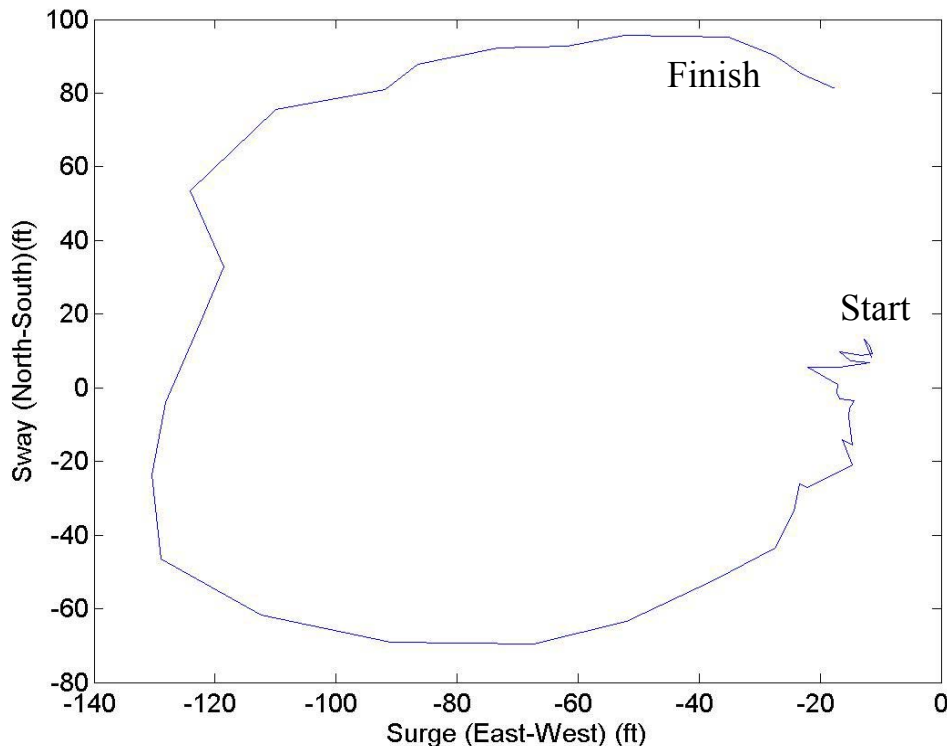
5.2.1 Figure 35 shows the trajectory of Brutus based on the half hour mean offsets. Figure 35 considers 48 hours of monitoring data that included the maximum environmental conditions during Lili.

Figure 35 - Brutus' Offset during Hurricane Lili

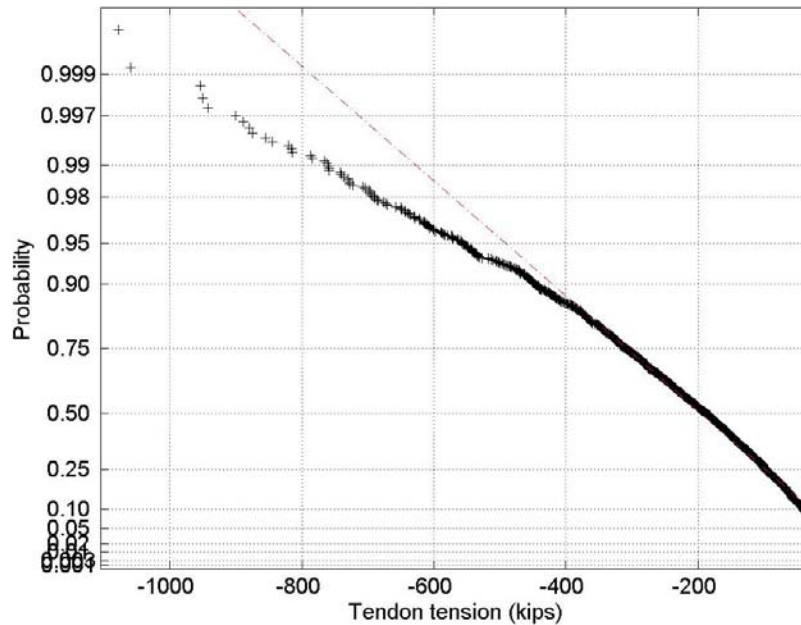
5.3.10 Likewise, comparisons between measured minimum peak tendon tensions and a Rayleigh distribution (straight line in the plots) may be viewed in Figures 42 - 45. Minimum tendon peaks exhibit trends similar to maximum tendon peak distributions with extreme values deviating from the Rayleigh distribution but within expectations.

Figure 42 - Probability of T2 Minimum Peak Tendon Tension for TI 15

Figure 43 - Probability of T5 Minimum Peak Tendon Tension for TI 15

Figure 44 - Probability of T8 Minimum Peak Tendon Tension for TI 18

Figure 45 - Probability of T11 Minimum Peak Tendon Tension for TI 15
